MINERALS PROGRAM INSPECTION REPORT

MINE NAME: Silt Pit	MINE/PROSPECTING ID#: M-1981-202-SG	MINERAL: Sand and gravel	COUNTY: Garfield
INSPECTION TYPE: Monitoring	INSPECTOR(S): Amy C. Yeldell	INSP. DATE: March 3, 2017	INSP. TIME: 12:00
OPERATOR: Flag Resources Inc	OPERATOR REPRESENTATIVE: Fred and Eric Frei	TYPE OF OPERATION: 112c - Construction Regular Operation

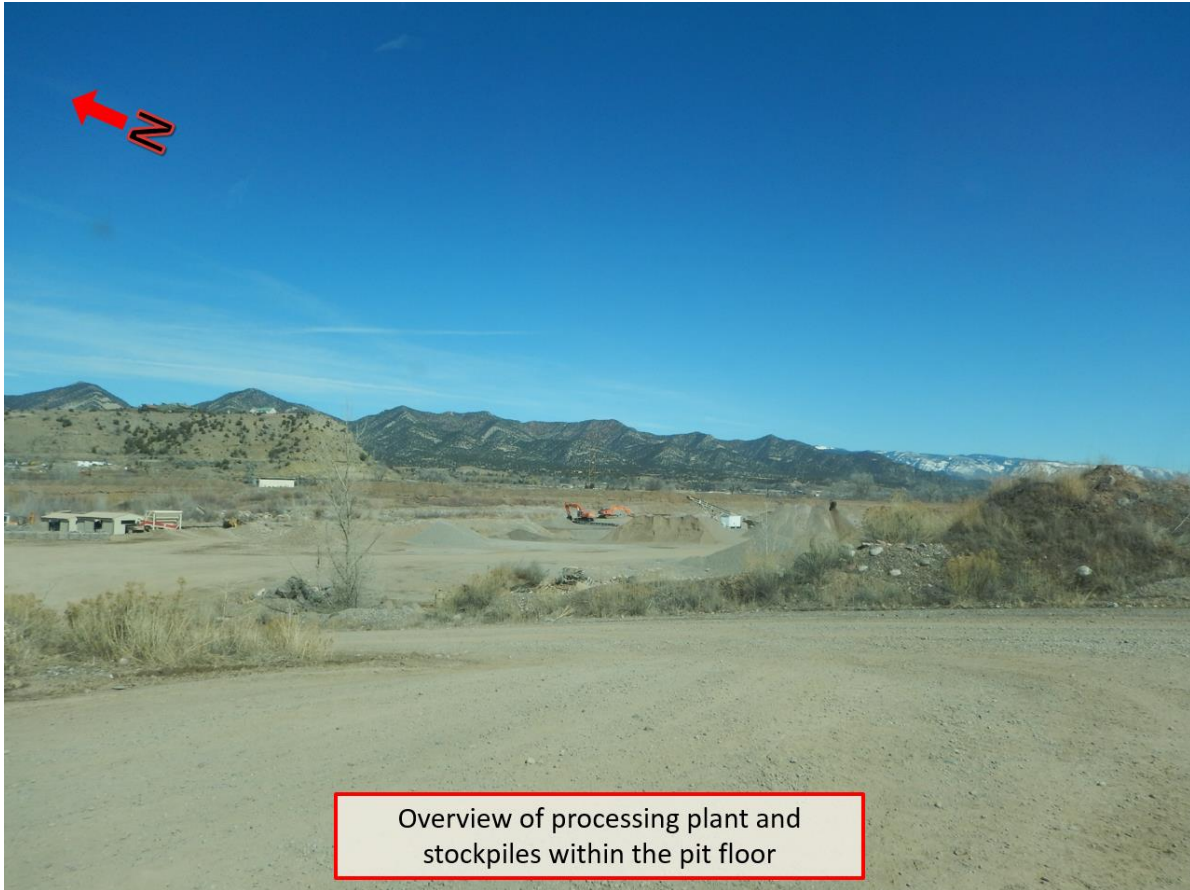
Overview of processing plant and stockpiles within the pit floor

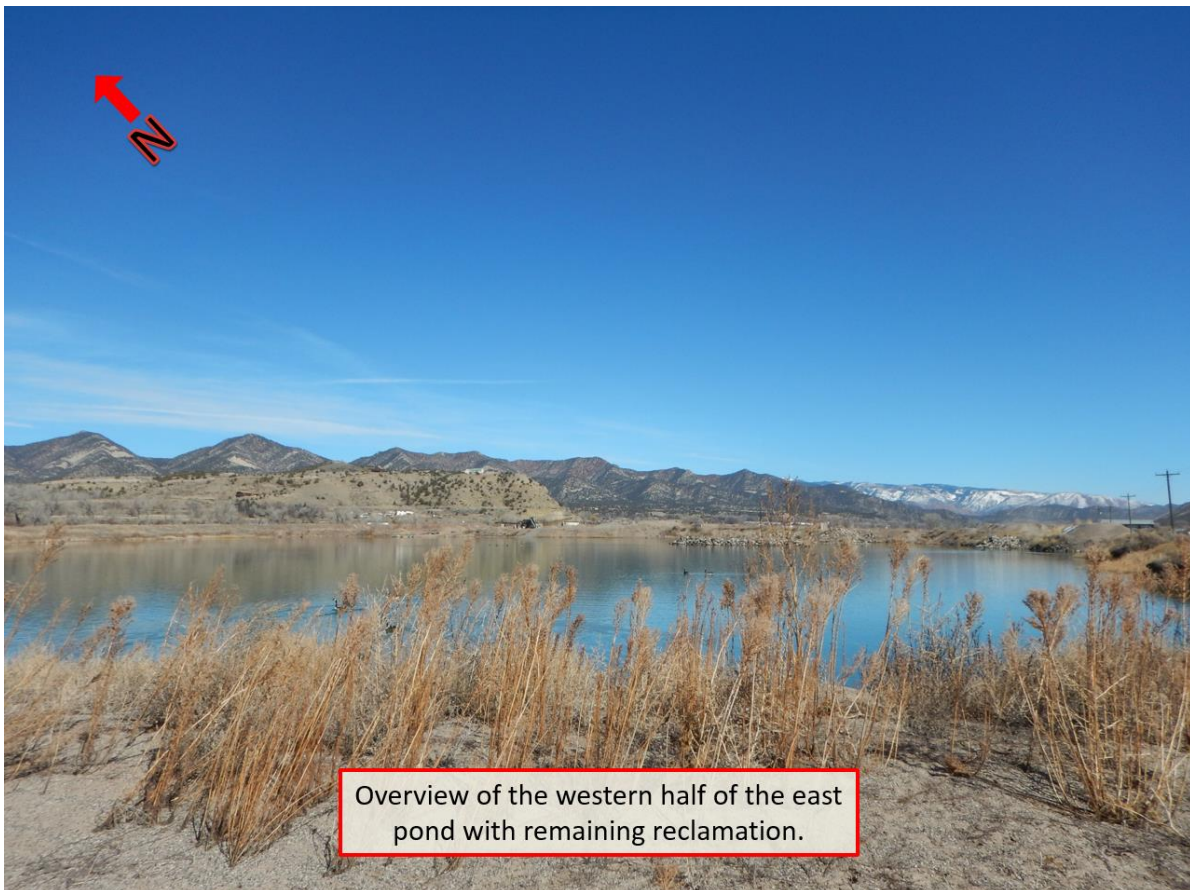
Overview of the western half of the east pond with remaining reclamation.
