MINERALS PROGRAM INSPECTION REPORT
PHONE: (303) 866-3567

MINE NAME: Lykins Gulch	MINE/PROSPECTING ID#: M-2000-090	MINERAL: Dolomite and Sandstone	COUNTY: Boulder
INSPECTION TYPE: Monitoring	INSPECTOR(S): Amy Eschberger	INSP. DATE: March 22, 2017	INSP. TIME: 09:00
OPERATOR: Loukonen Bros. Stone Company	OPERATOR REPRESENTATIVE: Michael Loukonen	TYPE OF OPERATION: 110c - Construction Limited Impact	
REASON FOR INSPECTION: Normal I&E Program	BOND CALCULATION TYPE: Partial Bond	BOND AMOUNT: \$21,000.00	
DATE OF COMPLAINT: NA	POST INSP. CONTACTS: None	JOINT INSP. AGENCY: None	
WEATHER: Clear	INSPECTOR'S SIGNATURE:

M2000-090 / Lykins Gulch / Loukonen Bros. Stone Company

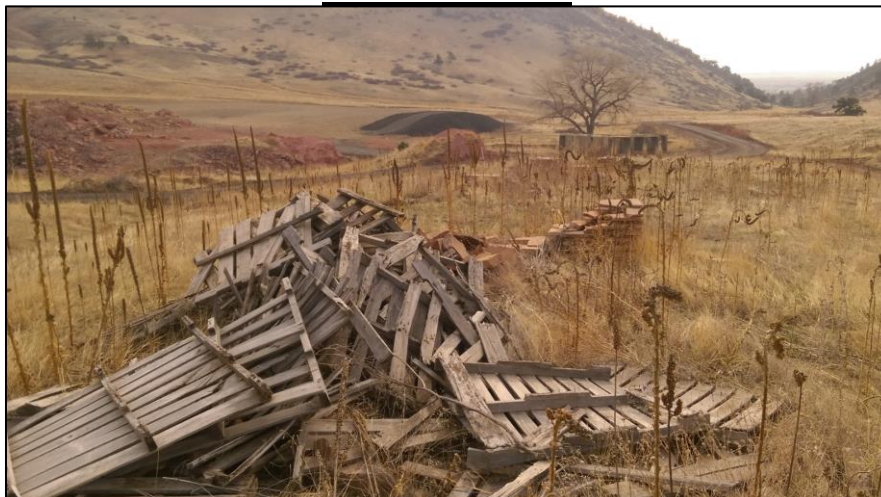
The Division observed the storage area adjacent to the main access road (**Photos 1-4**), which the operation uses for staging of equipment, storage of palletized material, and stone working. The Division observed a group of concrete culverts stored adjacent to the main access road, but outside of the permitted storage area. The Division also observed a stockpile of asphalt grindings (**Photo 5**) present north of the main access road, and southeast of the old dolomite quarry, which are outside of the permit area. The operator indicated this material was brought in by the county transportation department to be stored temporarily for nearby road improvement projects. Because the culverts and asphalt stockpile do not appear to be associated with the mine operation, the Division will not consider it affected land. However, the operator should be cautious in storing any construction-related materials or equipment close to the permitted areas, as it could be considered off-site damage.

Photo 1. View looking southeast across one acre storage area located adjacent to main access road. Note storage of wooden pallets.

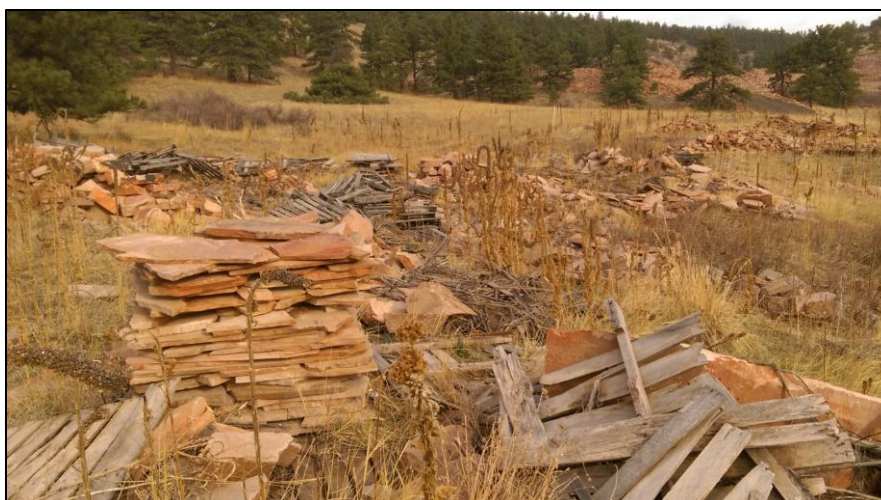
Photo 2. View looking north across one acre storage area located adjacent to main access road. Note storage of quarried stone and wooden pallets.

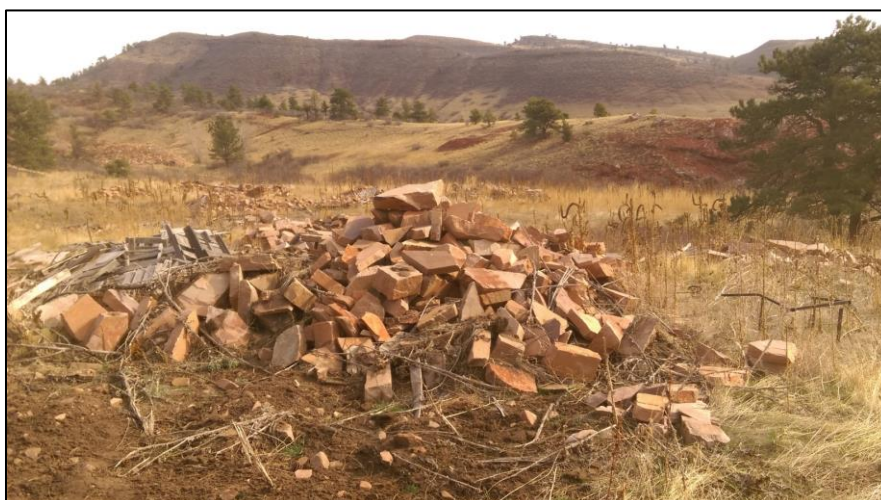
Photo 3. View looking northeast across one acre storage area located adjacent to main access road. Note storage of quarried stone.

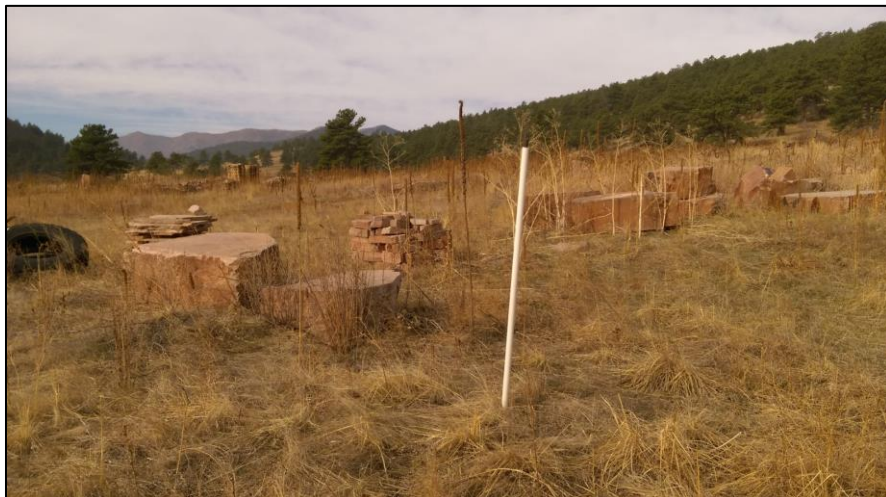
Photo 4. View of northwestern corner marker for one acre storage area located adjacent to main access road.

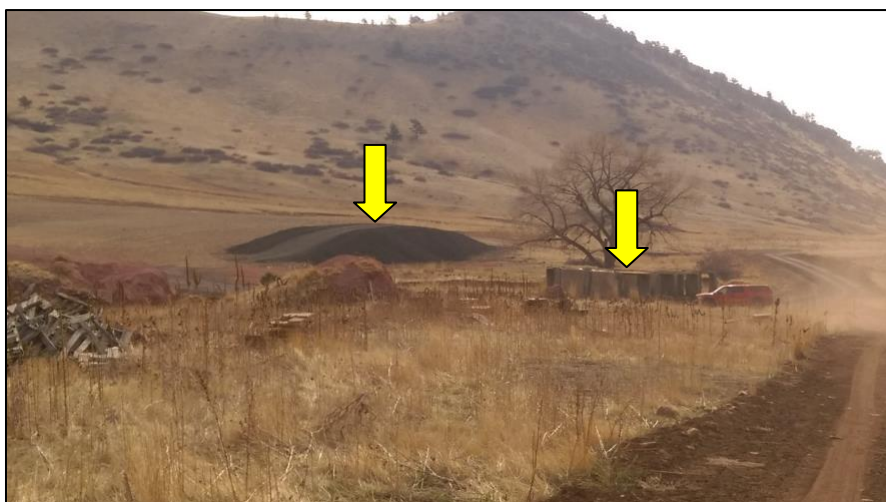
Photo 5. View of asphalt grindings stockpile (indicated) and concrete culverts (indicated) stored north of main access road, outside of permitted storage area.

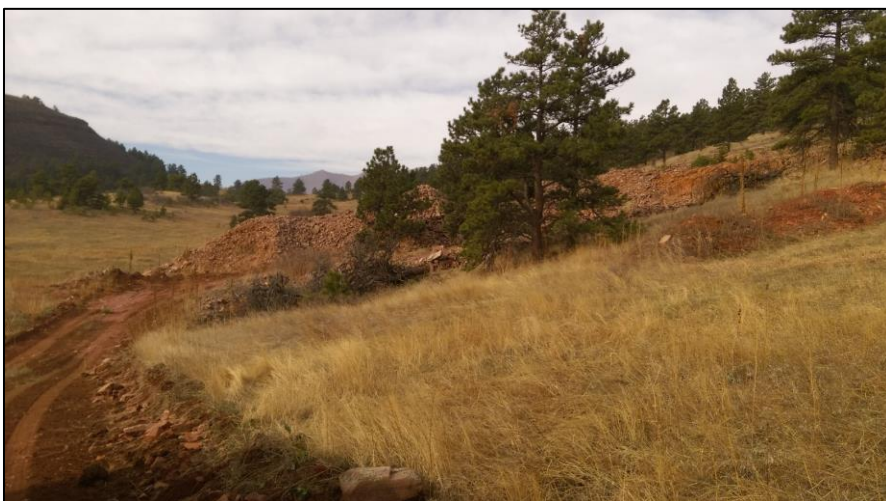
The Division observed the south quarry (**Photos 6-10**), which includes two primary working benches and various stockpiles of overburden and waste rock at the toe of the excavations. The operator appears to be mining the south quarry generally westward. The permitted acreage for the south quarry is 2.5 acres. The Division estimates the operation has disturbed approximately 1.15 acres in the south quarry area. The Division observed the north quarry (**Photos 11-18**), which includes three primary working benches and various stockpiles of overburden and waste rock at the toe of the excavations. The operator appears to be mining the north quarry generally westward and northward. The permitted acreage for the north quarry is 5.5 acres. The Division estimates the operation has disturbed approximately 2.5 acres in the north quarry area.

Photo 6. View looking south from access road, showing south quarry in distance.

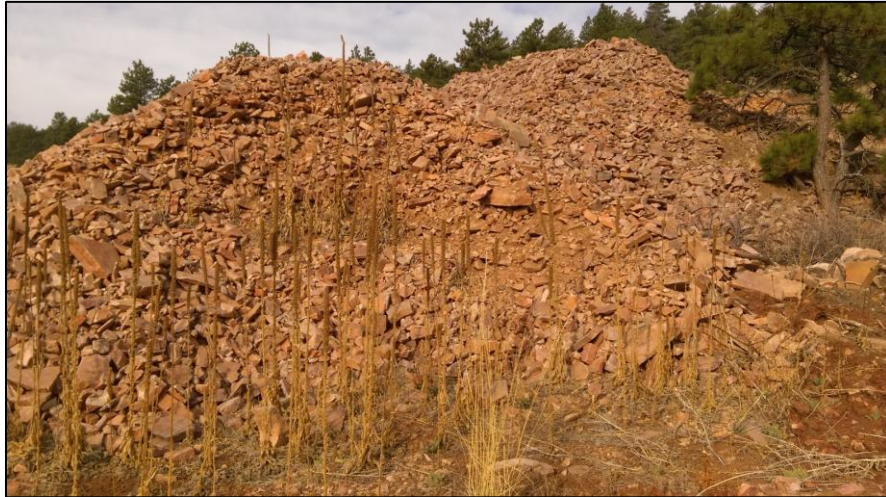
Photo 7. View of waste rock stockpiled at toe of excavation in south quarry.

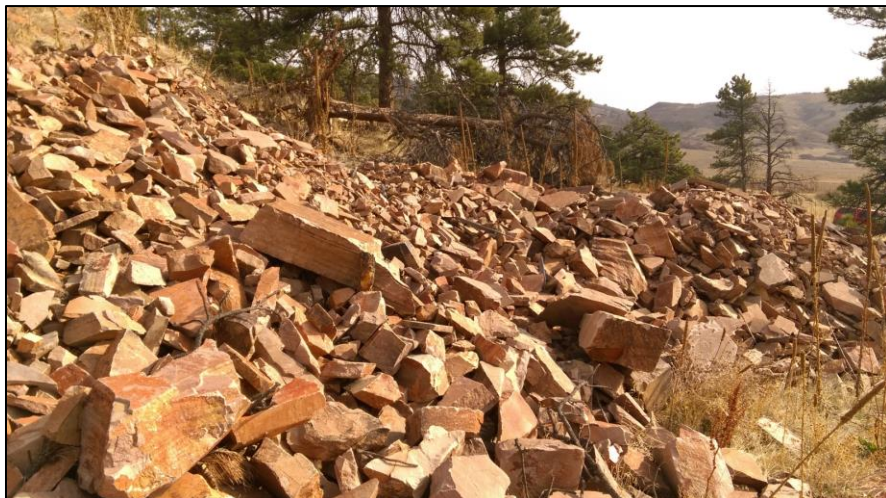
Photo 8. Another view of waste rock stockpiled at toe of excavation in south quarry.

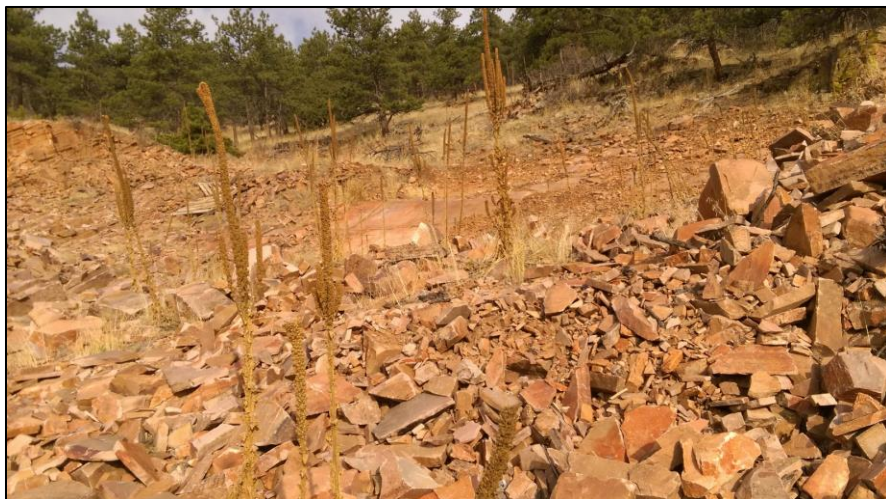
Photo 9. View of northern working bench in south quarry.

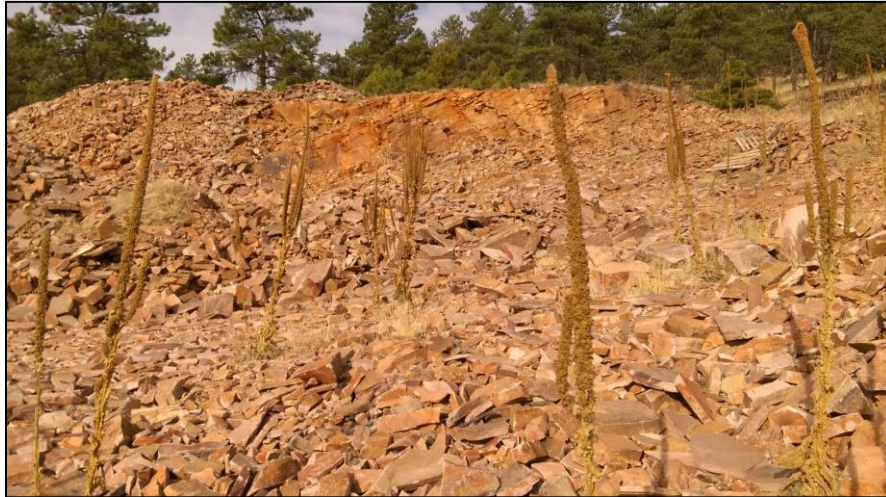
Photo 10. View of western working bench in south quarry.

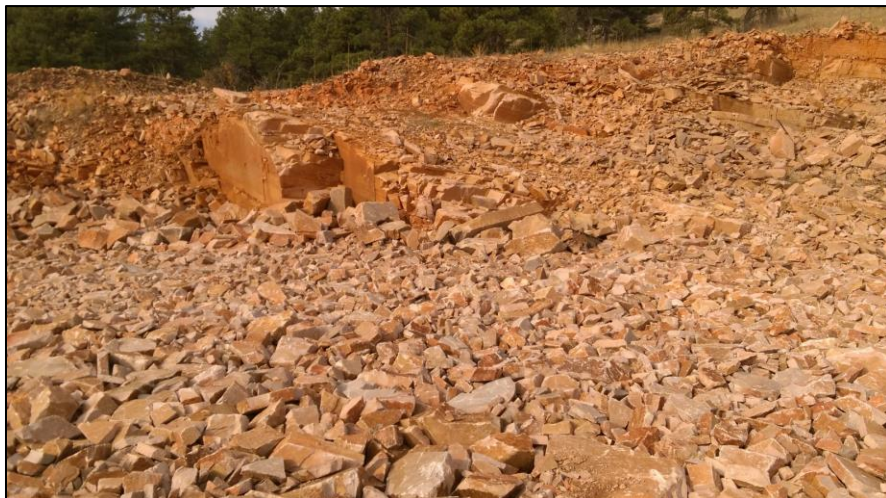
Photo 11. View of working bench near entrance of north quarry.

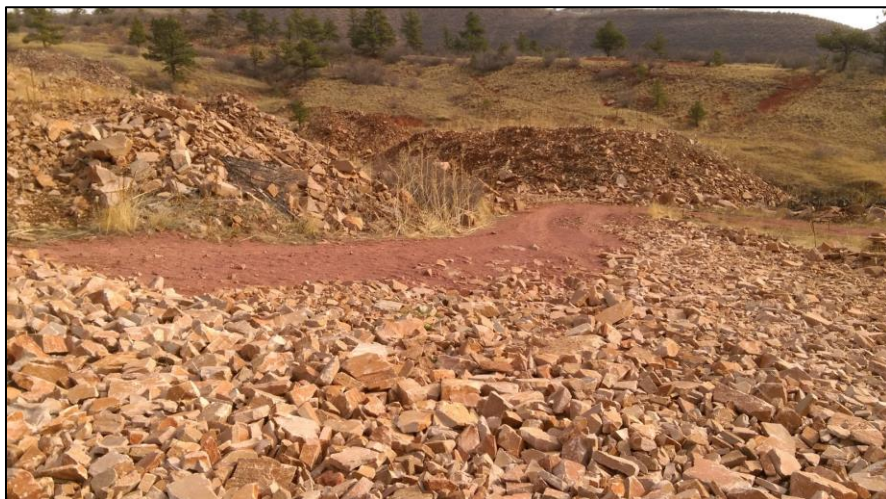
Photo 12. View of waste rock stockpiled at toe of excavations in north quarry.

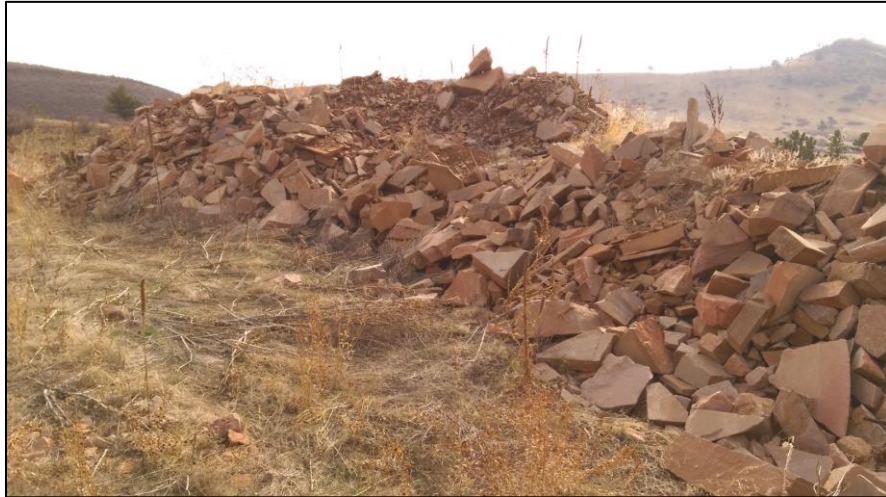
Photo 13. View of waste rock stockpiled at toe of excavations in north quarry.

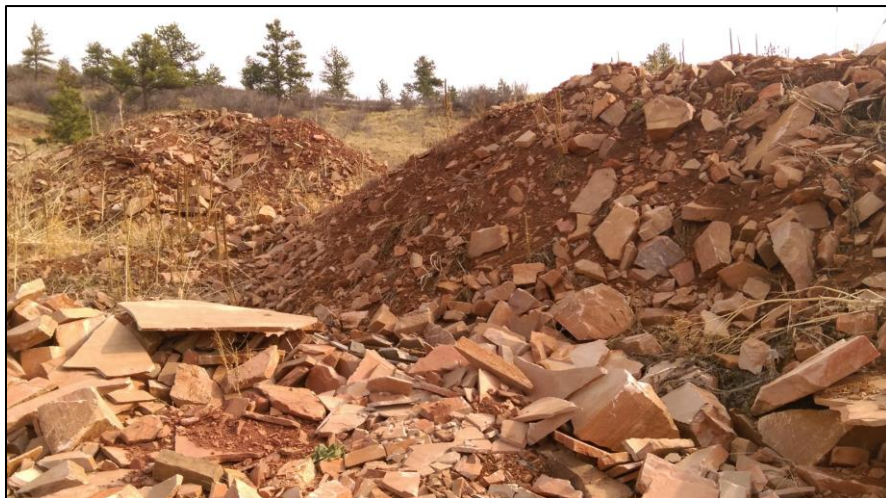
Photo 14. Another view of waste rock stockpiled at toe of excavations in north quarry.

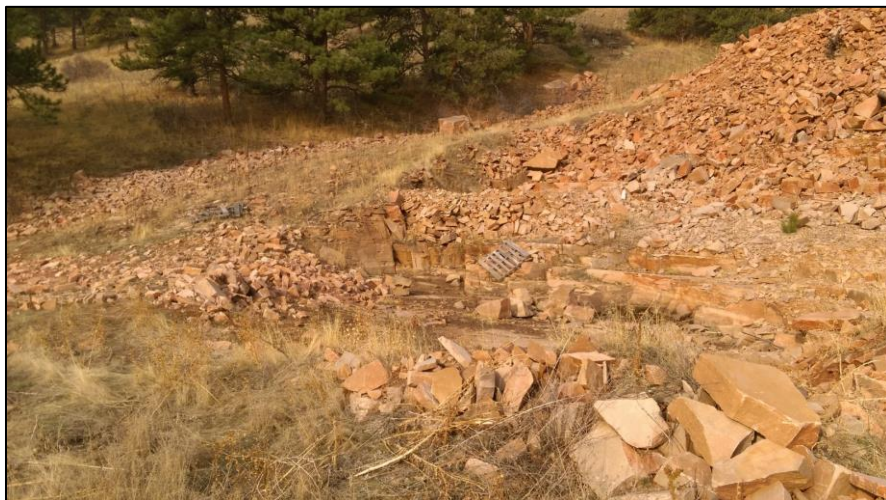
Photo 15. View of central working bench in north quarry.

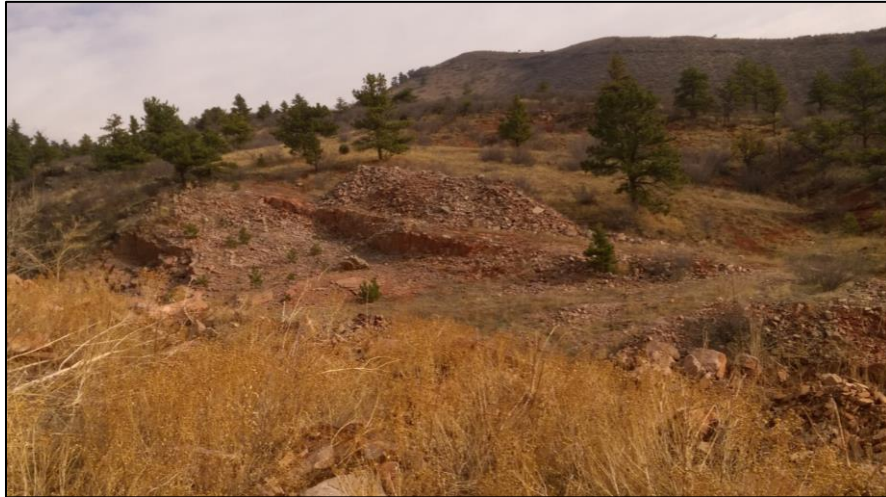
Photo 16. View looking northeast showing working bench located east of gulch in north quarry.

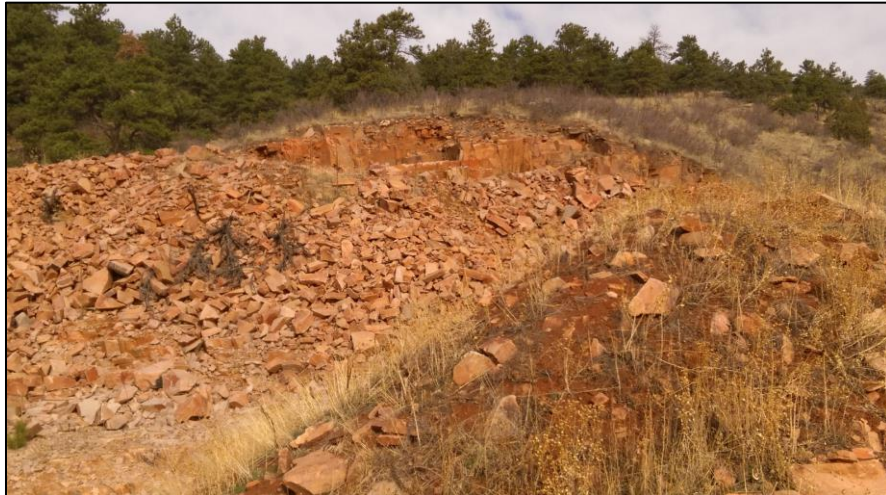
Photo 17. View of working bench at top of ridge in north quarry.

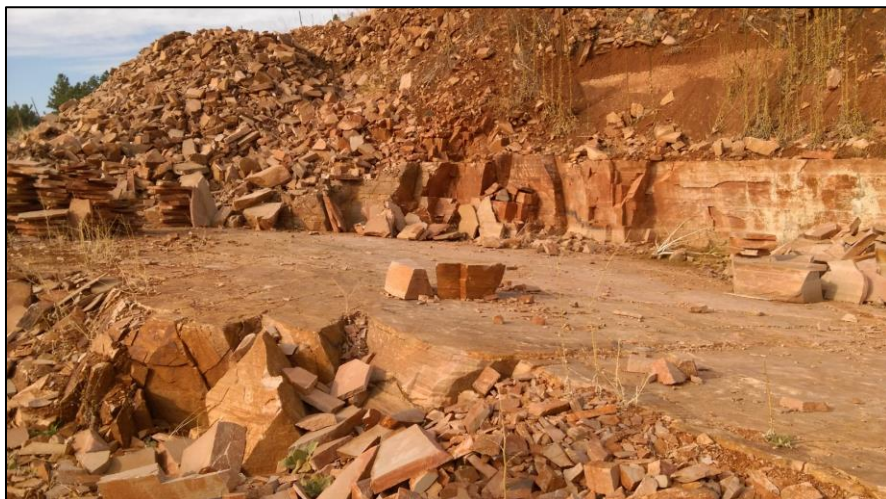
Photo 18. Closer view of working bench located east of gulch in north quarry.

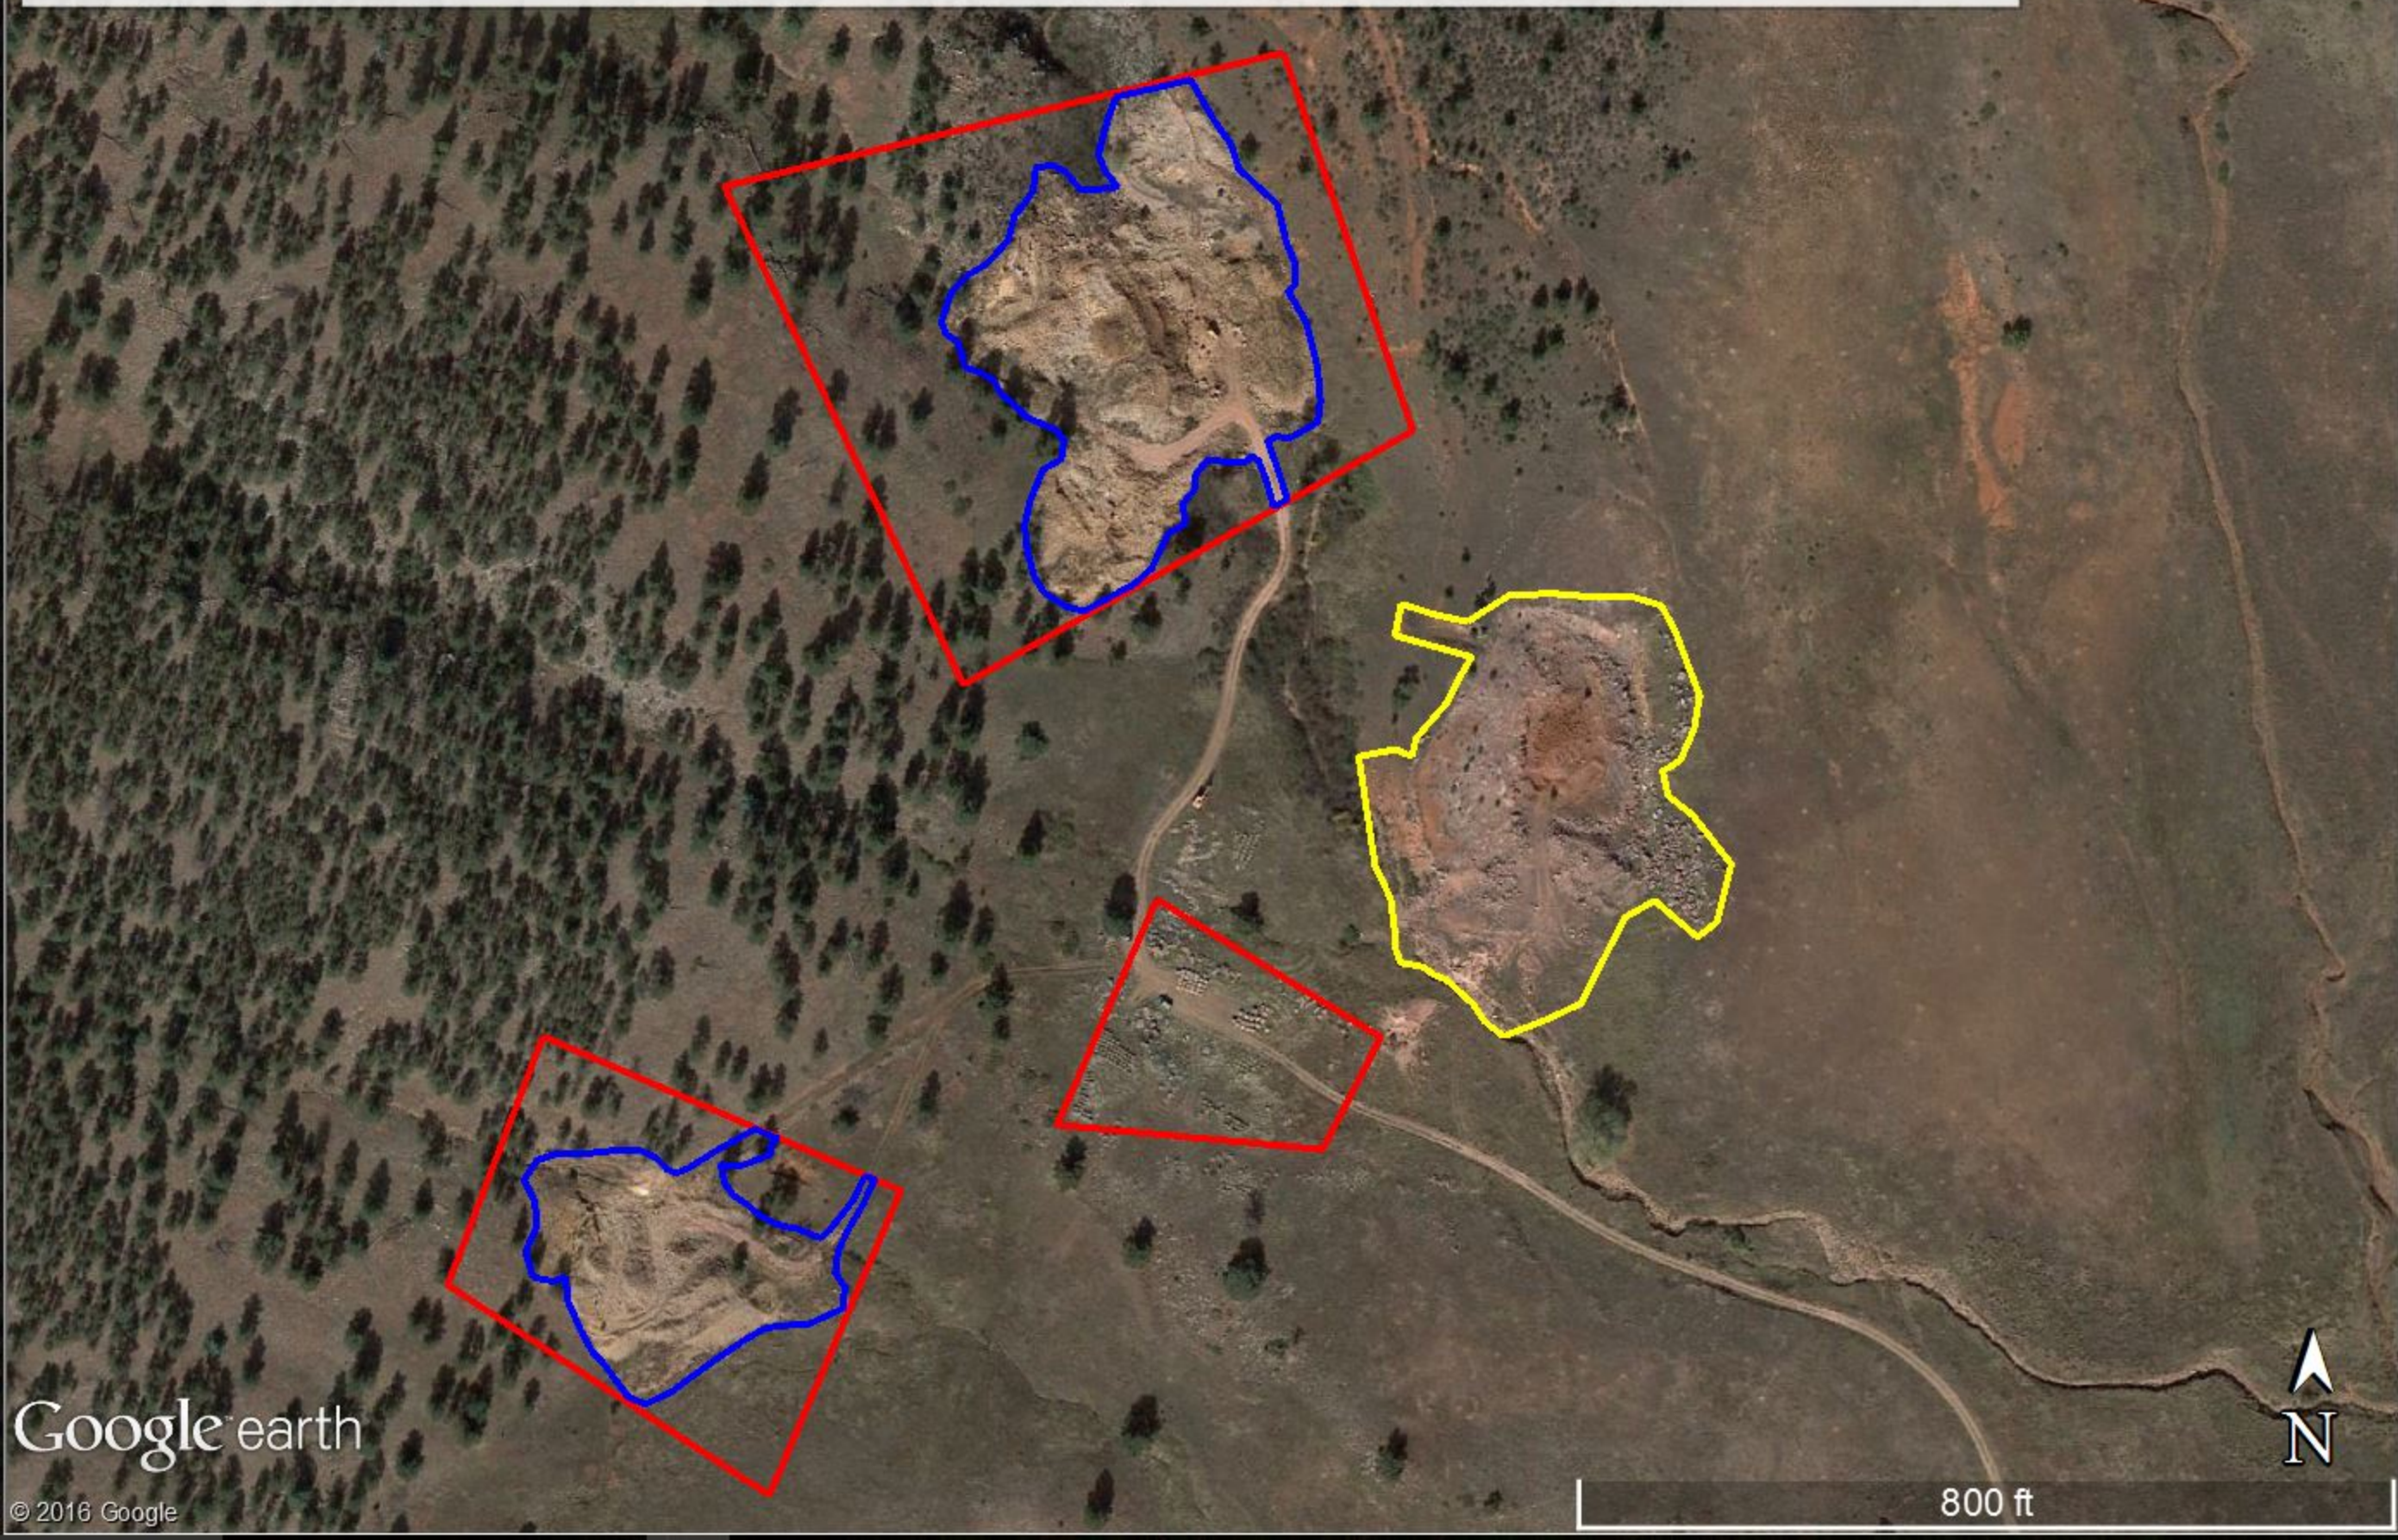
The Division estimates the operation has disturbed a total of 4.65 acres at the site, including both quarries and the one acre storage area (**see enclosed Google Earth image of site**). The Division has determined the financial warranty currently held for the permit in the amount of \$21,000.00 to be sufficient for reclaiming existing disturbance in accordance with the approved reclamation plan.

Red Outline = 9 acres = Approved Permit Area [5.5 acres (North Quarry) + 2.5 acres (South Quarry) + 1 acre (Storage Area)]

Blue Outline = 4.65 acres = Total Disturbed Area [2.5 acres (North Quarry) + 1.15 acres (South Quarry) + 1 acre (Storage Area)]

Yellow Outline = 2.4 acres = 1960's dolomite quarry not permitted (will not be redisturbed by this operation)
