**COLORADO**Division of Reclamation,  
Mining and Safety

**MINERALS PROGRAM INSPECTION REPORT****PHONE: (303) 866-3567**

<b>MINE NAME:</b> Schwartzwalder Mine	<b>MINE/PROSPECTING ID#:</b> M-1977-300	<b>MINERAL:</b> Uranium	<b>COUNTY:</b> Jefferson
<b>INSPECTION TYPE:</b> Monitoring	<b>INSPECTOR(S):</b> Michael A. Cunningham	<b>INSP. DATE:</b> November 1, 2016	<b>INSP. TIME:</b> 10:00
<b>OPERATOR:</b> Cotter Corporation	<b>OPERATOR REPRESENTATIVE:</b> Ken Mushinski, Steve Cohen	<b>TYPE OF OPERATION:</b> 112d-2 - Designated Mining Operation	
<b>REASON FOR INSPECTION:</b> Normal I&E Program	<b>BOND CALCULATION TYPE:</b> None	<b>BOND AMOUNT:</b> \$4,339,003.39	
<b>DATE OF COMPLAINT:</b> NA	<b>POST INSP. CONTACTS:</b> None	<b>JOINT INSP. AGENCY:</b> None	
<b>WEATHER:</b> Clear	<b>INSPECTOR'S SIGNATURE:</b>

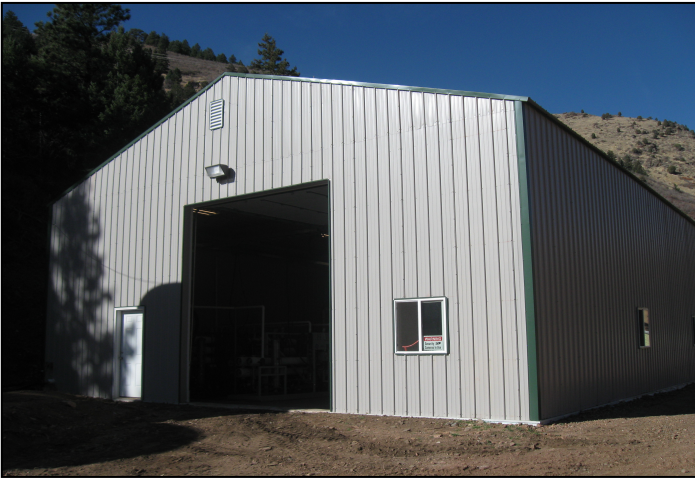
The primary activities occurring at the Schwartzwalder Mine are related to water treatment. Technical Revision No. 24 which addressed the relocation of the water treatment facility was approved on November 2, 2016. Construction of the new water treatment building is complete and the two reverse osmosis (RO) units have been transferred to the new facility. The ion exchange (IX) water treatment system is still located in the original water treatment building and will be transferred to the new water treatment building upon renewal of the radioactive materials license. The IX water treatment system was not online at the time of the inspection. All water was being treated through the RO water treatment system. The Operator anticipated using the IX system during periods of high flow/runoff, and occasionally running the RO effluent through the IX system. The Operator is working with Alexco Environmental to solve technical challenges related to the water treatment process. The RO filters are fouling quickly due to iron and manganese in the treated water and the filters are currently being replaced monthly rather than quarterly. The current estimated life of the RO treatment system is between 10 to 15 years.

1. New water treatment building.

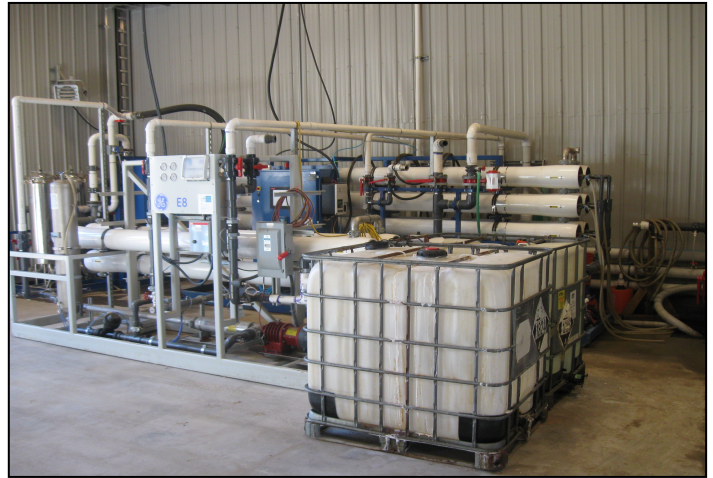
2. Reverse osmosis water treatment system.

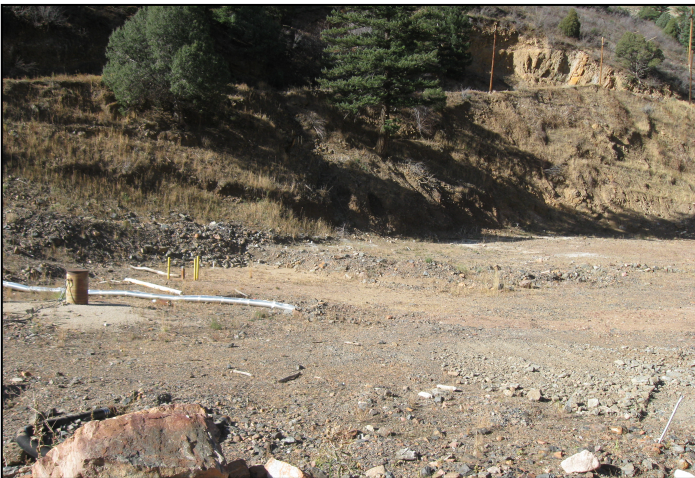
The Division inspected Sump 10 and did not observe any standing water. The Operator carried out a grouting project at Sump 10 in 2015 under Technical Revision No. 22. The Division also inspected the three pumps located within Ralston Creek. The pumps had become clogged with sediment following above average flows in Ralston Creek during August of 2016. The Operator replaced all three pumps as well as the culverts which surround the pumps. In addition, the Operator placed coverings over the pumps to prevent leaves and other materials from accumulating near the pumps. The in-stream pumps were not operating at the time of the inspection, as all water in Ralston Creek was flowing through the pipeline diversion.

3. Sump 10 area.

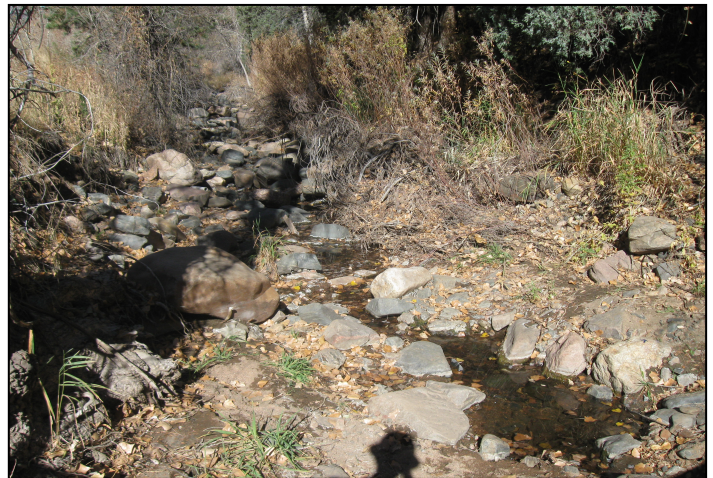
4. Ralston Creek.

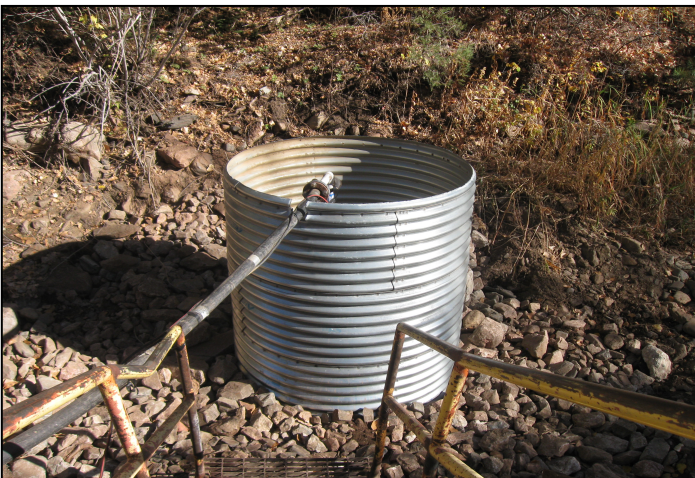
5. In-stream pump and culvert.

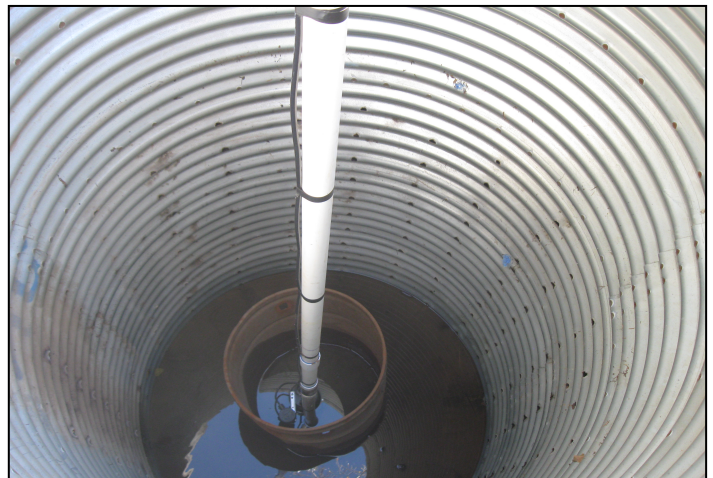
6. In-stream pump.
