Division of Reclamation,
Mining and Safety

MINERALS PROGRAM INSPECTION REPORT

MINE NAME: Baculite Mesa Pit	MINE/PROSPECTING ID#: M-1997-011	MINERAL: Sand and Gravel	COUNTY: Pueblo
INSPECTION TYPE: Monitoring	INSPECTOR(S): Elliott R. Russell	INSP. DATE: March 1, 2017	INSP. TIME: 14:00
OPERATOR: Baculite Mesa, LLC	OPERATOR REPRESENTATIVE: Steve O'Brian	TYPE OF OPERATION: 112c - Construction Regular Operation

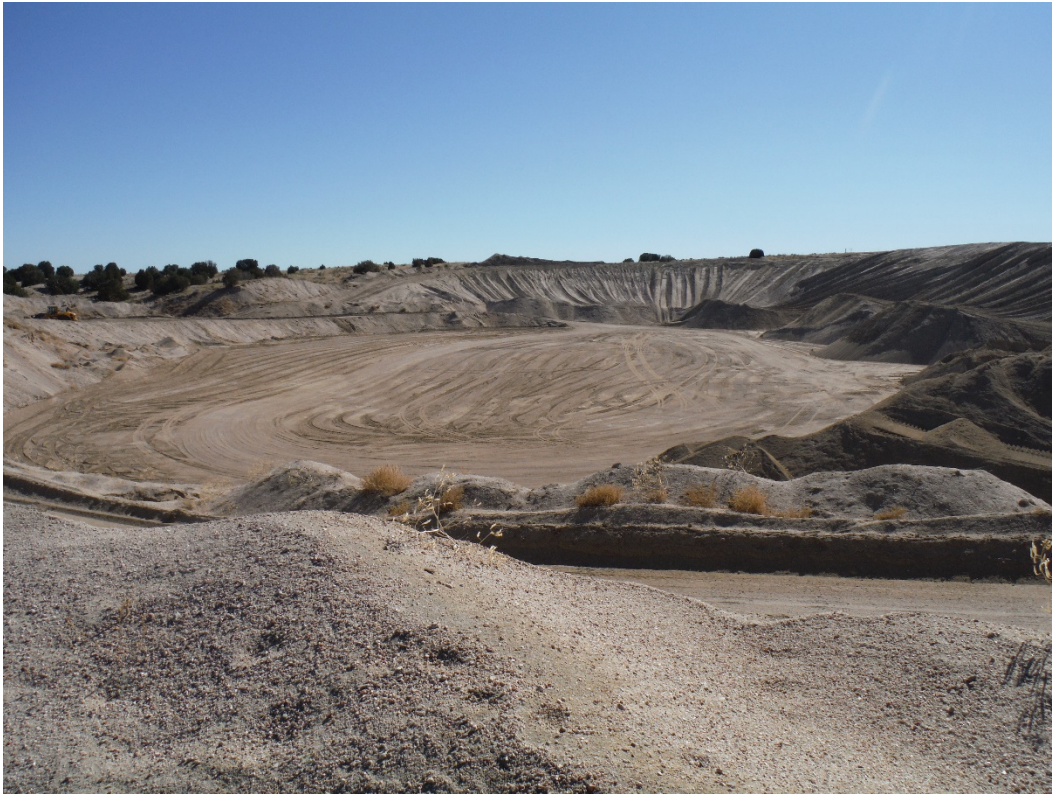
Fig 1. Pit overview; looking south.

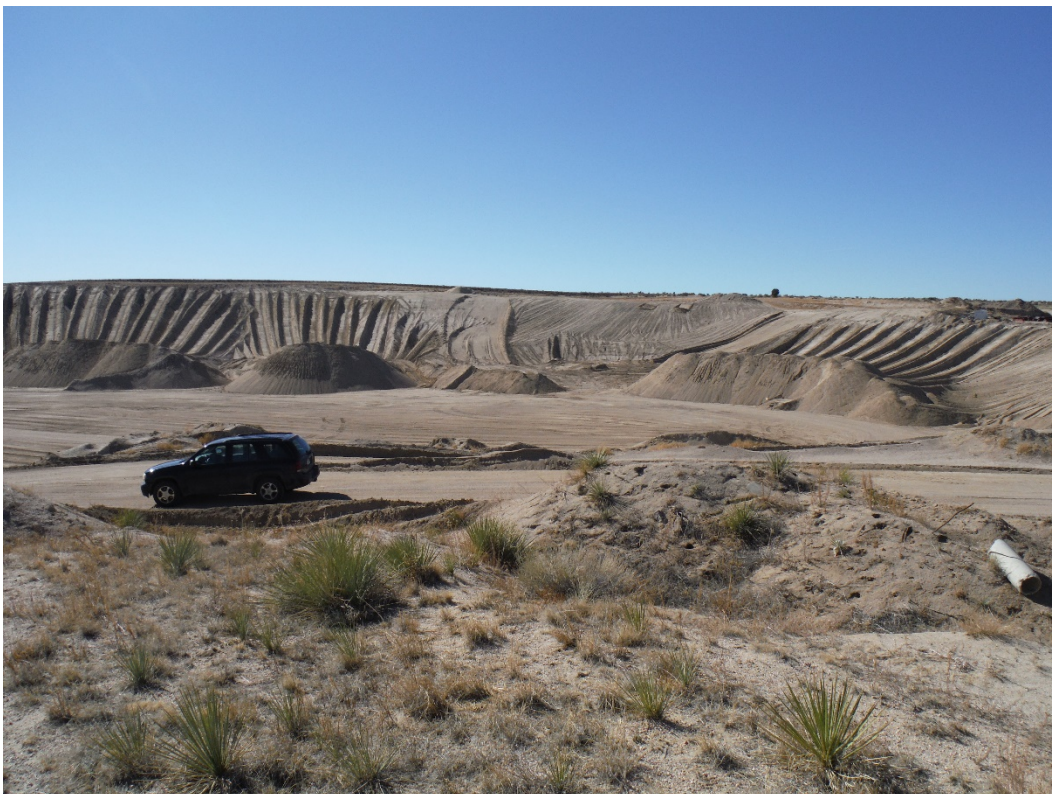
Fig 2. Pit overview; looking west.

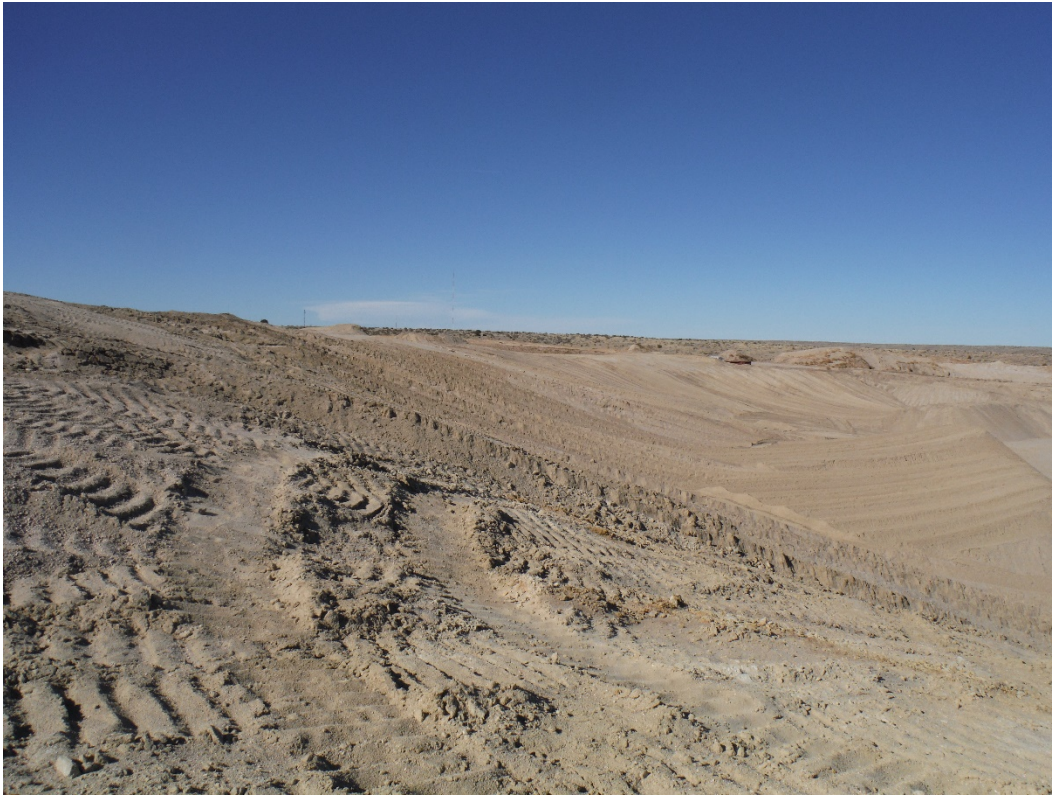
The site consists of a single pit, approximately 40 feet deep. The side slopes of the pit have been graded to approximately 2H:1V or flatter. Various stockpiles of product are located at the toe of the western pit slope. Topsoil has been stripped and is stockpiled along the western and southern sides of the pit.

Fig 3. Western pit slope; looking north.

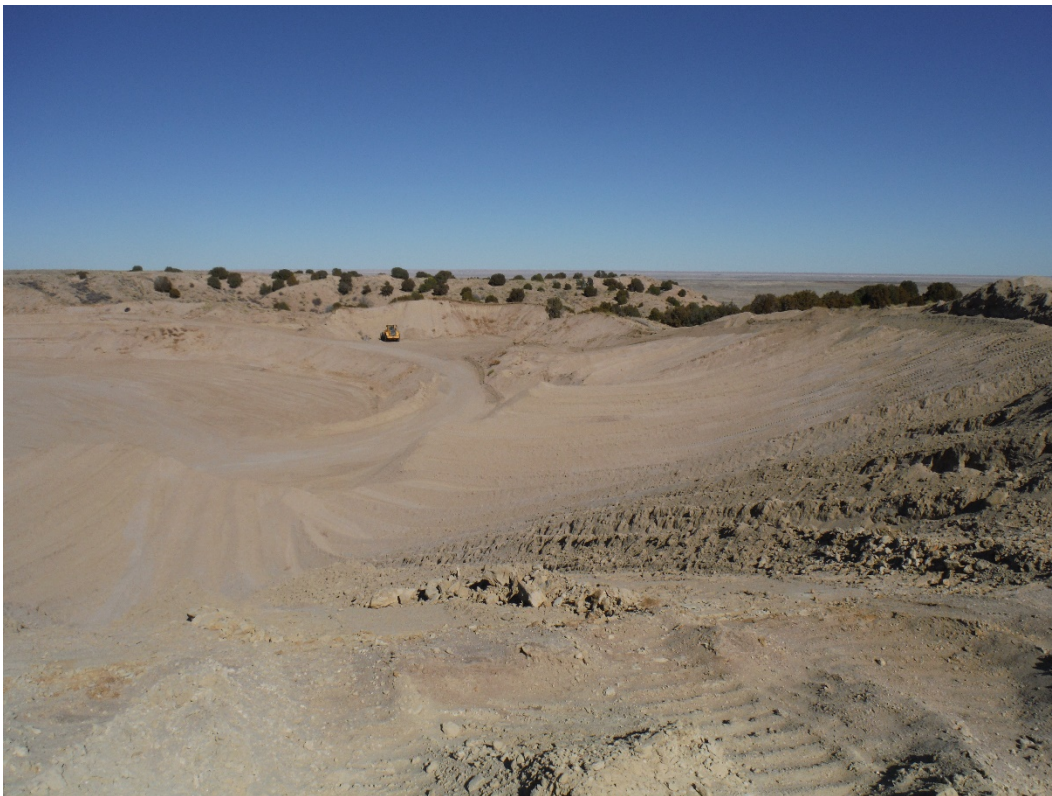
Fig 4. Southern pit slope; looking east.

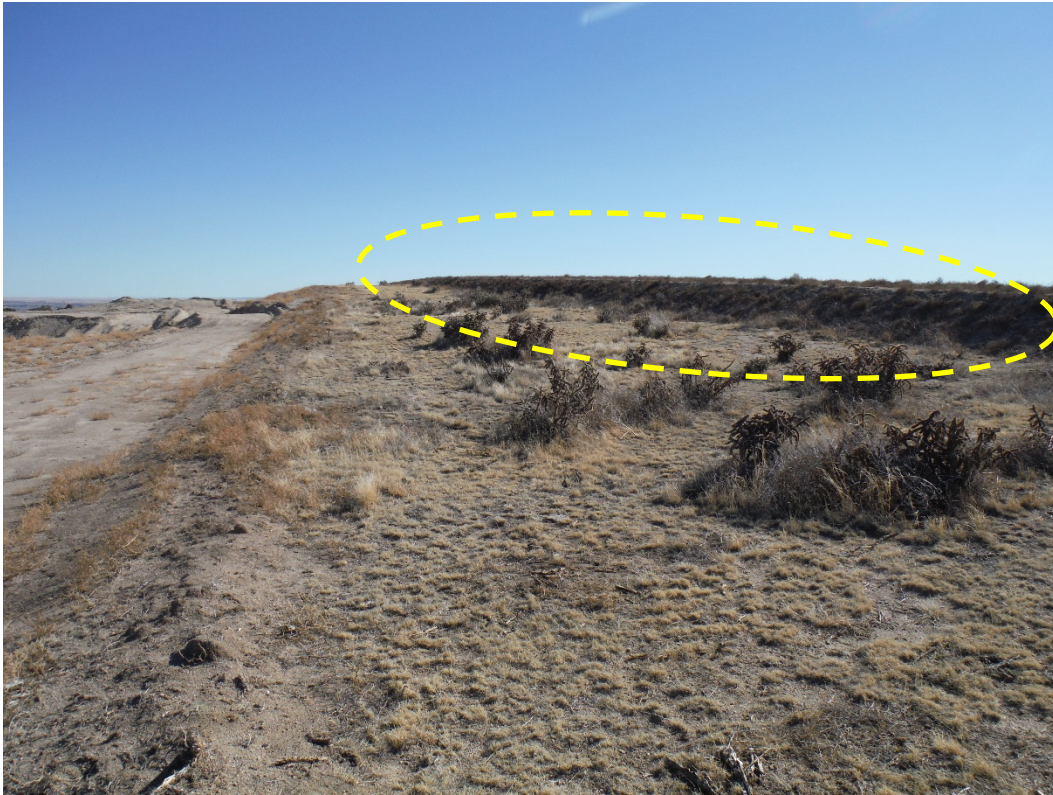
Fig 5. Topsoil stockpile west of pit; looking south.

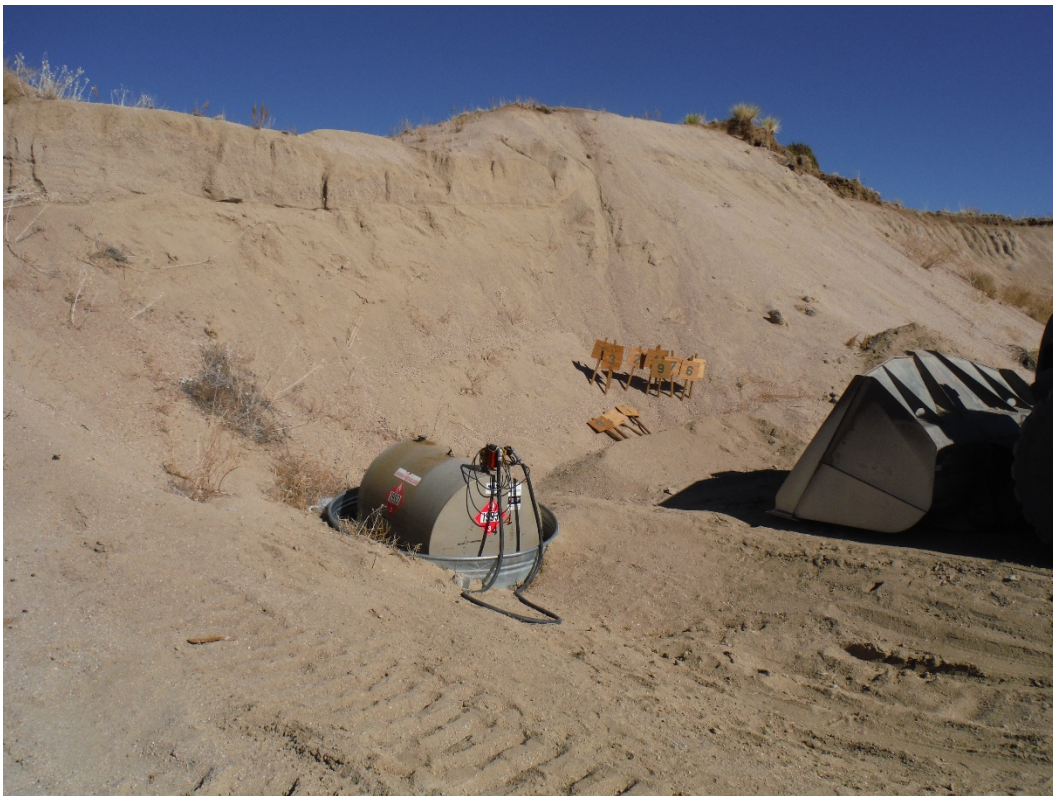
COMPLIANCE PROBLEM #2: Improper storage and containment of fuels and/or other hazardous materials was present on site.

During the inspection the Division observed a fuel storage tank located in the eastern portion of the pit. The tank is located within a metal trough serving as secondary containment. The trough was tilted at an angle and filled with debris, reducing the capacity of the secondary containment. This has been cited as Compliance Problem #2 on page two of this report. The Operator will need to level and clean out the fuel storage secondary containment trough. The Operator will also need to verify that the secondary containment is adequately sized.

Fig 6. Fuel storage tank; looking east.

CORRECTIVE ACTIONS: All storage tanks, petroleum and any hazardous materials on site for any period of time shall have appropriate secondary containment. The site will also have to comply with all applicable SPCC requirements. Please supply photo documentation that any fuel or hazardous materials containers are stored properly - including applicable secondary containment structures by the corrective action date. Note that secondary containment structures shall consist of an impermeable containment which could contain all contents of the tanks and various containers (when full) plus 10% of the total capacity. The operator may also provide photo documentation that all containers have been removed from the site on or before the corrective action date.

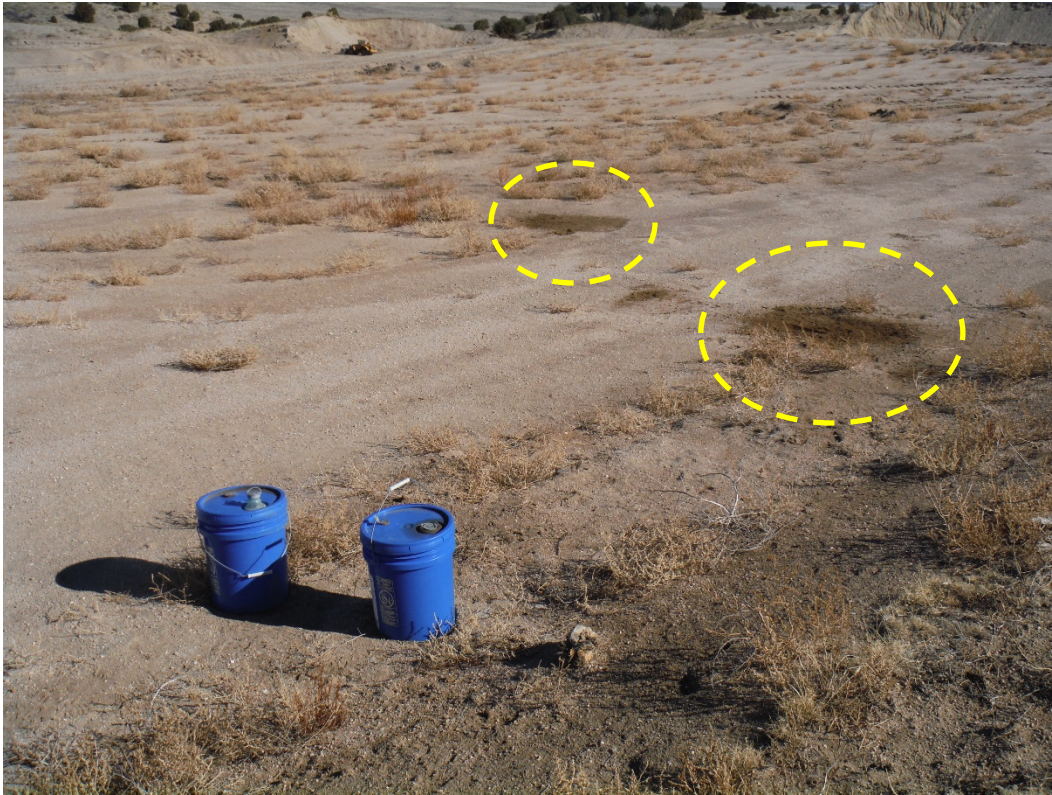
COMPLIANCE PROBLEM #3: A fuel spill has occurred at the site which has impacted soils, surface water or groundwater.

Additionally, the Division observed evidence of an oil spill located on the northeast portion of the pit. Two five gallon buckets of oil and two oil spill stains were present. This has been cited as Compliance Problem #3 on page two of this report.

Fig 7. Oil buckets and stains (circled); looking southeast.

CORRECTIVE ACTIONS: The operator shall immediately remediate the spill and submit a final report to the Division containing at least the following information:

- 1.) A description of how the spill was cleaned up containing at a minimum - the appropriate maps, volumes removed, sample locations, analytical data, and photo documentation.
- 2.) Evidence in the form of a receipt that the contaminated soil was disposed of by an approved method (such as sent to an approved landfill, land farming, recycling center, etc.).
