**MINERALS PROGRAM INSPECTION REPORT**  
**PHONE: (303) 866-3567**

<b>MINE NAME:</b> Cresson Project	<b>MINE/PROSPECTING ID#:</b> M-1980-244	<b>MINERAL:</b> Gold	<b>COUNTY:</b> Teller
<b>INSPECTION TYPE:</b> Monitoring	<b>INSPECTOR(S):</b> Timothy A. Cazier	<b>INSP. DATE:</b> January 19, 2017	<b>INSP. TIME:</b> 10:30
<b>OPERATOR:</b> Cripple Creek & Victor Gold Mining Company	<b>OPERATOR REPRESENTATIVE:</b> Jeff Campbell	<b>TYPE OF OPERATION:</b> 112d-3 - Designated Mining Operation	
<b>REASON FOR INSPECTION:</b> Normal I&E Program	<b>BOND CALCULATION TYPE:</b> None	<b>BOND AMOUNT:</b> \$173,934,420.00	
<b>DATE OF COMPLAINT:</b> NA	<b>POST INSP. CONTACTS:</b> None	<b>JOINT INSP. AGENCY:</b> None	
<b>WEATHER:</b> Clear	<b>INSPECTOR'S SIGNATURE:</b>

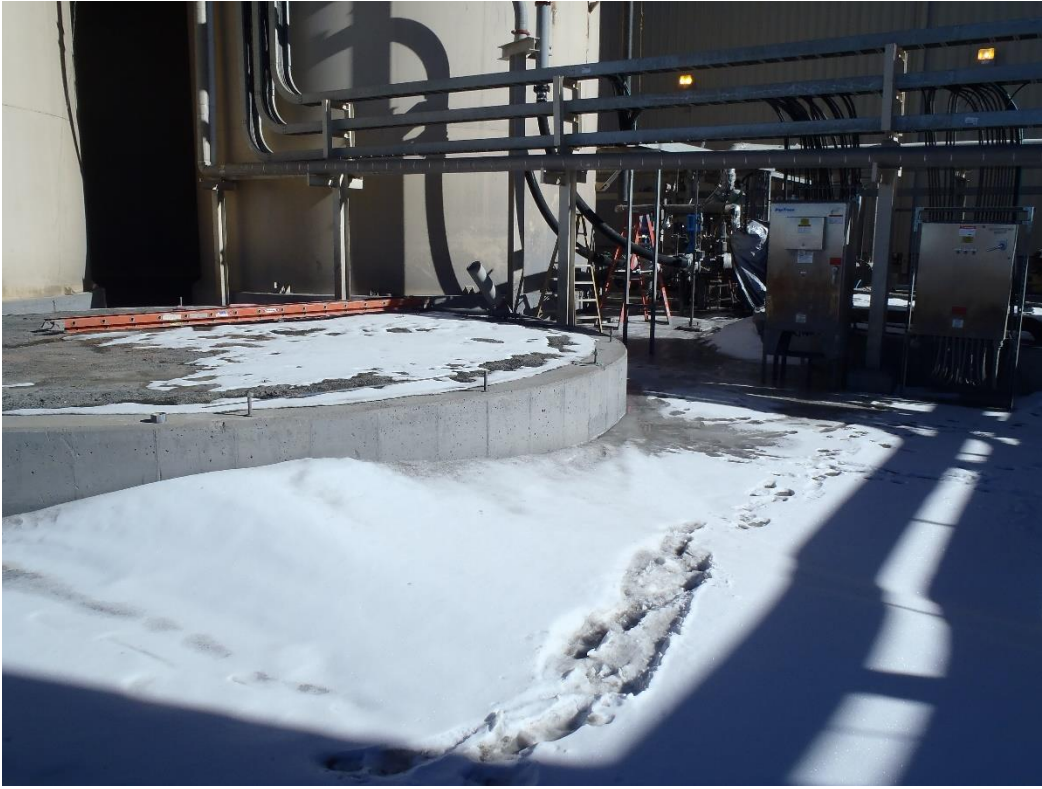
**High Grade Mill:** The Division was accompanied by Gary Horton and Don Rodabough to the HGM to perform an exterior walk-around inspection. The Division noted snow and ice in the leach tank secondary containment area (**Photo 1**). CC&V submitted photographic evidence of removing the snow and ice via email on February 2, 2017, so this was not cited as a problem in this inspection report. The Division also noted a leaking pump on the south side of the neutral pH process water tank (see **Photo 2**). Mr. Rodabough indicated maintenance was scheduled for the pump and the sludge would be cleaned out of the secondary containment as part of the maintenance program. The water level in the southwest stormwater sump (see **Photo 3**) appeared to be well below the overflow elevation of the mill liner. Mr. Rodabough pointed out CC&V had replaced an exterior pipe (see **Photo 4**) from the neutral pH filter press to the process ore thickener with a new rubber lined pipe to prevent leaking the pipe.

Photo 1. Snow & ice in Vat leach tank secondary containment area (removed post inspection).

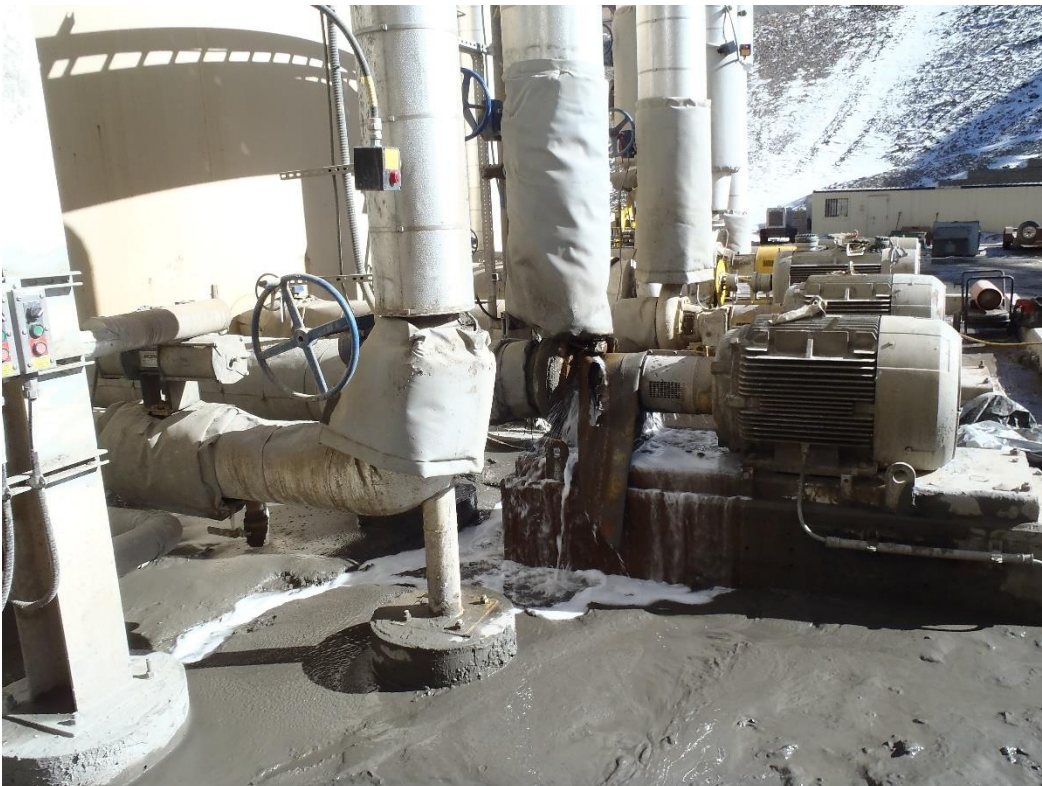
Photo 2. Leaking pump on south side of the neutral pH process water tank (note sludge to be cleaned up).

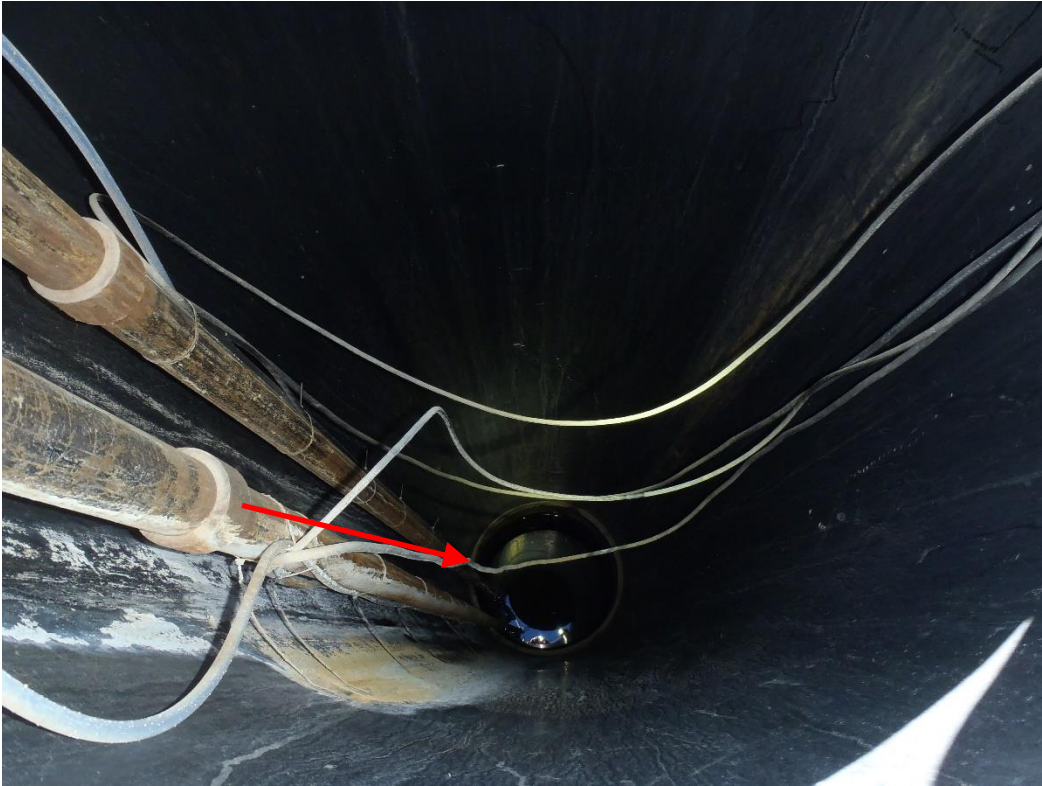
Photo 3. Water level in the HGM southwest stormwater sump.

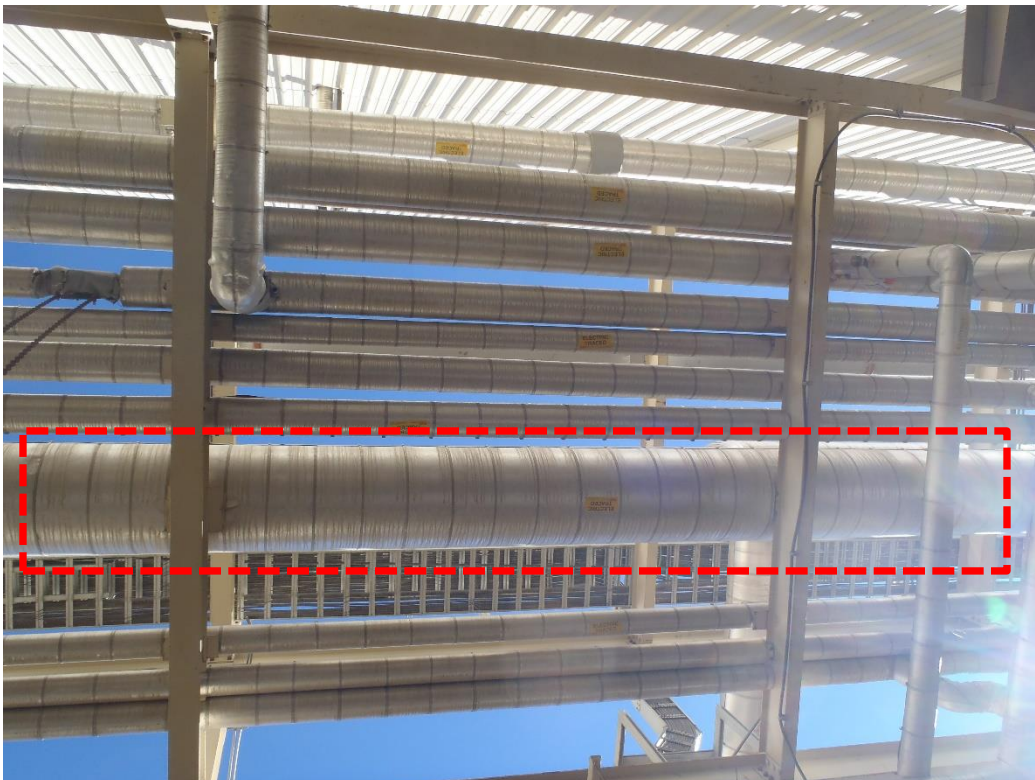
Photo 4. New rubber lined pipe from neutral pH filter press to process ore thickener.

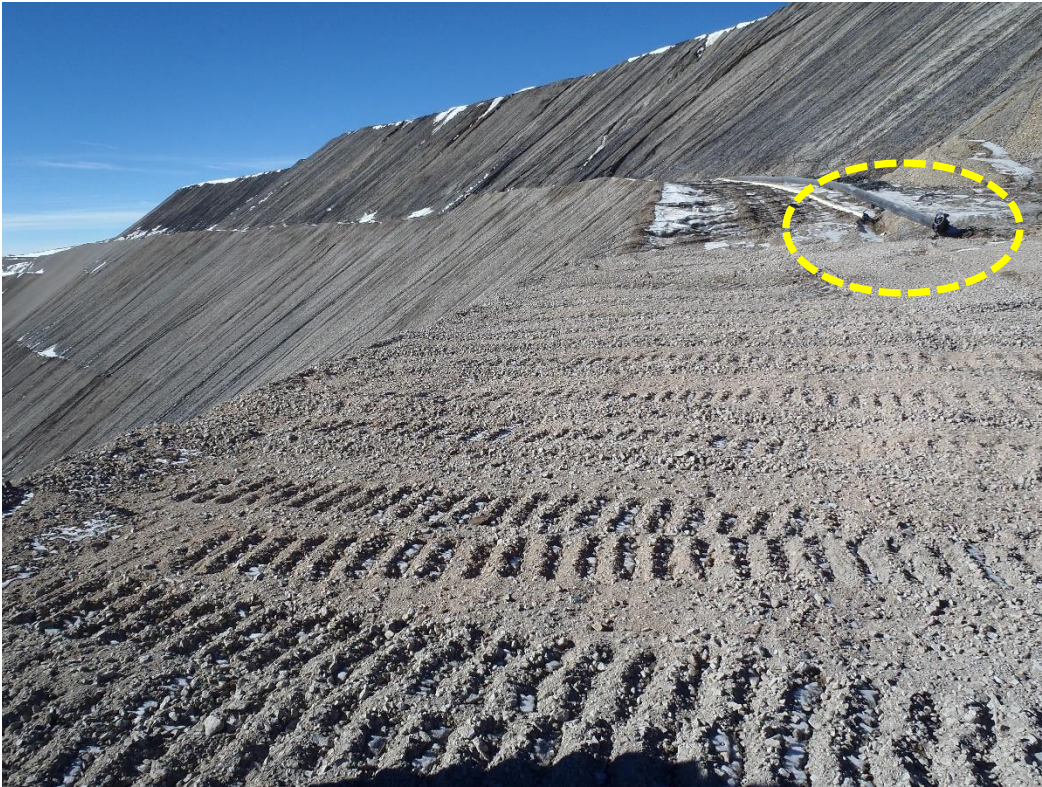
**AGVLF:** The Division was accompanied by Mr. Campbell and Mr. Jason Cruz to inspect the area where a 12" header pipe ruptured on January 4, 2017 (**Photo 5**) on the northeast end of the AGVLF between the Load Out Bin (LOB) and the Lime Silo. Back fill of the washed out area had been completed (**Photo 6**) and CC&V representatives pointed out how the release solution remained on the VLF liner area. The inspection proceeded to the southeast area of the AGVLF where CC&V representatives pointed out the progress made in replacing the edge of liner (EOL) signs cited as a problem in the Division's November 21, 2016 inspection report. Mr. Campbell indicated 65 signs had been replaced (**Photo 7**) and CC&V was waiting for an additional 17 signs to arrive in order to complete the task (**Photo 8**). The Division noted the replaced signs had only one bolt attaching the signs to the T-posts, a condition that led to the previous signs being torn off by high winds. The Division strongly recommends CC&V use two bolts to attach each EOL sign to each T-post.

Photo 5. Source of header failure and top of backfill (looking west).

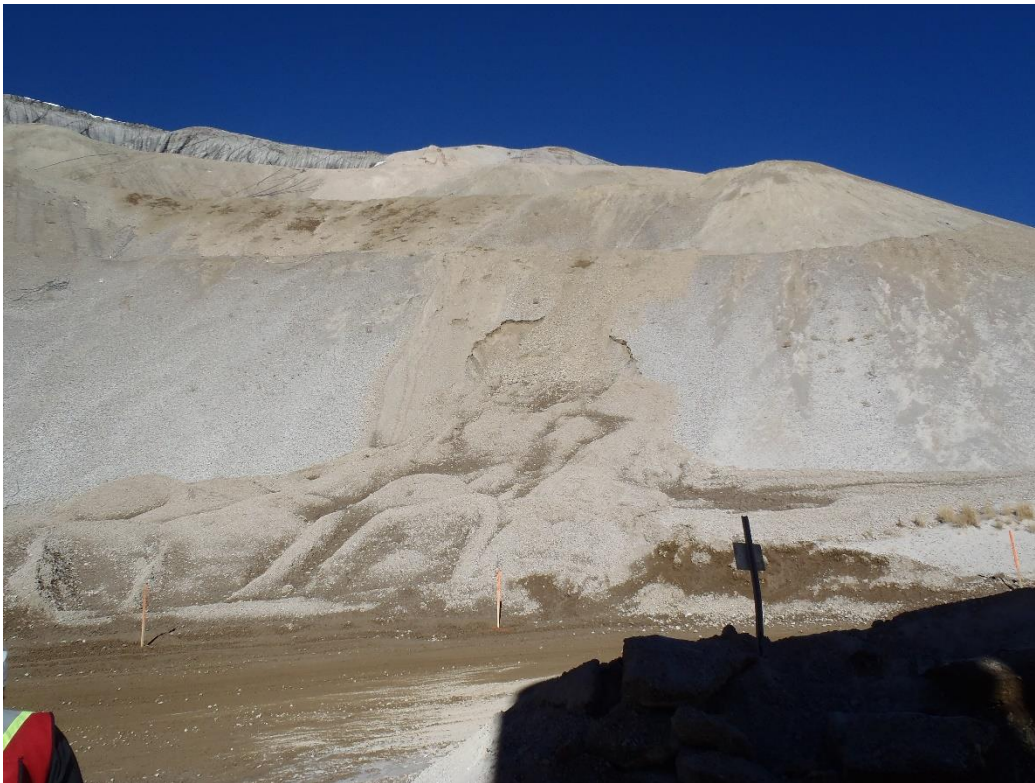
Photo 6. Completed Backfill of the washed out area from header failure (looking north).

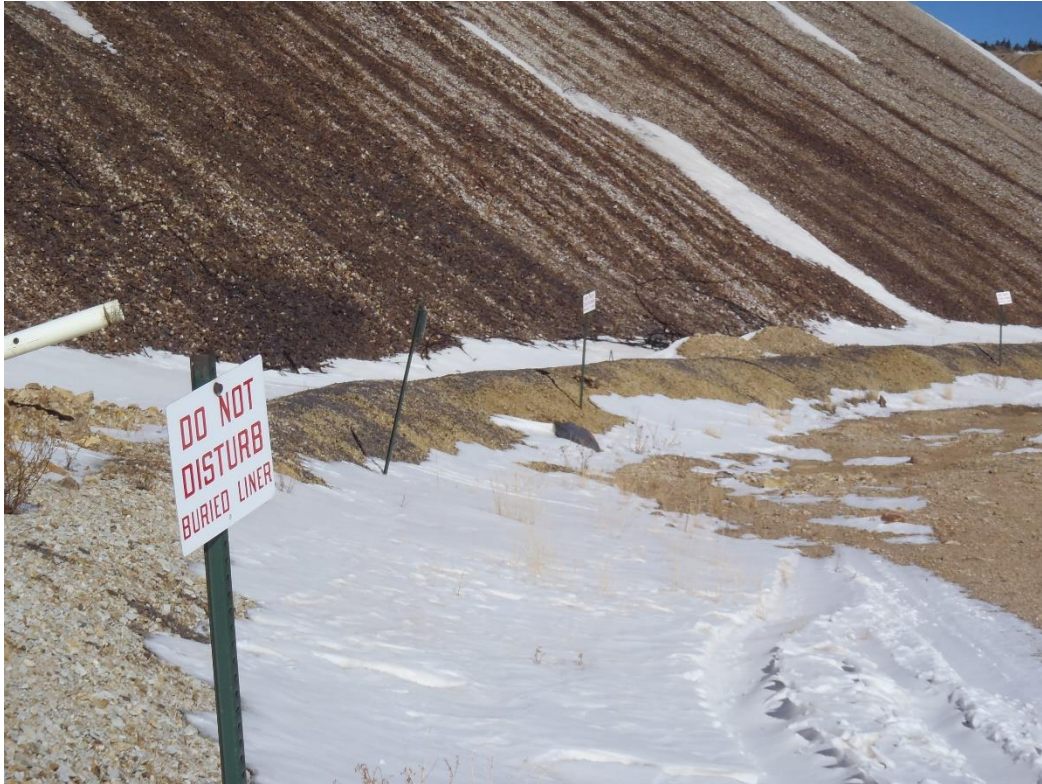
Photo 7. Four of 65 edge of liner signs replaced on T-posts.

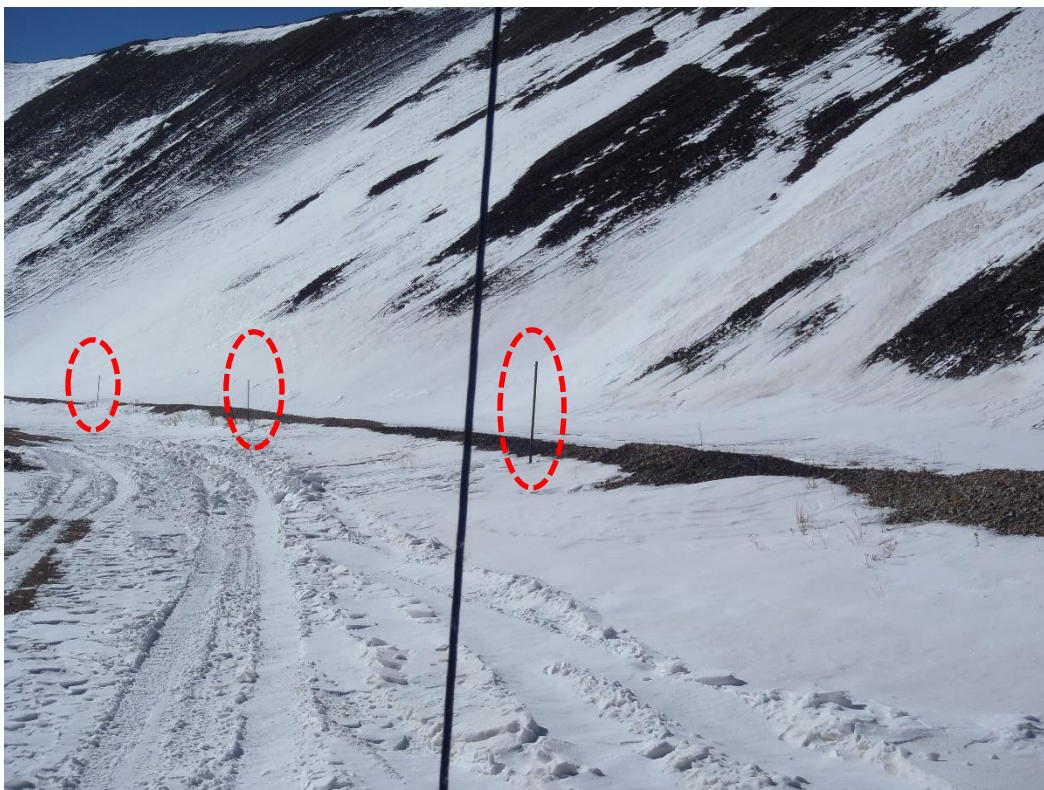
Photo 8. Three of 17 edge of liner T-posts still needing signage.

1. The Division strongly recommends CC&V use two bolts to attach each EOL sign to each T-post.
2. Post inspection, CC&V confirmed a) the SGVLF piezometer (ID #88314/pond level) is being monitored and recorded; b) ore storage near the South Cresson is temporary; and c) the snow and ice in the HGM vat leach area was removed and mine personnel will continue to maintain secondary containment capacity in that area.
3. The concentrate shipping revision to the permit could be submitted as a TR, but the Division will make a final determination as to whether it requires an amendment through the review process.
4. No problems were cited.
5. The Division is waiting for CC&V to submit a copy of the 2016 annual geotechnical report.

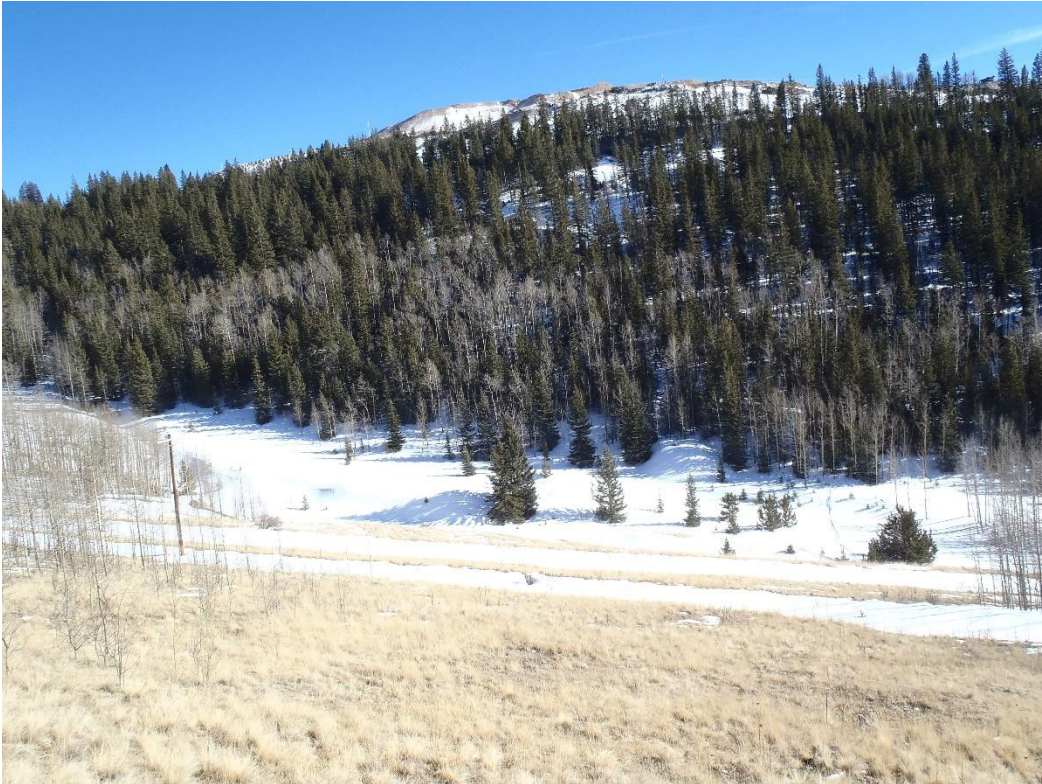
Globe Hill Development Area: The Division visited the area where the Globe Hill stormwater diversion channel is planned for the purpose of maintaining flows in Poverty Gulch. Ms. Steward and Mr. Ben Larsen accompanied the Division on this portion of the inspection. This area was covered by snow (see **Photos 9 and 10**). CC&V representatives indicated the Globe Hill pit would remove most, if not all the trees in this area.

Photo 9. Globe Hill stormwater diversion channel area (1 of 2, looking SE).

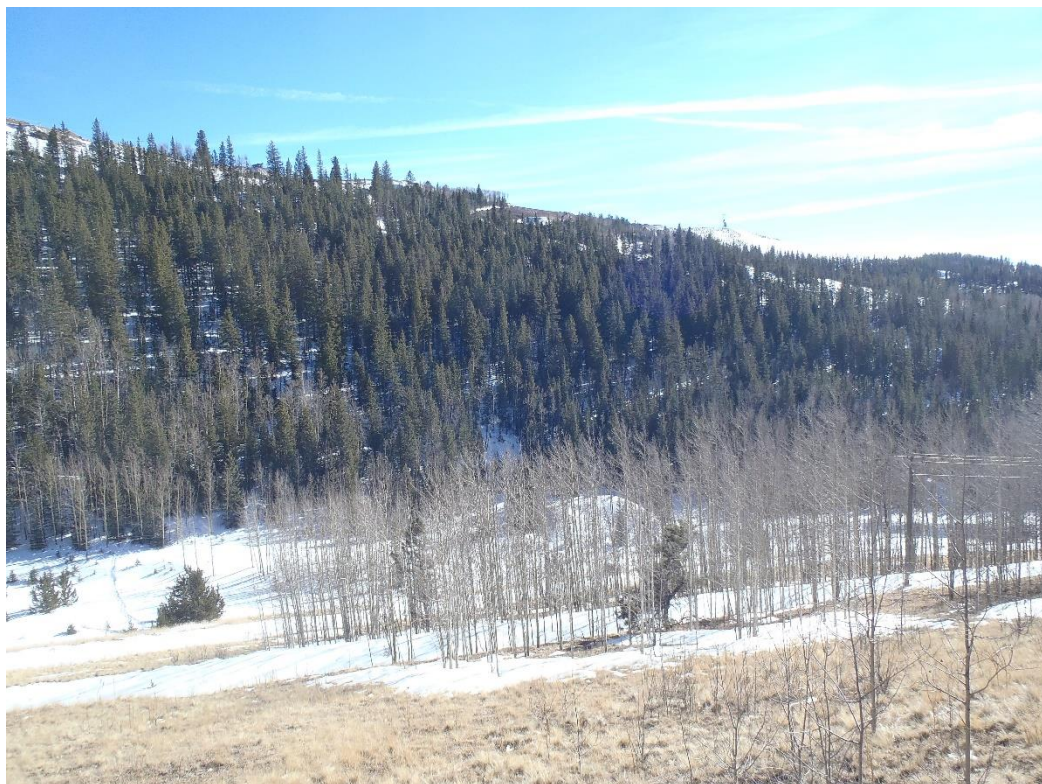
Photo 10. Globe Hill stormwater diversion channel area (1 of 2, looking south).
