**COLORADO**Division of Reclamation,
Mining and Safety

MINERALS PROGRAM INSPECTION REPORT**PHONE: (303) 866-3567**

MINE NAME: Schwartzwalder Mine	MINE/PROSPECTING ID#: M-1977-300	MINERAL: Uranium	COUNTY: Jefferson
INSPECTION TYPE: Monitoring	INSPECTOR(S): Michael A. Cunningham	INSP. DATE: March 23, 2017	INSP. TIME: 10:00
OPERATOR: Cotter Corporation	OPERATOR REPRESENTATIVE: Steve Cohen, Bruce Nordquist	TYPE OF OPERATION: 112d-2 - Designated Mining Operation	
REASON FOR INSPECTION: Normal I&E Program	BOND CALCULATION TYPE: None	BOND AMOUNT: \$4,339,003.39	
DATE OF COMPLAINT: NA	POST INSP. CONTACTS: None	JOINT INSP. AGENCY: None	
WEATHER: Clear	INSPECTOR'S SIGNATURE:

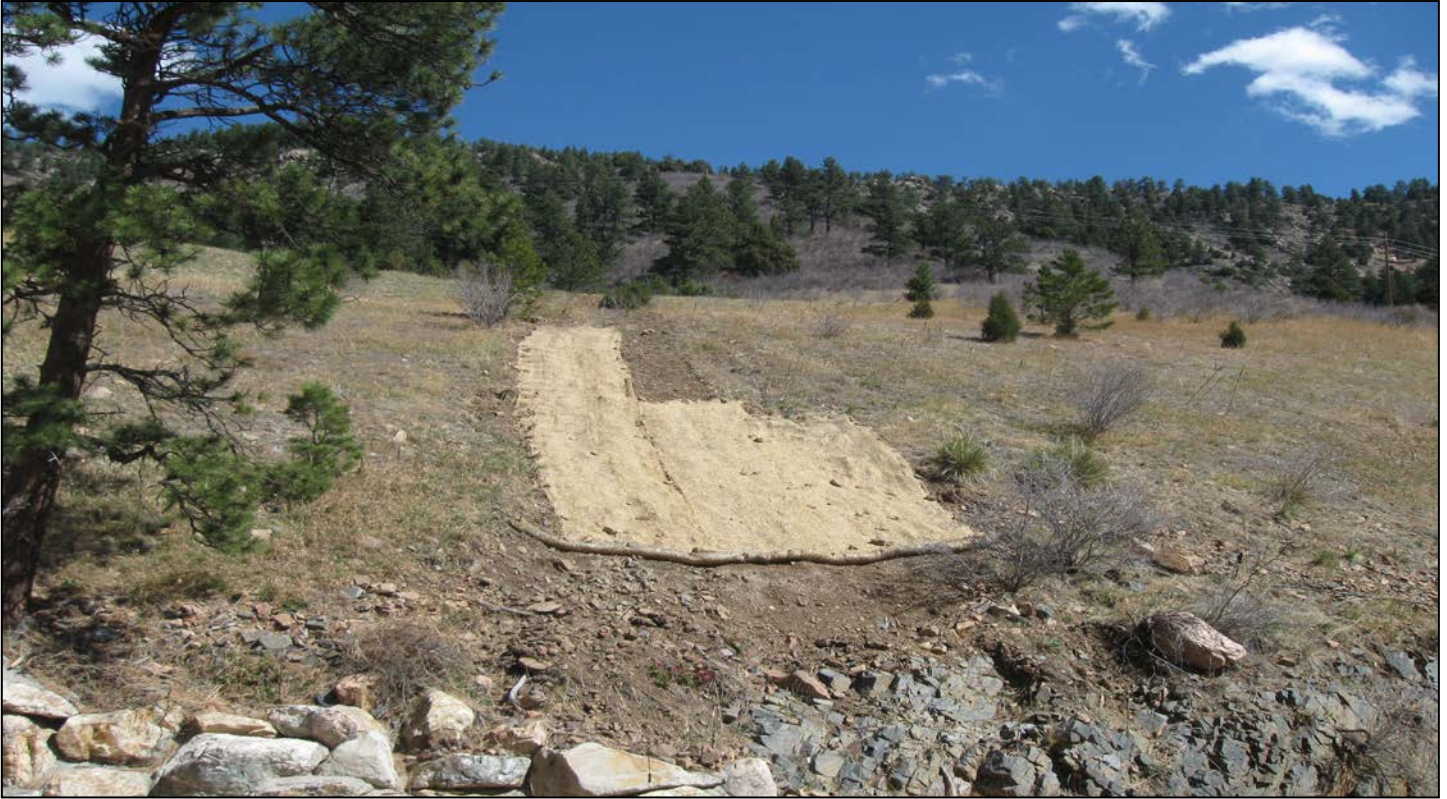
The Division observed erosion on the North Waste Rock Pile. The Operator had taken measures to repair the eroded area including installing jute netting and reseeding the repaired area. The Operator should continue to monitor this area to ensure no further erosion occurs.

1. Erosion repair on North Waste Rock Pile.
