COLORADO
Division of Reclamation,
Mining and Safety
Department of Natural Resources

PERMIT INFORMATION

Permit Number: C-1981-008 Mine Name: New Horizon Mine Operator: Elk Ridge Mining and Reclamation, LLC Operator Address: Mr. Tony Tennyson 5731 State Highway 13 Meeker, CO 81641	County: Montrose Operation Type: Surface Permit Status: Active Ownership: Private
	Operator Representative Present: Frank Ferris and Tom Fry
Operator Representative Signature: (Field Issuance Only)

Inspection Start Date: March 27, 2017 Inspection Start Time: 14:30 Inspection End Date: March 29, 2017 Inspection End Time: 11:00		Inspection Type: Coal Complete Inspection Inspection Reason: Normal I&E Program Weather: Cloudy	
Joint Inspection Agency: None		Joint Inspection Contacts: 	
Post Inspection Agency: None		Post Inspection Contacts: 	
Inspector(s): Brock F. Bowles	Inspector's Signature:

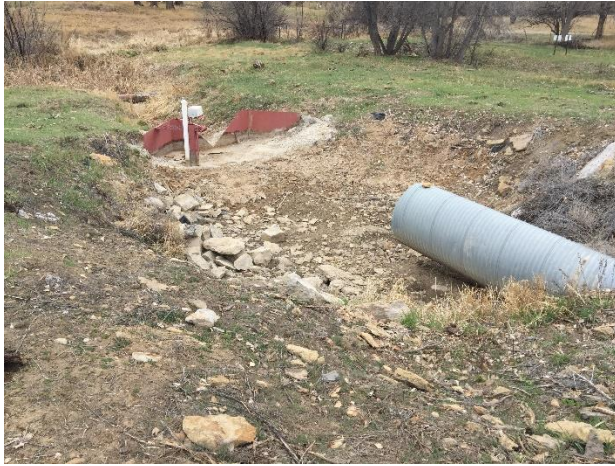
Photo 1 – Pond 7 Discharge Structure

Pond 7 contained water but was not discharging (photo 1).

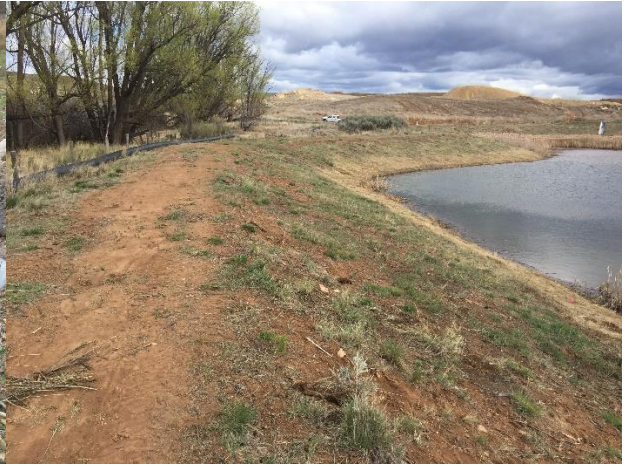
Photo 2 – Pond 13 Embankment

Pond 13 contained water and was discharging as was the trench drain. The emergency spillway was clear of obstructions. The embankment was recently cleared of vegetation (photo 2).

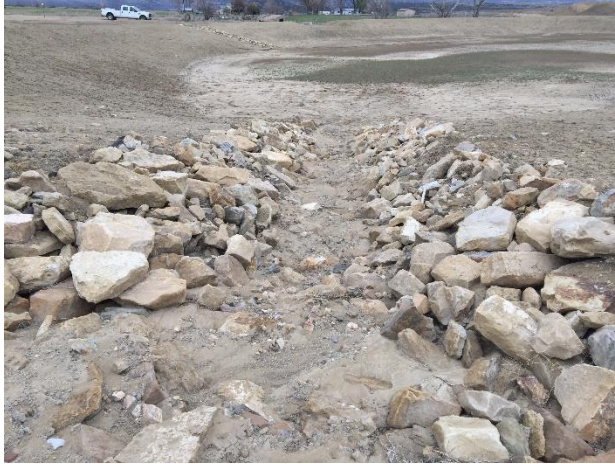
Photo 3 – Pond 16

Pond 16 did not contain water. The inlet structures were in good condition (photo 3). The emergency spillway was clear of obstructions.

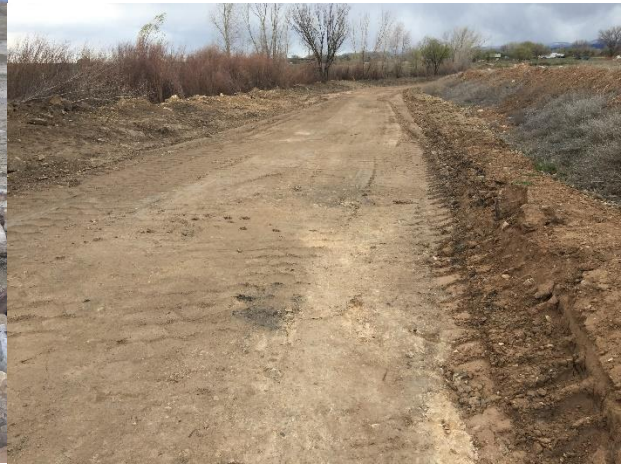
Photo 4 – Ditch C4A

Pond 18 did not contain water. Fill was added to ditch C4A to prevent water from ponding in the ditch (photo 4). The emergency spillway was free of obstructions. Culverts C175 and C176 were unobstructed.

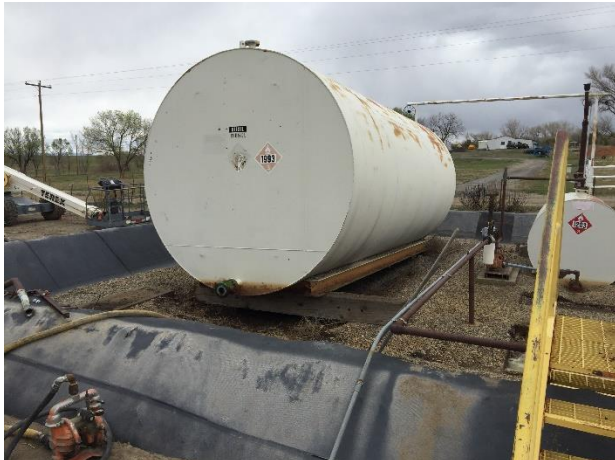
Photo 5 – Diesel Tank Disassembled

The diesel fuel storage tank was disassembled and prepared to be removed as it is no longer needed at the NH2 facilities area (photo 5).

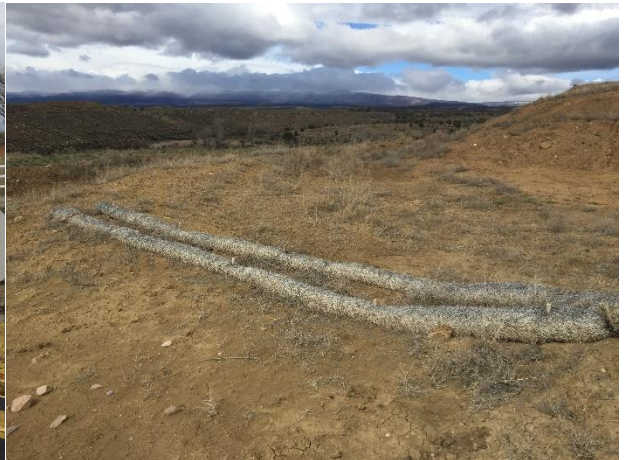
Photo 6 – Ring Ditch with Sediment Trap

The ring ditches and sediment traps were in place around the multiple piles of stockpile 12 (photo 6).
