**PERMIT INFORMATION**

| <b>Permit Number:</b> C-2010-089<br><b>Mine Name:</b> New Horizon North Mine<br><b>Operator:</b> Elk Ridge Mining and Reclamation, LLC<br><b>Operator Address:</b><br>Mr. Tony Tennyson<br>5731 State Highway 13<br>Meeker, CO 81641 | <b>County:</b> Montrose<br><b>Operation Type:</b> Surface<br><b>Permit Status:</b> Active<br><b>Ownership:</b> Private |

| <b>Inspection Start Date:</b> March 28, 2017<br><b>Inspection Start Time:</b> 16:00<br><b>Inspection End Date:</b> March 29, 2017<br><b>Inspection End Time:</b> 11:00 | | <b>Inspection Type:</b> Coal Partial Inspection<br><b>Inspection Reason:</b> Normal I&E Program<br><b>Weather:</b> Cloudy | |

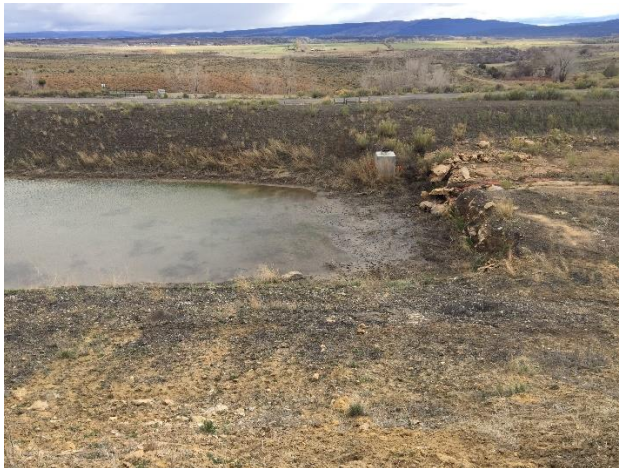
Pond 001 contained water but was not discharging (photo 1).

Photo 1 – Pond 001 Discharge Structure

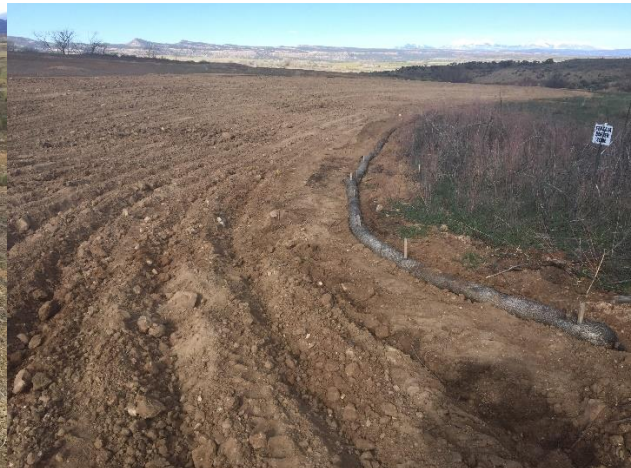
Pond 002 did not contain water. The north ditch of Pond 002 has been backfilled to just east of the Pond 2 topsoil stockpile. Straw wattles were installed on the downhill side of the reclaimed ditch in drainages (photo 2) and areas where the slope appeared to be steep (photo 3). A berm with a straw wattle filter was installed at the east end of the topsoil laydown area. This berm catches any topsoil runoff from going into sediment pond 002. The disturbed area around the topsoil stockpile still reports to Pond 002.

Photo 2 – Drainage Area With Wattles

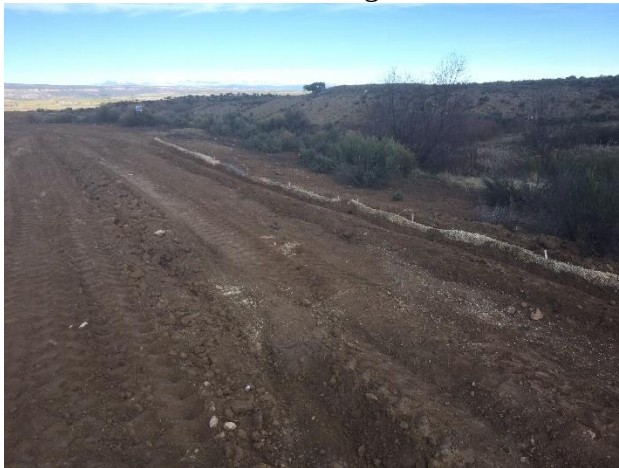
Photo 3-Wattles Along Reclaimed North Ditch

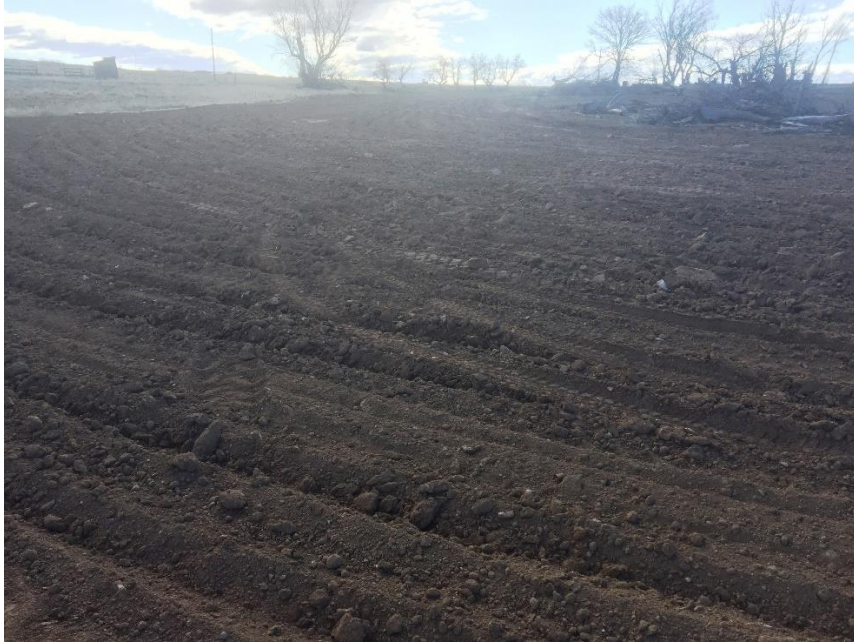
Topsoil has been replaced over the backfilled areas of the Pond 002 north ditch. The topsoil was replaced to a depth of 2 feet in most areas (photo 4). Areas that received shallower depths of topsoil were identified by the soil profile made visible by the disturbance of the ditch. A ledge rock layer was the most common reason the top soil was shallow in certain areas. The topsoil on the reclaimed area had been ripped. ERM is planning to rock pick the reclaimed area.

Photo 4 – Topsoil Contoured to AOC Blending in Very Well

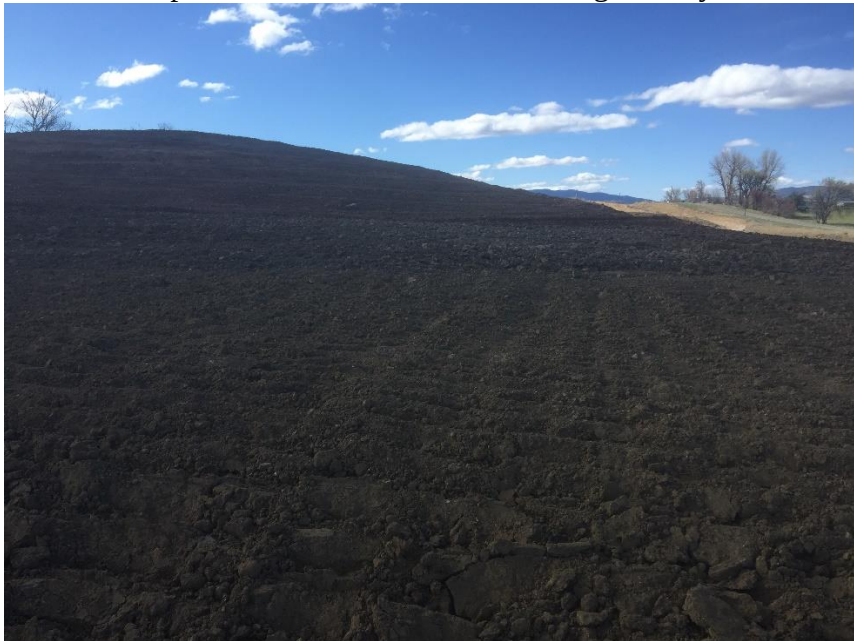
Topsoil for the Pond 002 north ditch was taken from the Pond 002 topsoil pile. The remaining part of the topsoil pile was recontoured, ripped and dimpled with dozer tracks (photo 5). The ring ditch was reestablished around the pile. The area from where the topsoil had been removed was recontoured, ripped and dimpled with dozer tracks.

Photo 5 – Topsoil Pile and Disturbed Area
