MINERALS PROGRAM INSPECTION REPORT PHONE: (303) 866-3567

MINE NAME:		MINE/PROSPECTING ID#:	MINERAL:	COUNTY:	
Wright Pit		M-1986-140	Sand and gravel	Park	
INSPECTION TYPE:		INSPECTOR(S):	INSP. DATE:	INSP. TIME:	
Preoperation Inspection		Michael A. Cunningham	January 31, 2017	10:00	
OPERATOR:		OPERATOR REPRESENTATIVE:	TYPE OF OPERATION:		
Park County		Tammie Crawford	112c - Construction Regular Operation		
REASON FOR INSPECTION:		BOND CALCULATION TYPE:	BOND AMOUNT:		
Normal I&E Program		None	\$0.00		
DATE OF COMPLAINT:		POST INSP. CONTACTS:	JOINT INSP. AGENCY:		
NA		None	None		
WEATHER:	INSPECTOR'S SIGNATURE:		SIGNATURE DATE:		
Snowing	Ill C.L		April 4, 2017

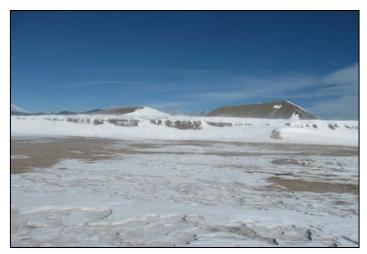
1. View of pit floor, photo taken facing west.
