**MINERALS PROGRAM INSPECTION REPORT**  
**PHONE: (303) 866-3567**

<b>MINE NAME:</b> Stout - Amick Pit	<b>MINE/PROSPECTING ID#:</b> M-1981-275	<b>MINERAL:</b> Sand and gravel	<b>COUNTY:</b> Rio Blanco
<b>INSPECTION TYPE:</b> Monitoring	<b>INSPECTOR(S):</b> Travis H. Marshall	<b>INSP. DATE:</b> April 4, 2017	<b>INSP. TIME:</b> 12:00
<b>OPERATOR:</b> Diana K. Watson	<b>OPERATOR REPRESENTATIVE:</b> NA	<b>TYPE OF OPERATION:</b> 112c - Construction Regular Operation	
<b>REASON FOR INSPECTION:</b> Normal I&E Program	<b>BOND CALCULATION TYPE:</b> Complete Bond	<b>BOND AMOUNT:</b> \$68,521.00	
<b>DATE OF COMPLAINT:</b> NA	<b>POST INSP. CONTACTS:</b> None	<b>JOINT INSP. AGENCY:</b> None	
<b>WEATHER:</b> Cloudy	<b>INSPECTOR'S SIGNATURE:</b>

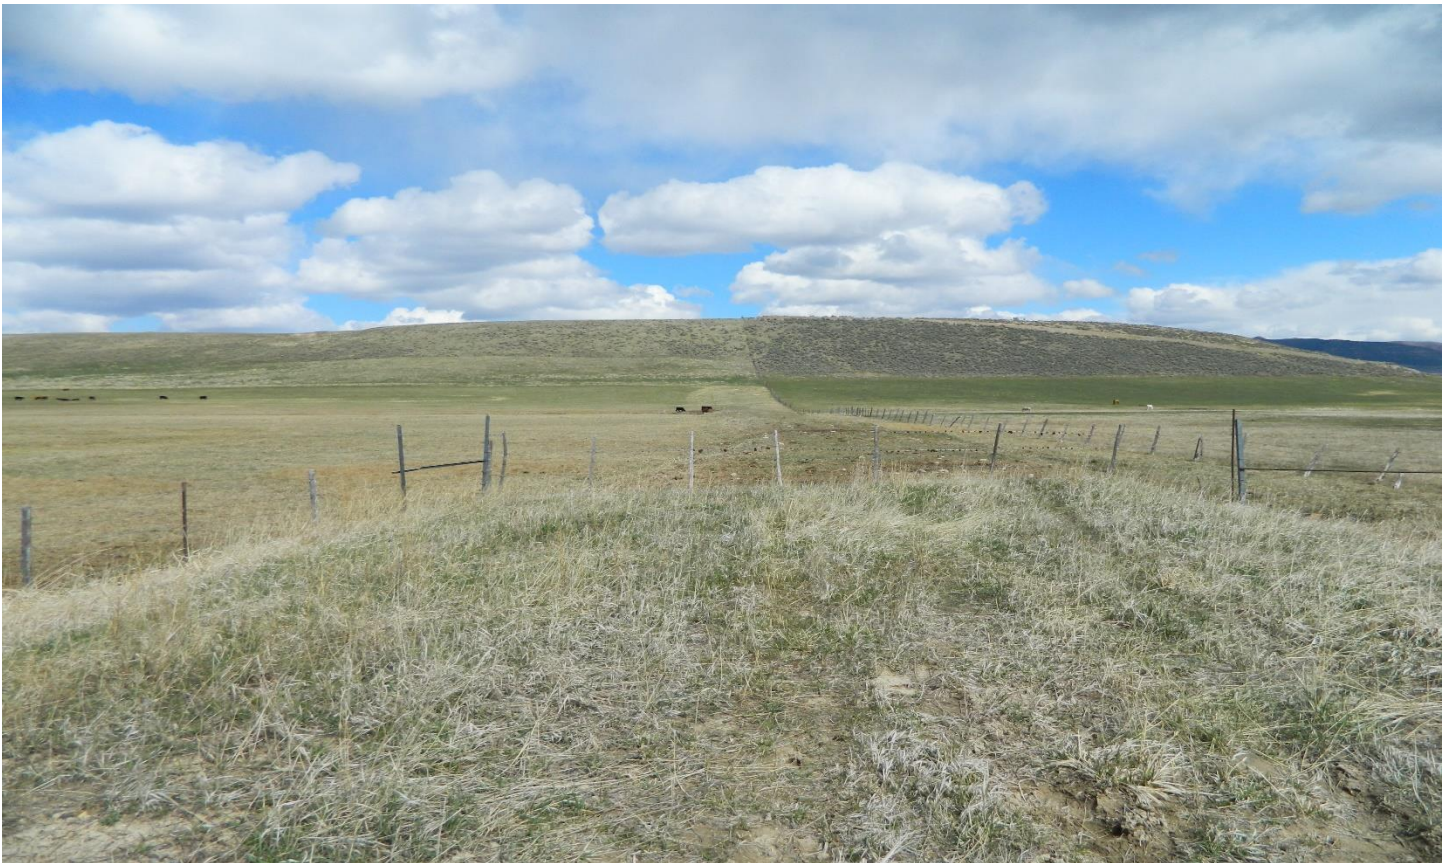
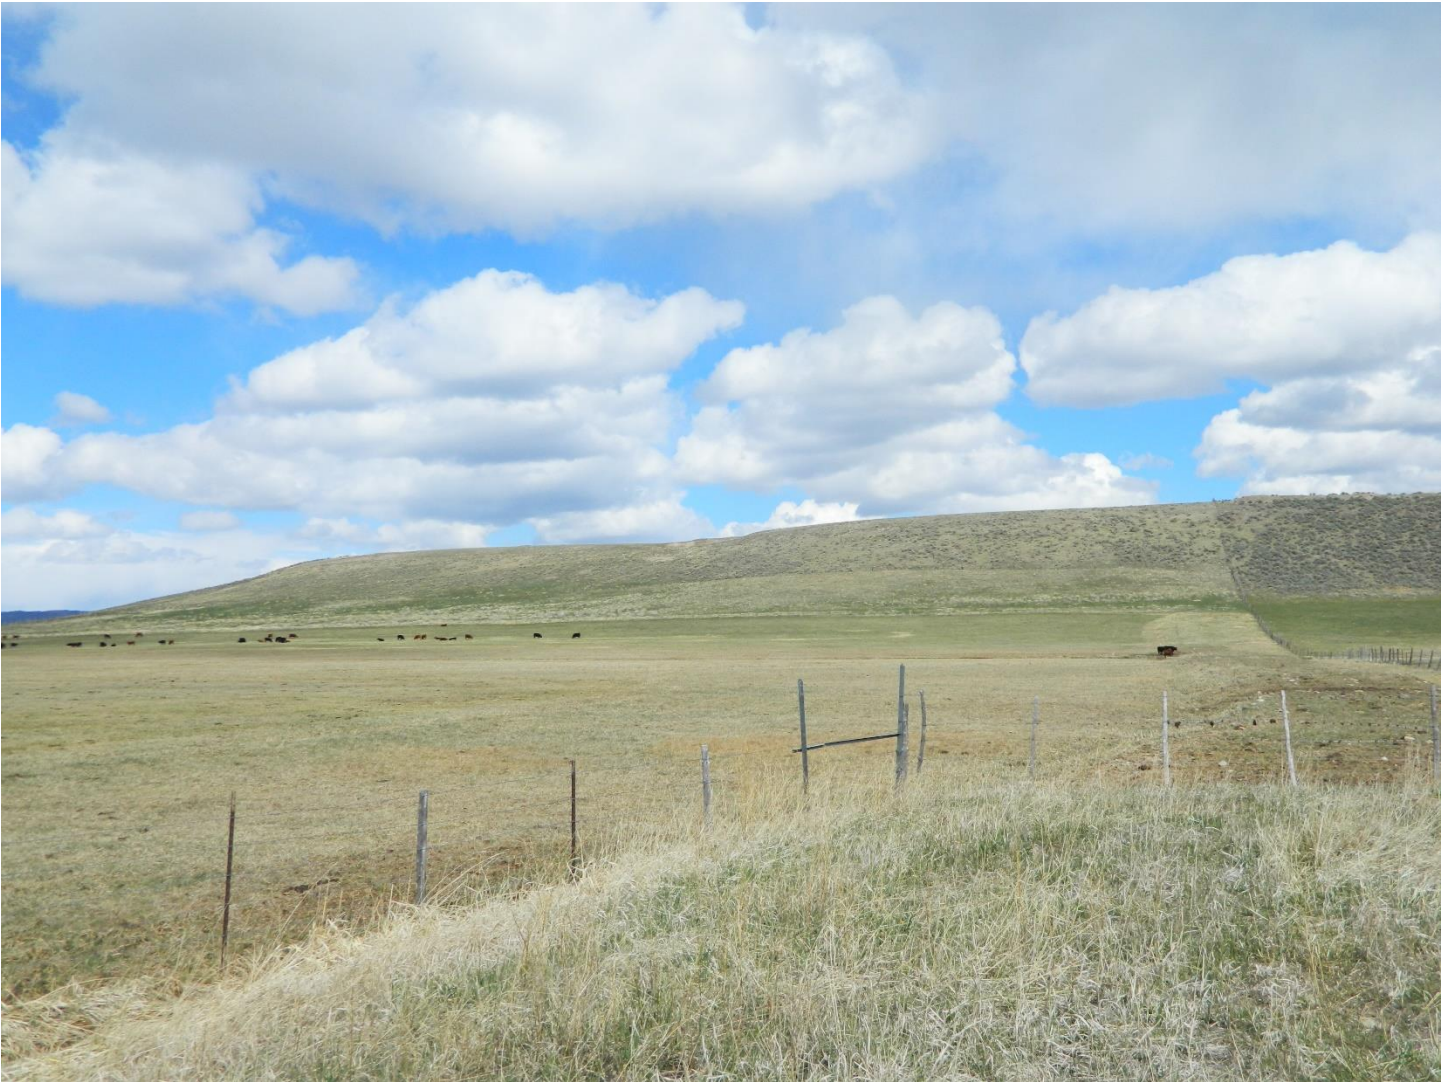
The site was inactive during the inspection. No major disturbance has taken place on the site. The site appears to be stable due to adequate vegetation.
