**MINERALS PROGRAM INSPECTION REPORT**  
**PHONE: (303) 866-3567**

<b>MINE NAME:</b> Trout Valley Ranch	<b>MINE/PROSPECTING ID#:</b> M-2016-080	<b>MINERAL:</b> Sand and gravel	<b>COUNTY:</b> Park
<b>INSPECTION TYPE:</b> Monitoring	<b>INSPECTOR(S):</b> Michael A. Cunningham	<b>INSP. DATE:</b> January 31, 2017	<b>INSP. TIME:</b> 12:00
<b>OPERATOR:</b> Brannan Sand and Gravel Company, L.L.C.	<b>OPERATOR REPRESENTATIVE:</b> Alex Schatz	<b>TYPE OF OPERATION:</b> 112c - Construction Regular Operation	
<b>REASON FOR INSPECTION:</b> Normal I&E Program	<b>BOND CALCULATION TYPE:</b> Complete Bond	<b>BOND AMOUNT:</b> \$415,073.00	
<b>DATE OF COMPLAINT:</b> NA	<b>POST INSP. CONTACTS:</b> None	<b>JOINT INSP. AGENCY:</b> None	
<b>WEATHER:</b> Snowing	<b>INSPECTOR'S SIGNATURE:</b>

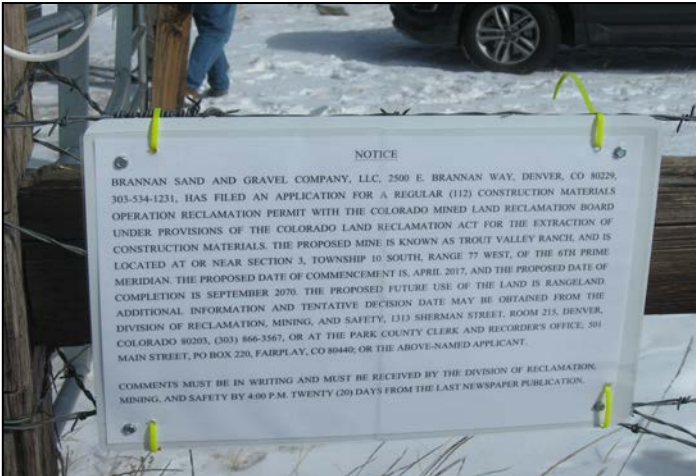
1. Public notice sign at site entrance.

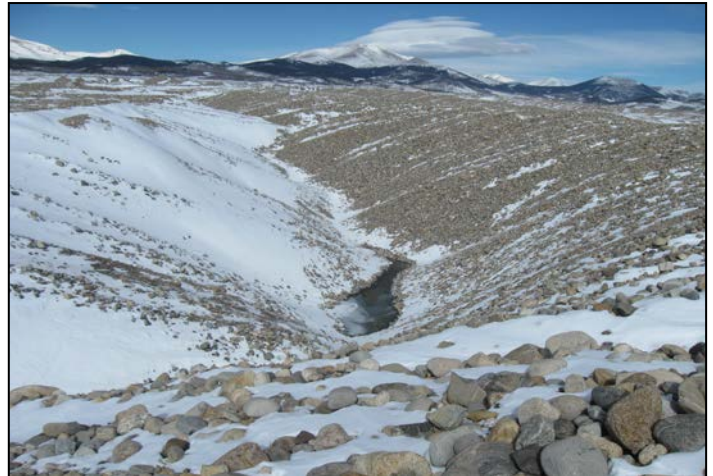
2. Top of dredge piles.

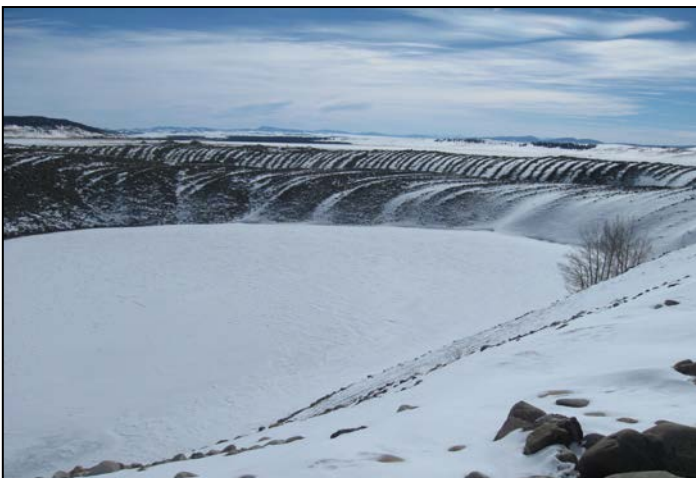
3. Artificial lake within dredge piles.

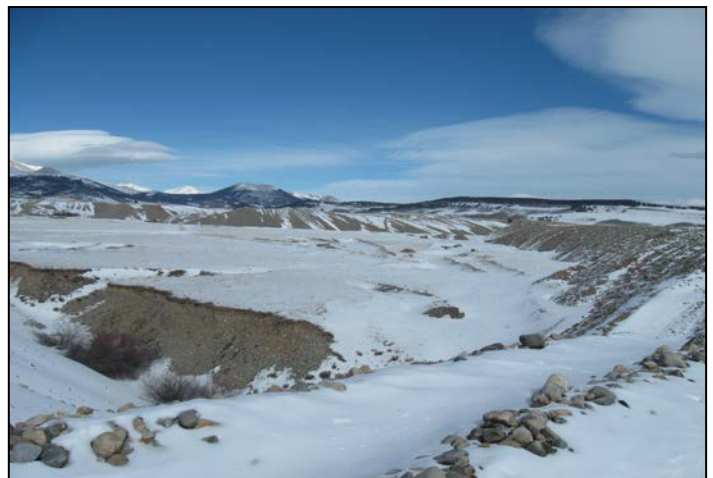
4. Central portion of mine, photo taken from top of dredge piles.

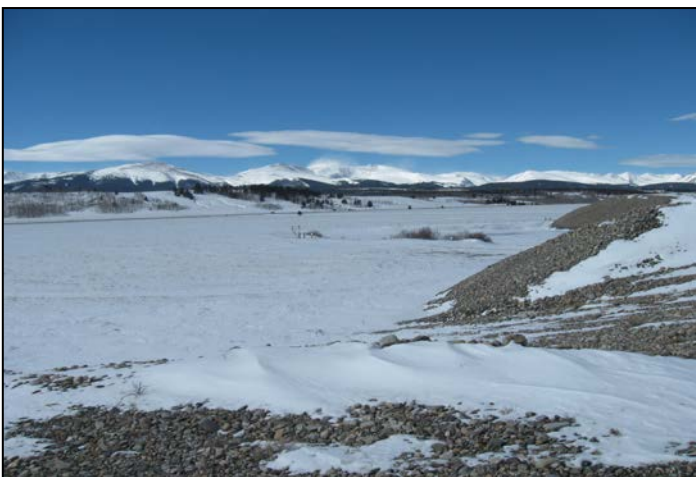
5. Western portion of the mine.

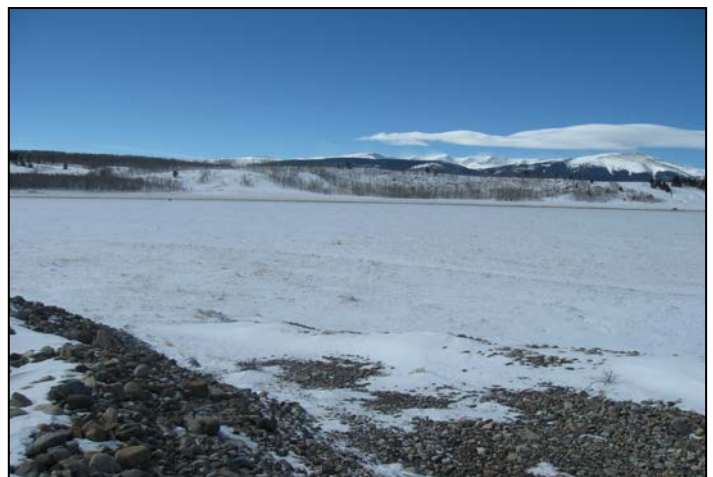
6. Western portion of the mine.
