## MINERALS PROGRAM INSPECTION REPORT

<b>MINE NAME:</b> Monks Plant No 1	<b>MINE/PROSPECTING ID#:</b> M-1983-193	<b>MINERAL:</b> Sand	<b>COUNTY:</b> El Paso
<b>INSPECTION TYPE:</b> Monitoring	<b>INSPECTOR(S):</b> Timothy A. Cazier	<b>INSP. DATE:</b> March 14, 2017	<b>INSP. TIME:</b> 11:00
<b>OPERATOR:</b> R E Monks Construction Co.	<b>OPERATOR REPRESENTATIVE:</b> Greigg Newlon & Leroy Garcia	<b>TYPE OF OPERATION:</b> 112c - Construction Regular Operation	
<b>REASON FOR INSPECTION:</b> Normal I&E Program	<b>BOND CALCULATION TYPE:</b> Partial Bond	<b>BOND AMOUNT:</b> \$18,450.00	
<b>DATE OF COMPLAINT:</b> NA	<b>POST INSP. CONTACTS:</b> None	<b>JOINT INSP. AGENCY:</b> None	
<b>WEATHER:</b> Cloudy	<b>INSPECTOR'S SIGNATURE:</b>

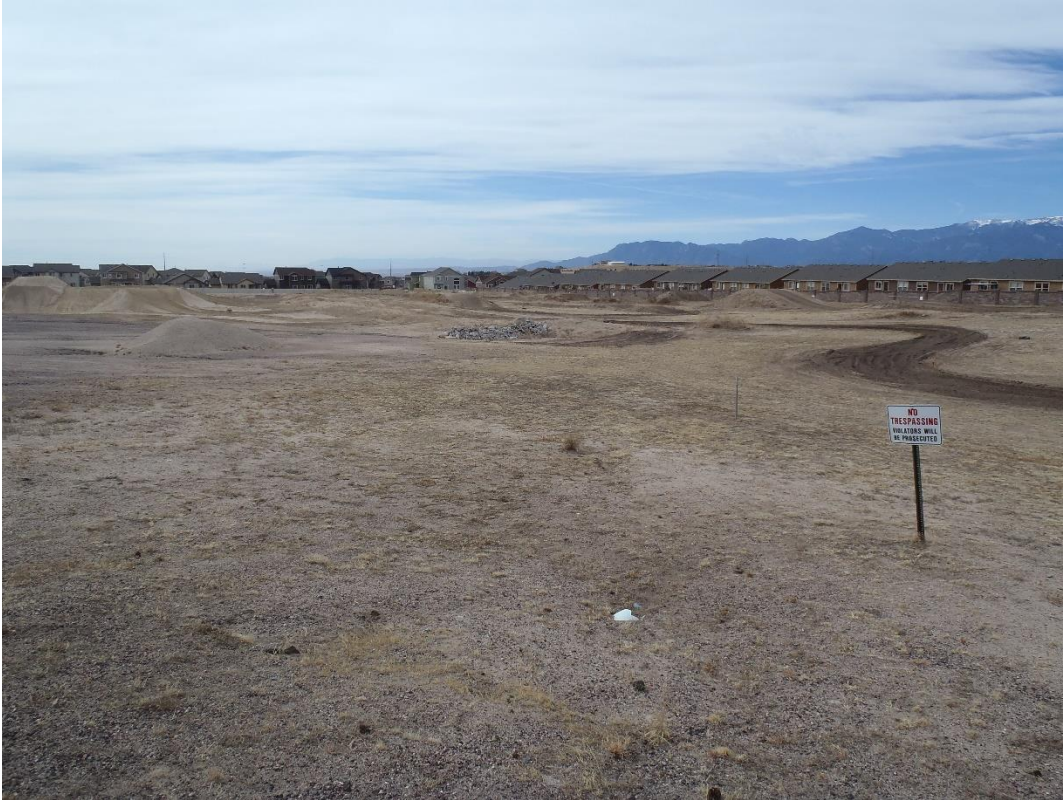
**Backfilling and Grading:** The pit is relatively shallow and currently being used as a motocross training track. Some of the features incorporated into the motocross track appear to have sufficient volume to backfill the pit (see **Photo 1**).

Photo 1. Southwest / Motocross area (looking SW, note new houses).

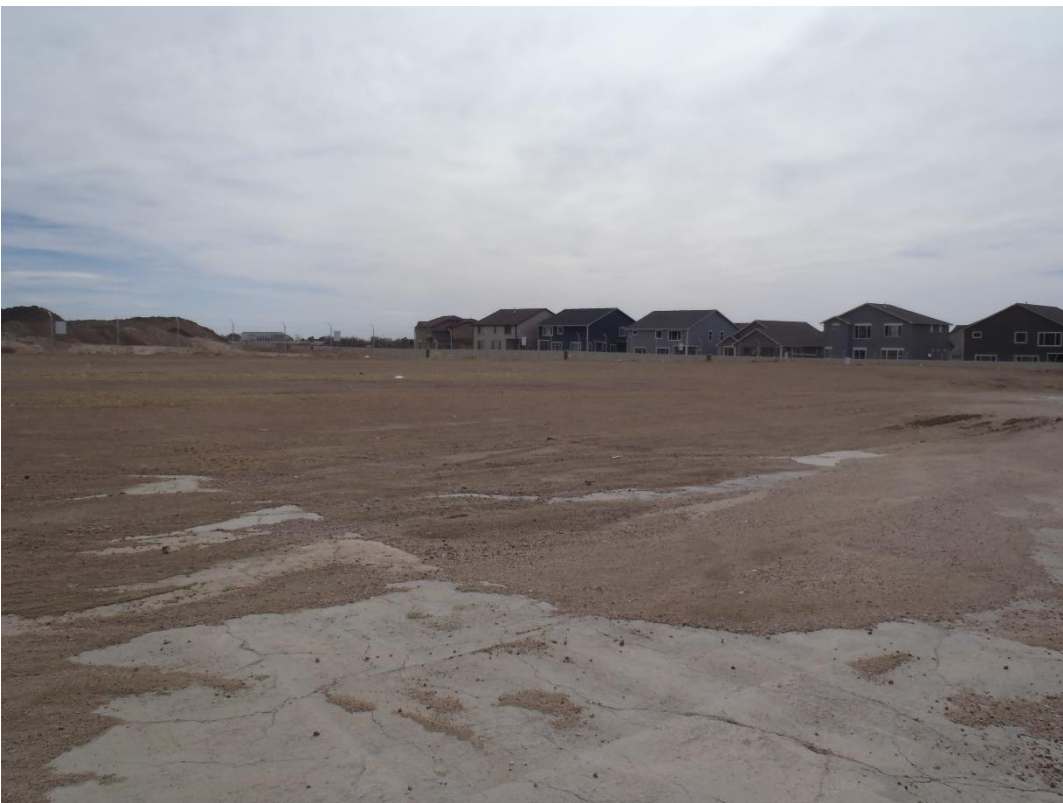
Reclamation Success: Messrs. Newlon and Garcia pointed out the grading work done on the southeast corner of the site (see **Photo 2**) and stated it is planned to be seeded this spring.

Photo 2. Regraded southeast corner of the permit (looking SE, note new houses).

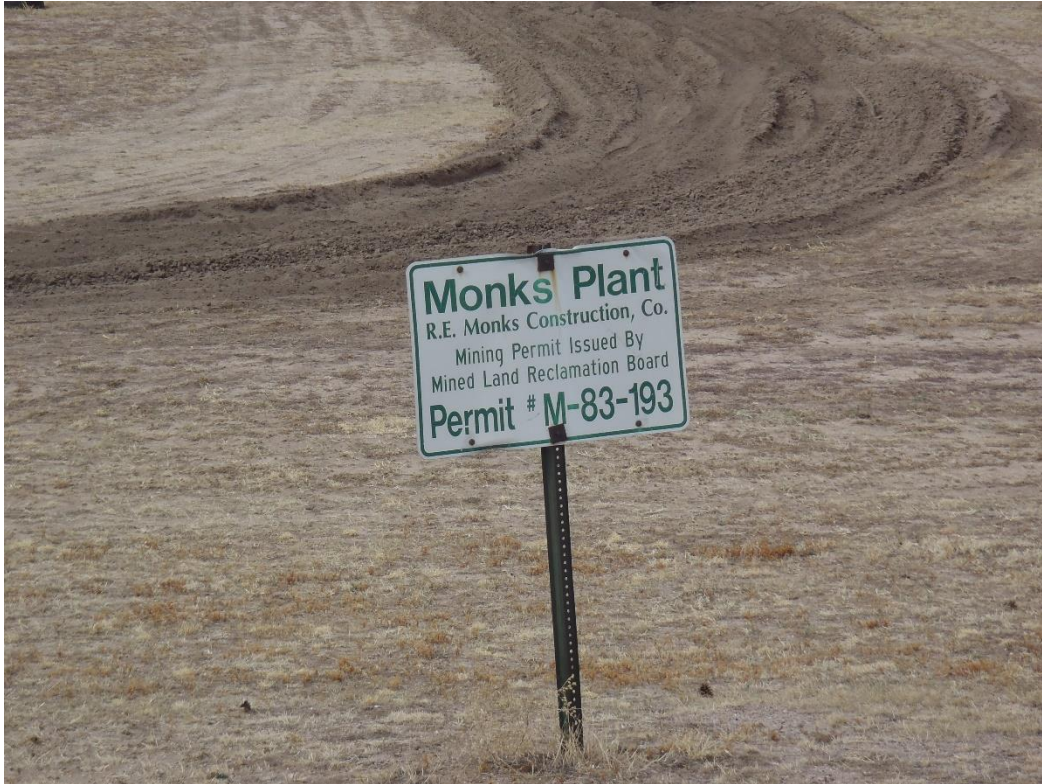
Signs and Markers: The permit sign was properly posted (see **Photo 3**) and the permit boundary is delineated with fencing.

Photo 3. Permit sign.
