**MINERALS PROGRAM INSPECTION REPORT**  
**PHONE: (303) 866-3567**

<b>MINE NAME:</b> Red Jasper Granite	<b>MINE/PROSPECTING ID#:</b> M-1982-200	<b>MINERAL:</b> Granite, granite gneiss	<b>COUNTY:</b> Teller
<b>INSPECTION TYPE:</b> Monitoring	<b>INSPECTOR(S):</b> Timothy A. Cazier	<b>INSP. DATE:</b> March 9, 2016	<b>INSP. TIME:</b> 09:30
<b>OPERATOR:</b> Colorado Quarries Inc	<b>OPERATOR REPRESENTATIVE:</b> Aaron Tezak	<b>TYPE OF OPERATION:</b> 110c - Construction Limited Impact	
<b>REASON FOR INSPECTION:</b> Normal I&E Program	<b>BOND CALCULATION TYPE:</b> Partial Bond	<b>BOND AMOUNT:</b> \$5,000.00	
<b>DATE OF COMPLAINT:</b> NA	<b>POST INSP. CONTACTS:</b> U.S.BLM	<b>JOINT INSP. AGENCY:</b> U.S.BLM	
<b>WEATHER:</b> Clear	<b>INSPECTOR'S SIGNATURE:</b>

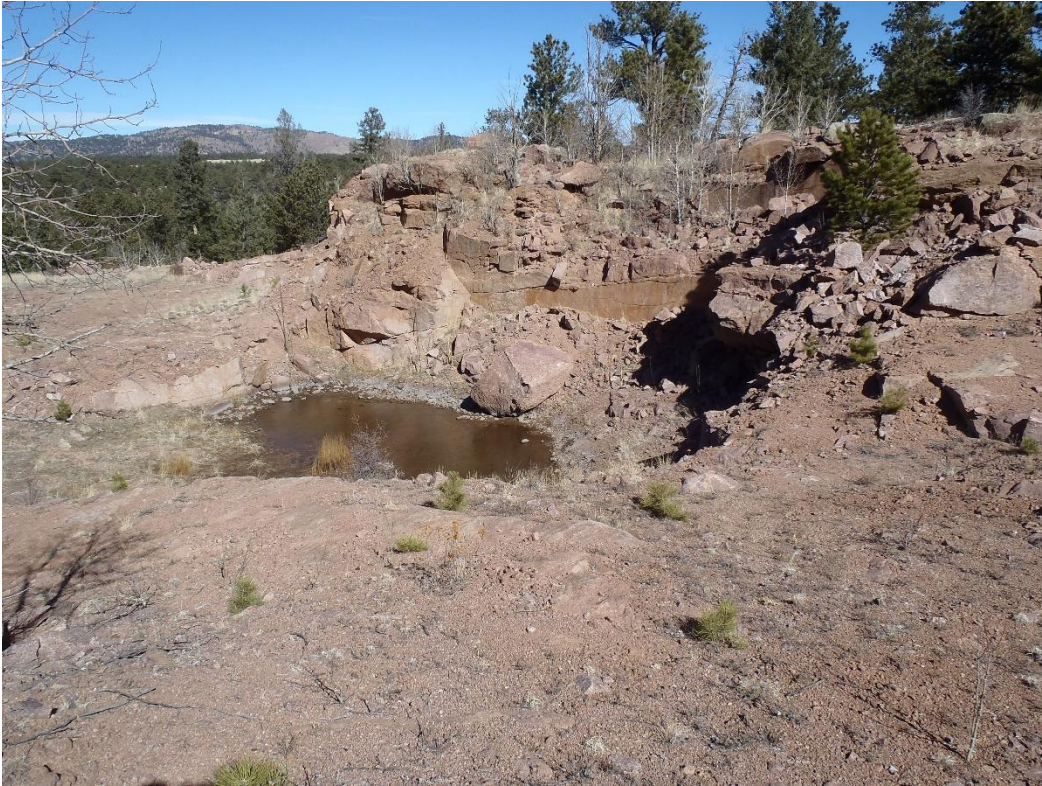
Hydrologic Balance: A small amount of water was observed in each pit (see **Photos 1 and 2**). It was believed to be stormwater.

Photo 1. East pit stormwater (looking north).

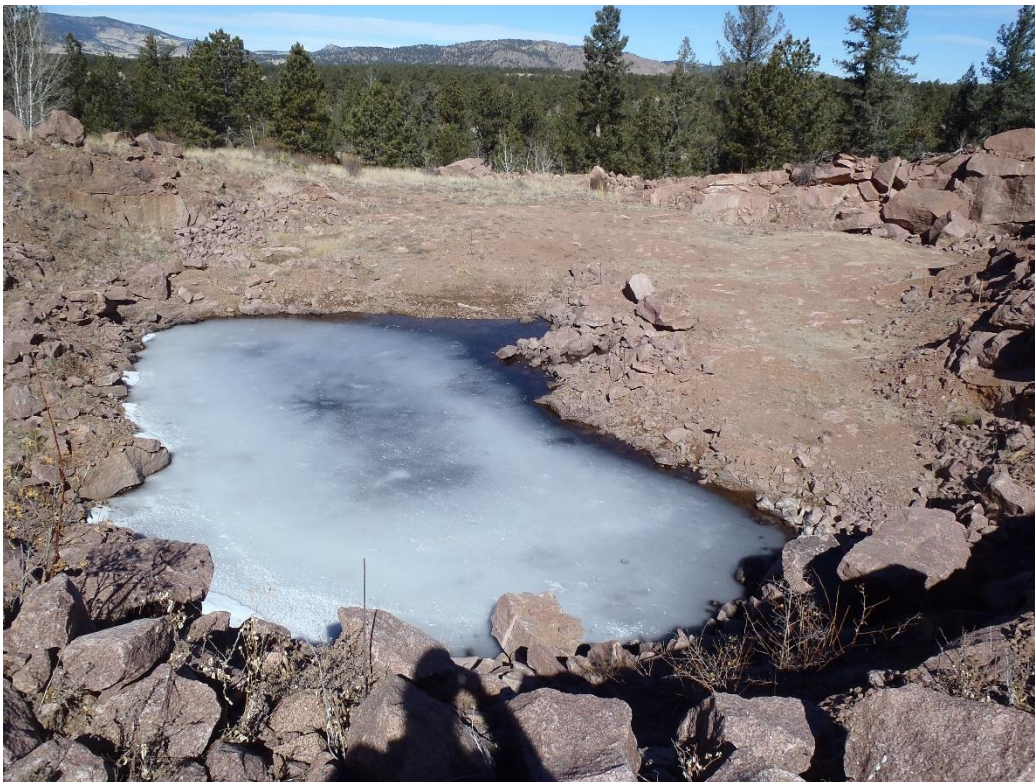
Photo 2. West pit stormwater (looking NW).

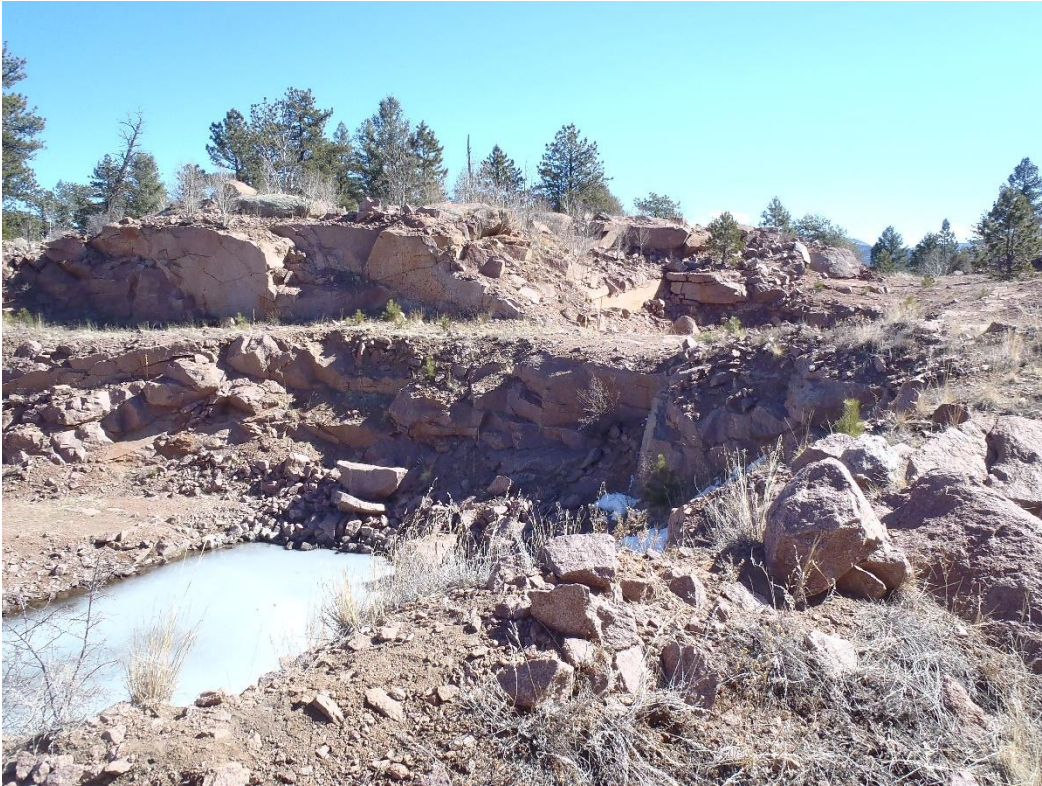
Gen. Compliance with Mine Plan: The operation appeared to be in compliance with the approved mine plan. The pit highwall was benched (see **Photo 3**). Google Earth was used to measure the disturbed area, which was estimated to be approximately 0.5 acres plus the 2-track access road which is mostly self-reclaimed due to the infrequent use.

Photo 3. West pit highwall – note bench (looking east).

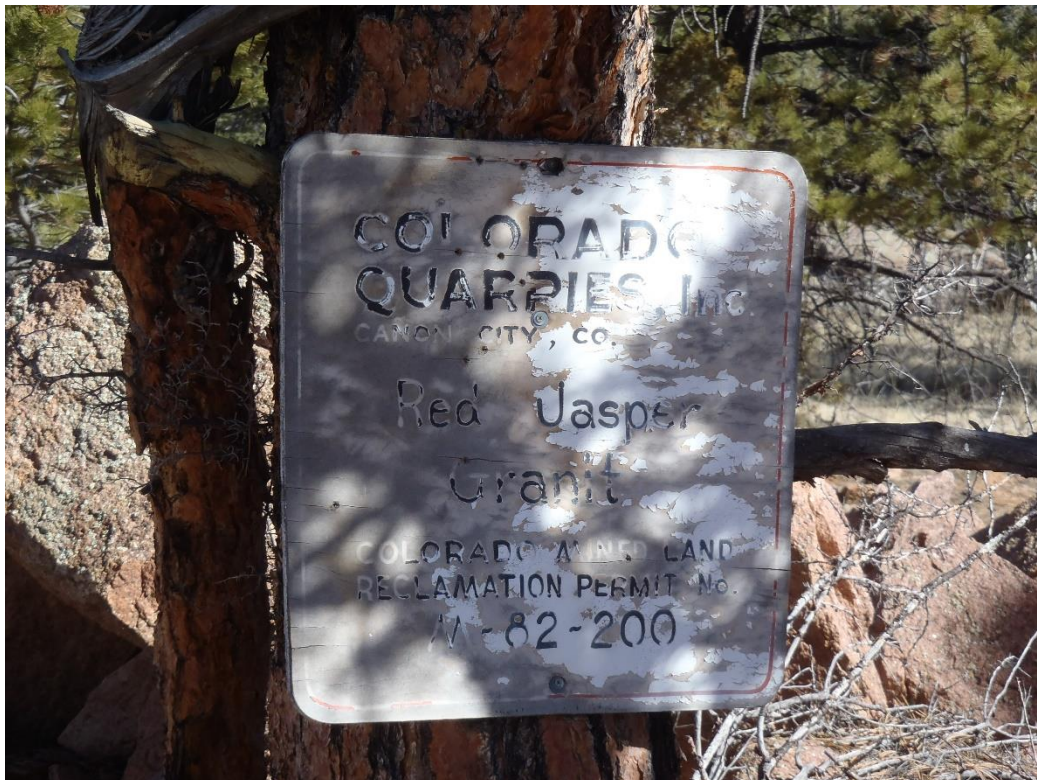
Photo 4. Permit sign (should be replaced or re-painted).

Signs and Markers: The permit sign was properly posted (see **Photo 4**) and boundary markers were observed to delineate the permit boundary (see **Photo 5**). The permit sign should be replaced or re-painted.

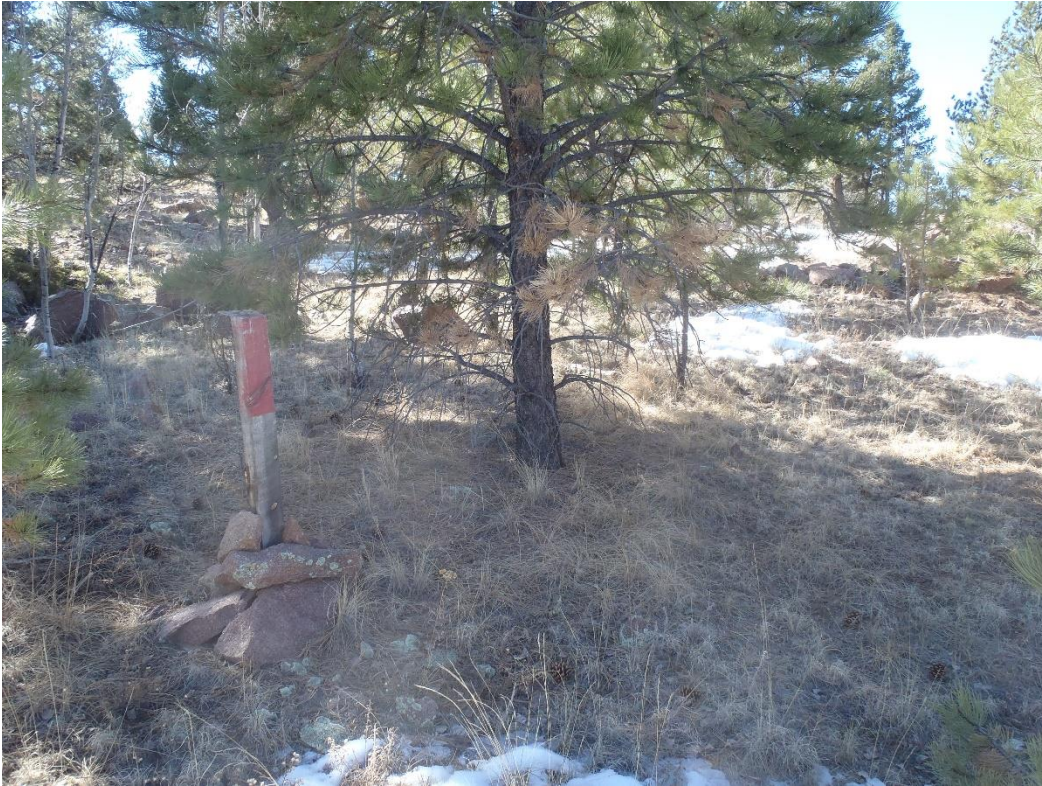
Photo 5. Typical permit boundary corner post (NW corner).
