**MINERALS PROGRAM INSPECTION REPORT**  
**PHONE: (303) 866-3567**

<b>MINE NAME:</b> Thomas Pit	<b>MINE/PROSPECTING ID#:</b> M-1976-020	<b>MINERAL:</b> Sand and gravel	<b>COUNTY:</b> La Plata
<b>INSPECTION TYPE:</b> Monitoring	<b>INSPECTOR(S):</b> Lucas J. West	<b>INSP. DATE:</b> April 4, 2017	<b>INSP. TIME:</b> 16:15
<b>OPERATOR:</b> Oldcastle SW Group, Inc. dba Four Corners M	<b>OPERATOR REPRESENTATIVE:</b> Matt Carnahan	<b>TYPE OF OPERATION:</b> 112c - Construction Regular Operation	
<b>REASON FOR INSPECTION:</b> Normal I&E Program	<b>BOND CALCULATION TYPE:</b> None	<b>BOND AMOUNT:</b> \$26,295.00	
<b>DATE OF COMPLAINT:</b> NA	<b>POST INSP. CONTACTS:</b> None	<b>JOINT INSP. AGENCY:</b> None	
<b>WEATHER:</b> Clear	<b>INSPECTOR'S SIGNATURE:</b>

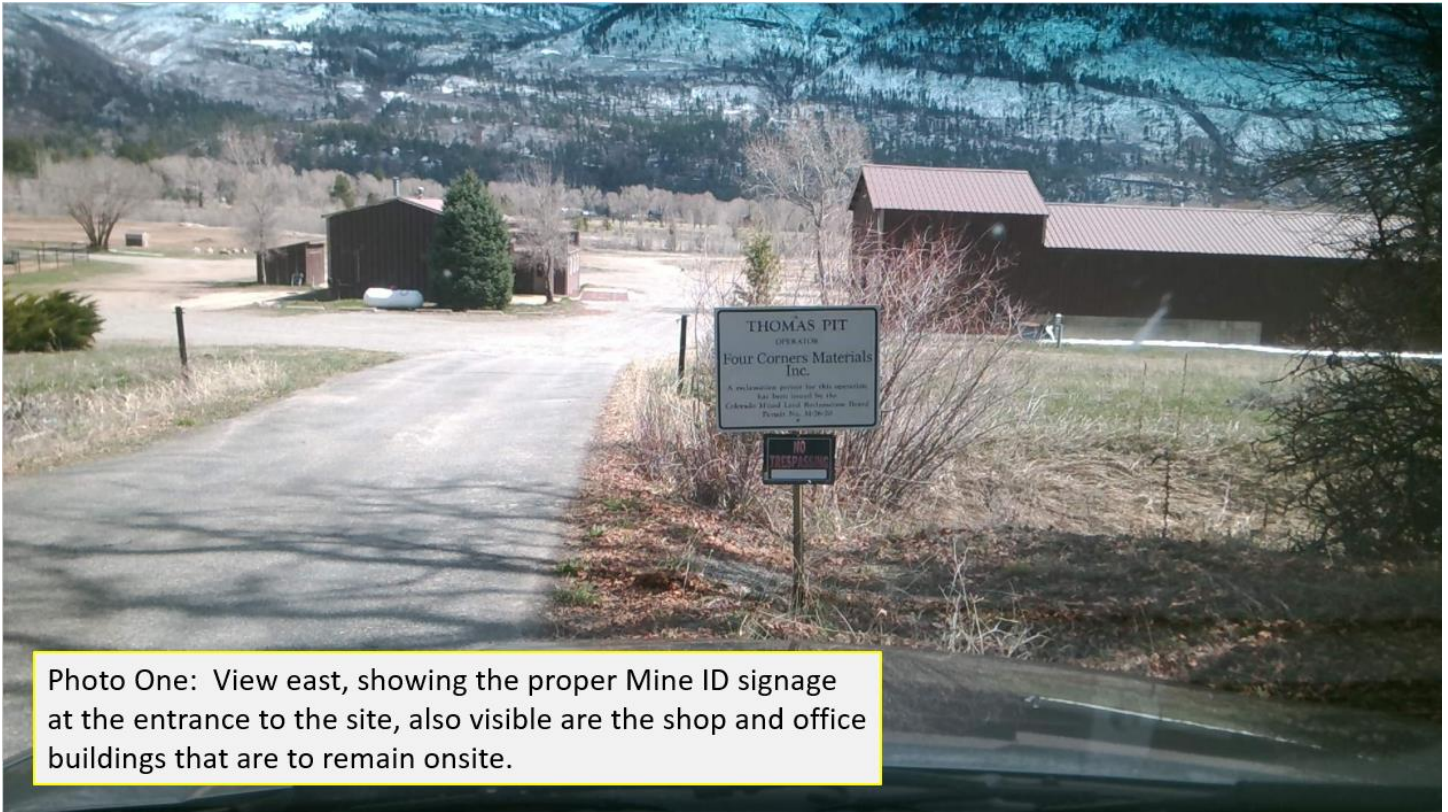
Photo One: View east, showing the proper Mine ID signage at the entrance to the site, also visible are the shop and office buildings that are to remain onsite.

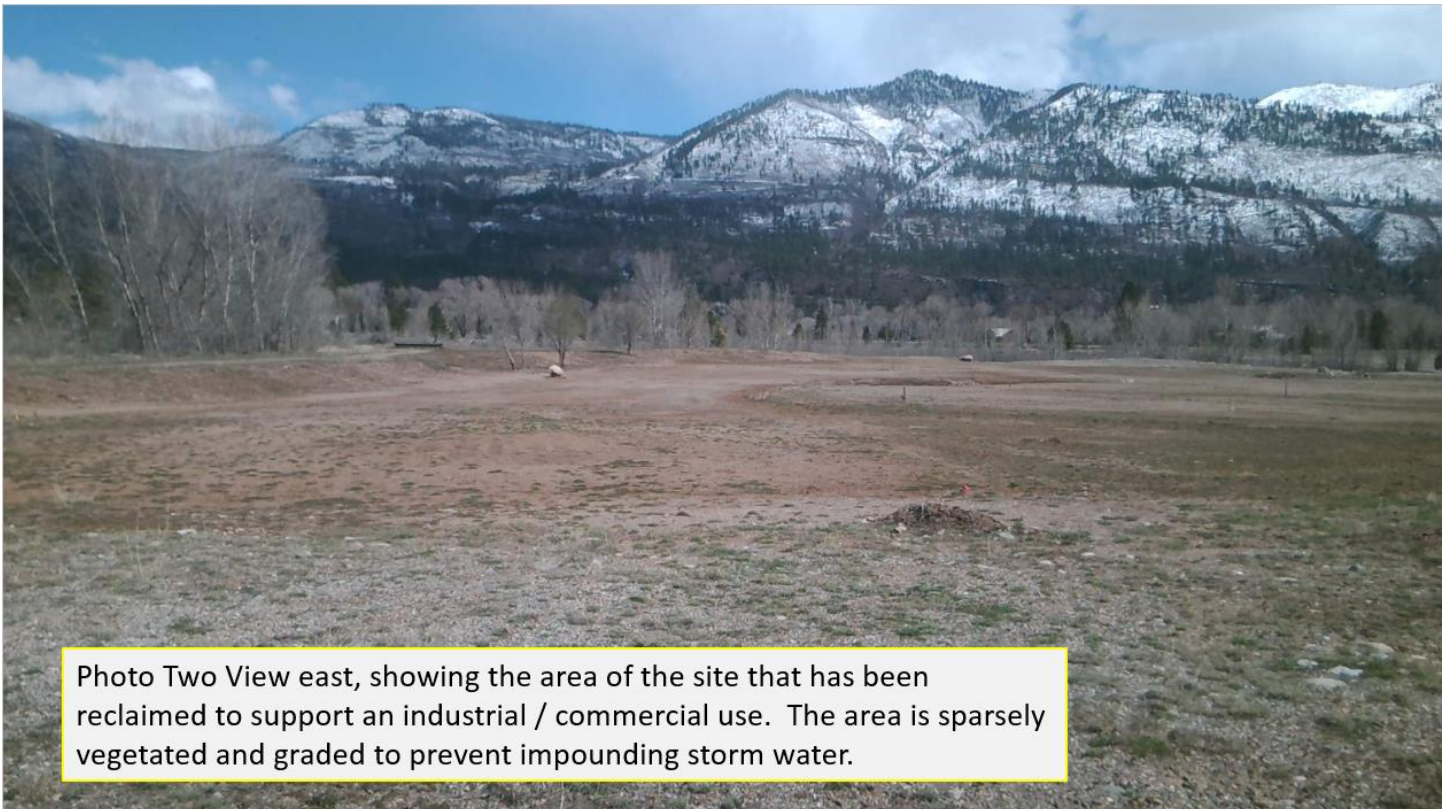
Photo Two View east, showing the area of the site that has been reclaimed to support an industrial / commercial use. The area is sparsely vegetated and graded to prevent impounding storm water.

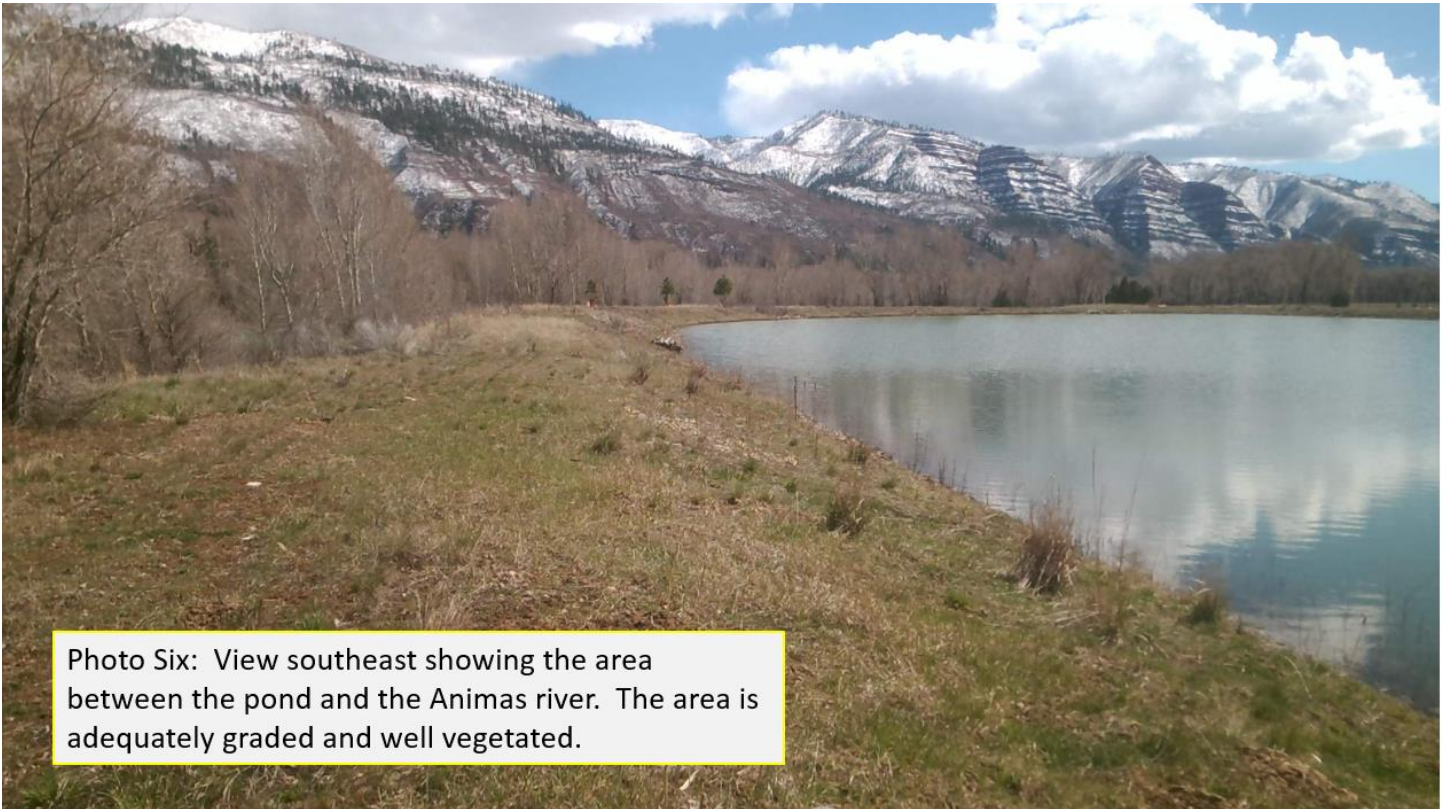
The site was not active at the time of the inspection, and in addition to Division Staff, Matt Carnahan of Four Corners Materials as well as Jim Bryce, the landowner representative were present during the inspection. The site consists of 34.8 permitted acres that have been almost fully reclaimed. The post mining land uses include Industrial Commercial, Wildlife Habitat and Cropland. Photo One shows the appropriate Mine Identification Signage was observed at the entrance to the site, also visible are the office and shop facilities which will remain on site for landowner use. All grading and earthwork on site has been completed throughout the site in accordance with the approved reclamation plan. As stated above the site is approved for mixed post mining land uses. The northern pit area, shown in Photos Two and Three has been reclaimed to support an industrial commercial land use. The areas have been graded to achieve positive drainage, and are sparsely vegetated with volunteer species. The center portion of the site has been reclaimed to support an agricultural land use, which is shown in Photo Four. The southern portion of the permitted area includes a large pond, approximately three acres in size. The pond is properly permitted through the landowner to remain on site. The side slopes and area around the shores have been reclaimed to support wildlife habitat. Photos Five and Six show the pond area which has graded and sufficiently revegetated.

Photo Six: View southeast showing the area between the pond and the Animas river. The area is adequately graded and well vegetated.

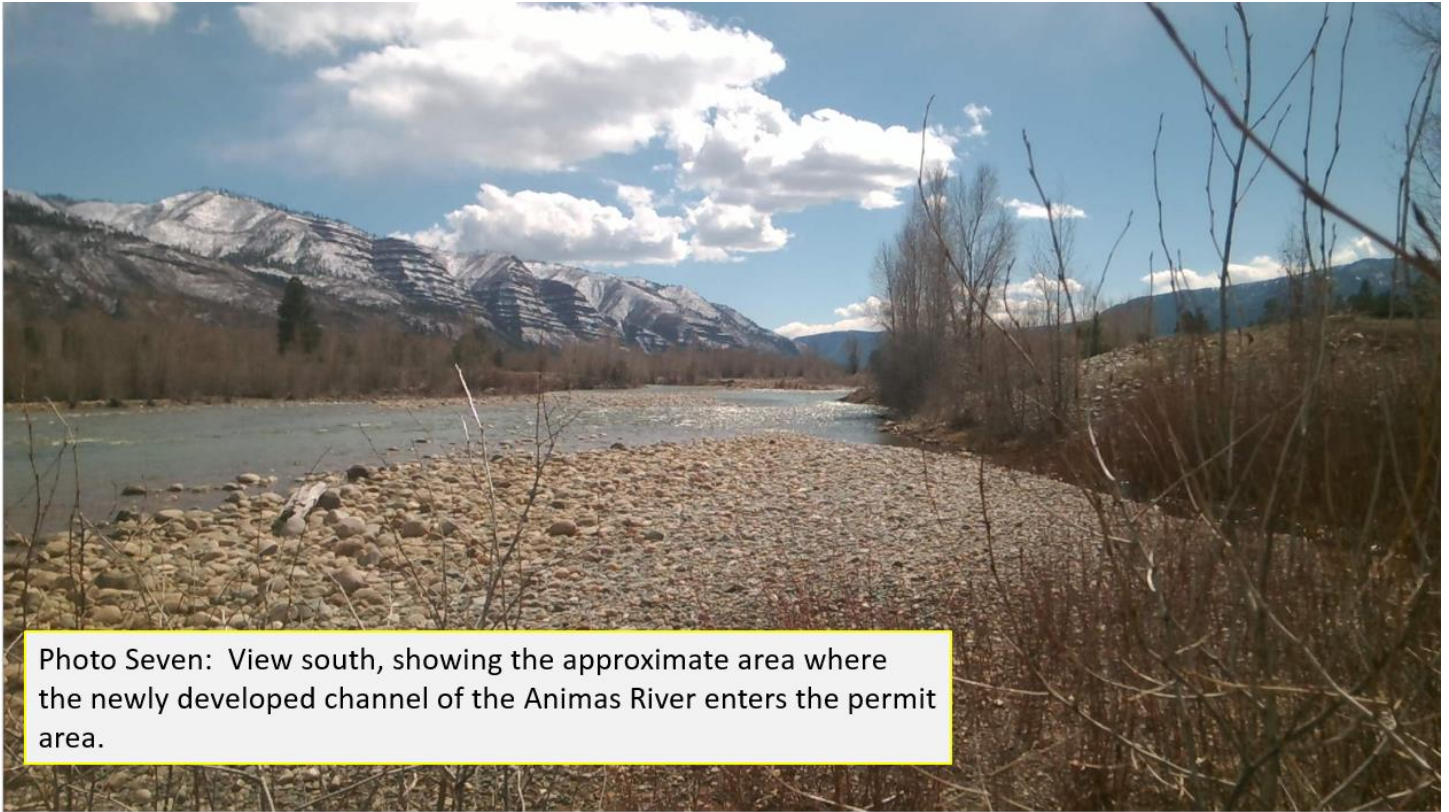
The Animas River runs through a significant portion of the eastern side of the site shown in Photos Seven and Eight. Since the completion of the mining activities on site, the flow regime and channel of the Animas River has changed significantly. Activities have been permitted through the Army Corps of Engineers, and discussions with the landowner indicate that they would like to discuss a potential river re-channelization project. A follow up inspection between the Operator, Landowner, Division Staff and ACOE Staff has been tentatively scheduled to discuss the project and the potential impacts to the DRMS permit.

Photo Seven: View south, showing the approximate area where the newly developed channel of the Animas River enters the permit area.

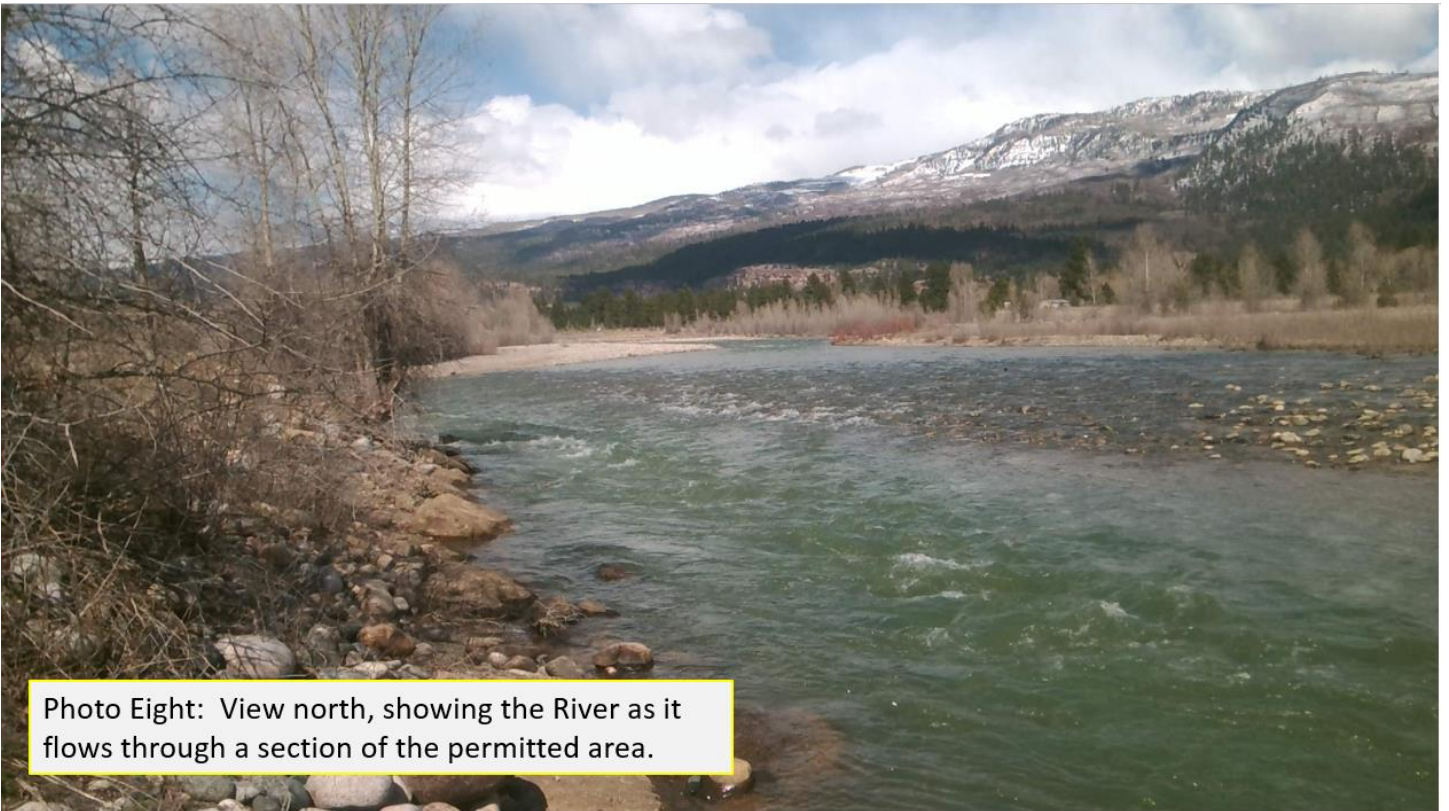
Photo Eight: View north, showing the River as it flows through a section of the permitted area.
