**MINERALS PROGRAM INSPECTION REPORT**  
**PHONE: (303) 866-3567**

<b>MINE NAME:</b> Climax Mine	<b>MINE/PROSPECTING ID#:</b> M-1977-493	<b>MINERAL:</b> Molybdenum	<b>COUNTY:</b> Summit
<b>INSPECTION TYPE:</b> Multi Person Inspection	<b>INSPECTOR(S):</b> Lucas J. West, Eric Scott	<b>INSP. DATE:</b> March 22, 2017	<b>INSP. TIME:</b> 09:30
<b>OPERATOR:</b> Climax Molybdenum Company	<b>OPERATOR REPRESENTATIVE:</b> Diana Kelts, Aaron Hilshorst	<b>TYPE OF OPERATION:</b> 112d-3 - Designated Mining Operation	
<b>REASON FOR INSPECTION:</b> Normal I&E Program	<b>BOND CALCULATION TYPE:</b> None	<b>BOND AMOUNT:</b> \$78,246,088.00	
<b>DATE OF COMPLAINT:</b> NA	<b>POST INSP. CONTACTS:</b> None	<b>JOINT INSP. AGENCY:</b> None	
<b>WEATHER:</b> Clear	<b>INSPECTOR'S SIGNATURE:</b>

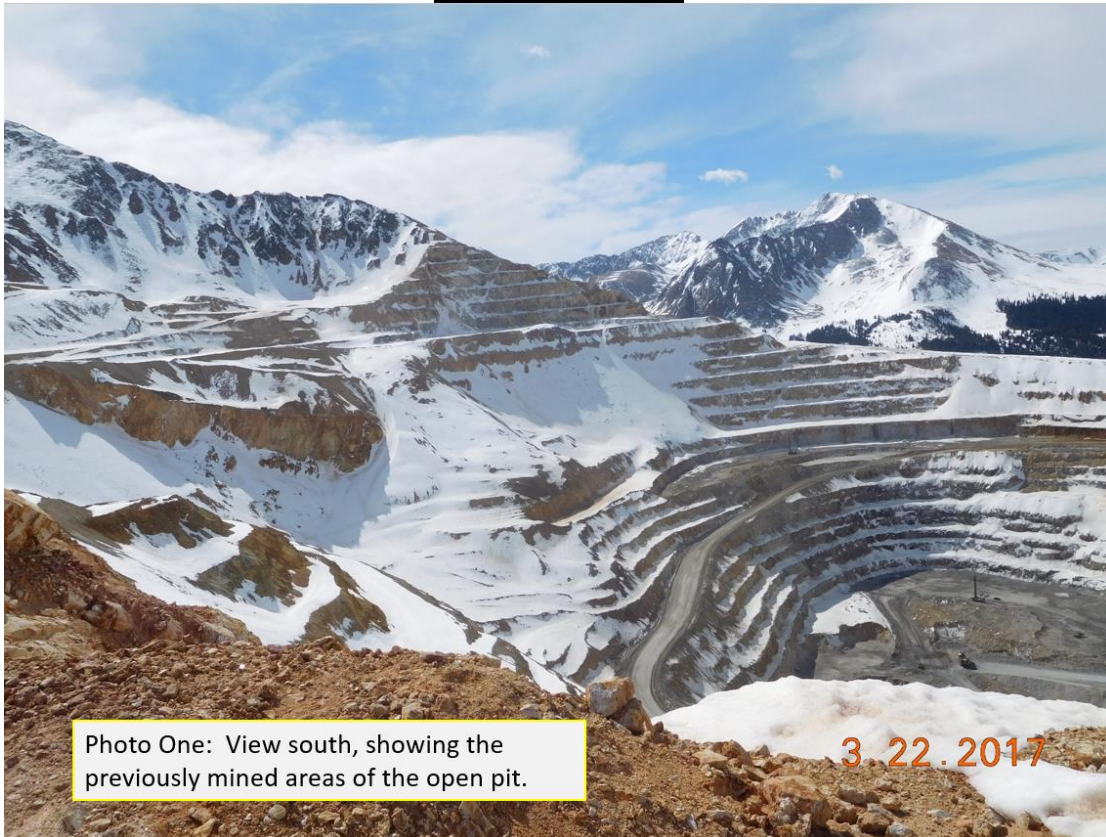
The first stop on the inspection was to the survey shacks that overlook the open pit excavation. Photos One and Two show the open pit from the shacks. The main purpose of the survey shacks is to continually survey the slopes of the pit for stability, and monitor any movement that may occur within the pit. The survey shacks also house a weather station for the site, allow for continuous mapping of the mining progress as ore is removed, as well as serve as a view area to oversee the operations. Once the ore is removed from the pit area, it is moved to the primary crusher, which crushes the material to approximately 8 inch minus and feeds it inside the mill facility. The interior of the mill facility was very clean and well organized from the various mills, flotation cells, thickeners and cleaners. Photo Three shows the Sag Mill, within the milling room, which is the first stop in the milling process. Also as seen in Photo Three, the mill room is neat and orderly, and all proper safety features appeared to be in working order. The entire room is built on a concrete apron that serves as a secondary containment facility. The secondary containment appears to of adequate volume to handle any potential spills that may happen. The various other equipment including screens, shakers, a ball mill and various conveyors all appeared to be in good condition and functioning properly.

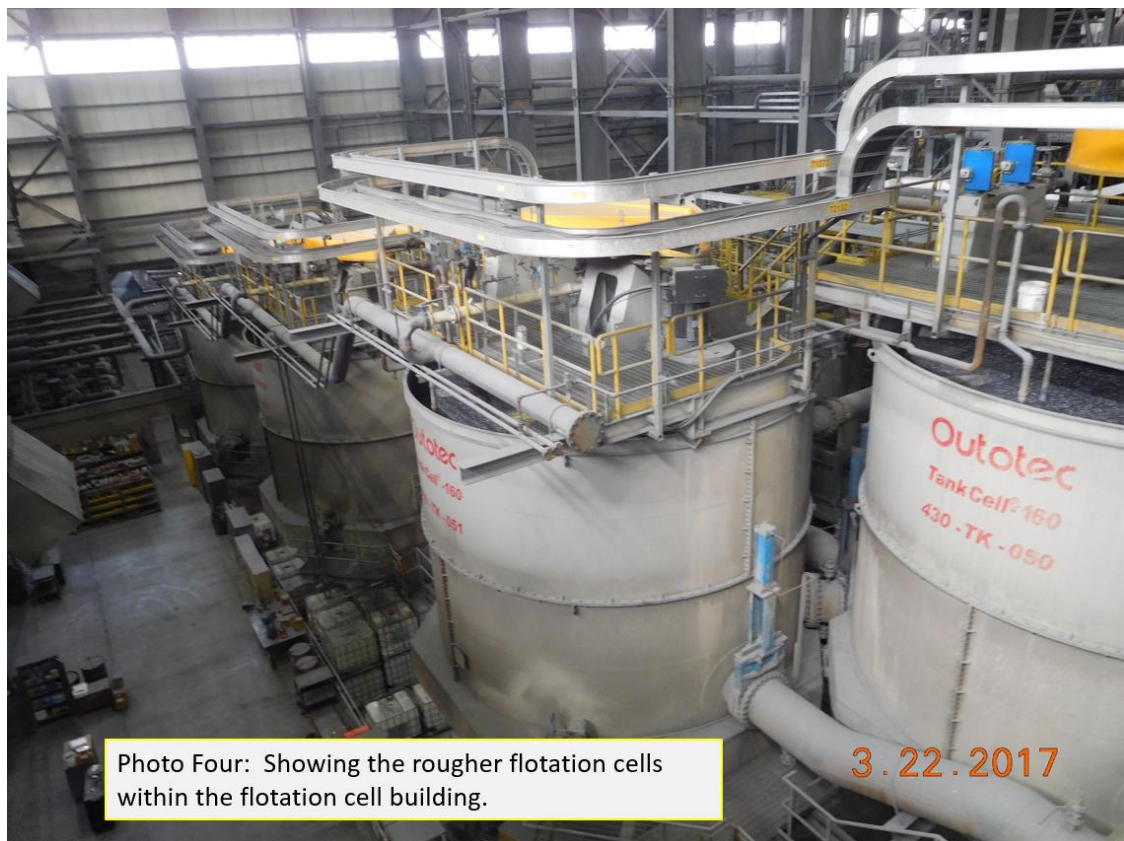
Once the ore is processed, water is added to create a slurry, and sent to the flotation cell. Photo Four shows a view of the flotation cells. As the ore slurry moves through each of the eight flotation cells, the ore is floated away from the host material and is sent through a thickener and then a cleaner. The waste material, the tailings, is sent to a separate thickener, shown in Photo Five, and prepared for transport to the various tailings storage facilities. Once the ore is cleaned and dried, it is loaded into Super Sacks and prepared for transport as shown in Photo Six. All areas within the flotation cell room are in good condition. The areas are free from clutter, and all equipment within the area appears to be functioning properly. The floor of the flotation cell room also serves as secondary containment for the facility and appears to be in good working order and of adequate volume to handle any potential spills.

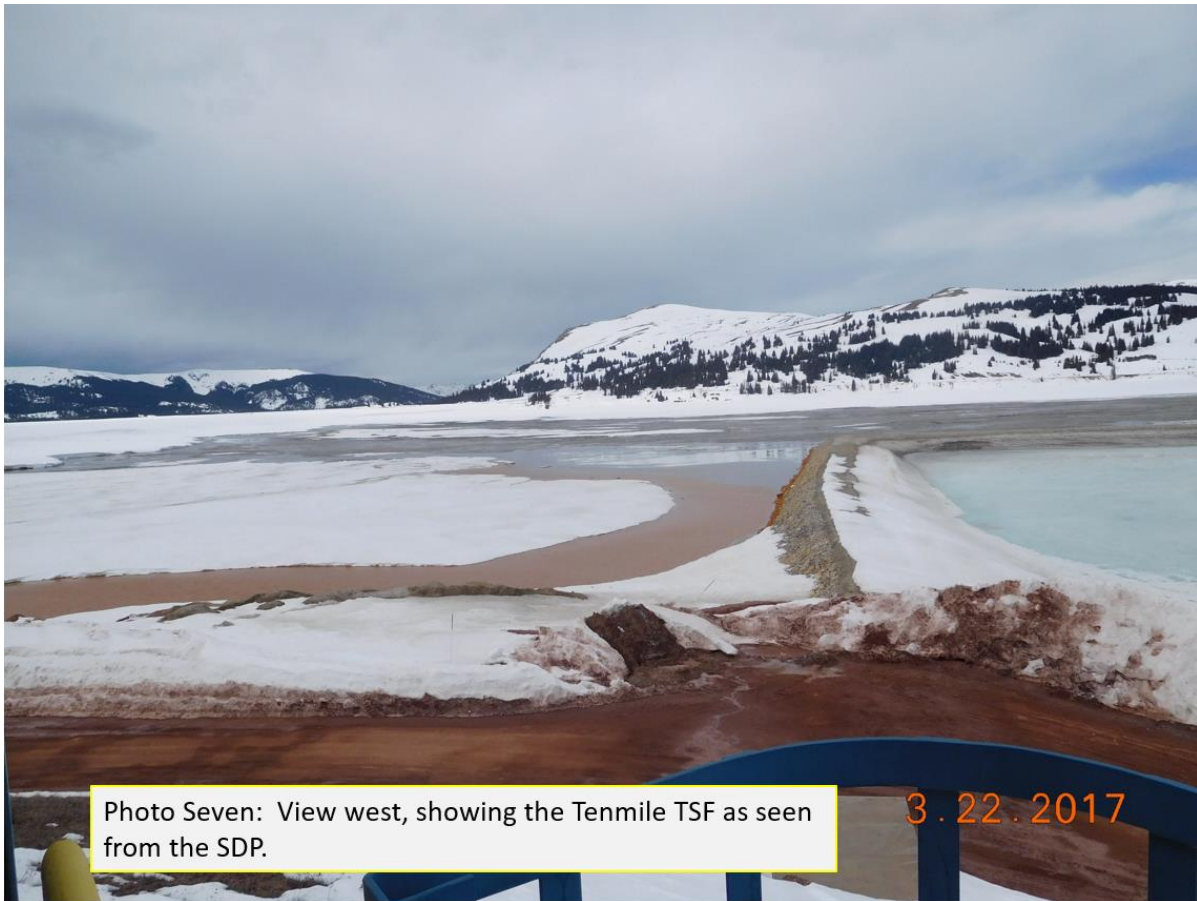
Photo Seven: View west, showing the Tenmile TSF as seen from the SDP.
