**COLORADO**Division of Reclamation,
Mining and Safety

MINERALS PROGRAM INSPECTION REPORT**PHONE: (303) 866-3567**

MINE NAME: J & J Pit	MINE/PROSPECTING ID#: M-1985-001	MINERAL: Sand and gravel	COUNTY: La Plata
INSPECTION TYPE: Monitoring	INSPECTOR(S): Lucas J. West	INSP. DATE: April 5, 2017	INSP. TIME: 08:00
OPERATOR: Glacier Gravel Products	OPERATOR REPRESENTATIVE: Jim Helmericks, Nathan Barton	TYPE OF OPERATION: 110c - Construction Limited Impact

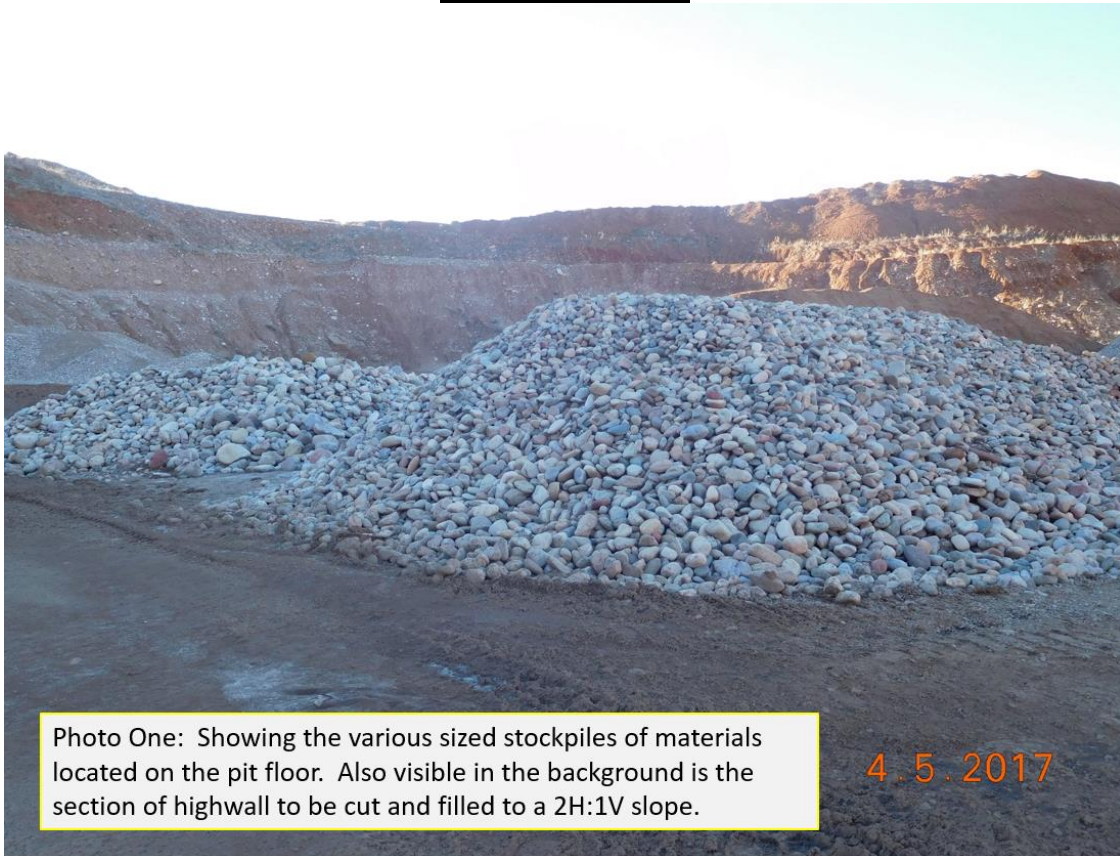
The proper Mine Identification Signage was observed at the entrance to the site. The site was not active during the inspection and the only equipment on site was a parked loader adjacent to the scale house. Several stockpiles of materials are located on the pit floor shown in Photo One, the stockpiles appear to be stable and are in good condition. A large section of the North highwall has been backfilled to approximately 2H : 1V slope with straw wattles installed for erosion control. Photo Two shows the backfilled slope which was hydro seeded shortly after the inspection concluded. The remaining highwall to be backfilled, shown in Photo Three, consists of 430 foot long section that is a mix of vertical face and 1.5H: 1V slopes. A stockpile of material is located approximately 300 feet from the highwall, which will need to be moved via Wheeled Loader to backfill the slope. The slope of the remaining highwalls can be reduced by utilizing the cut and fill method of dozing. The remaining highwalls are approximately 80 feet tall, 500 linear feet, and are a mix of vertical face and 1H :1V slopes.

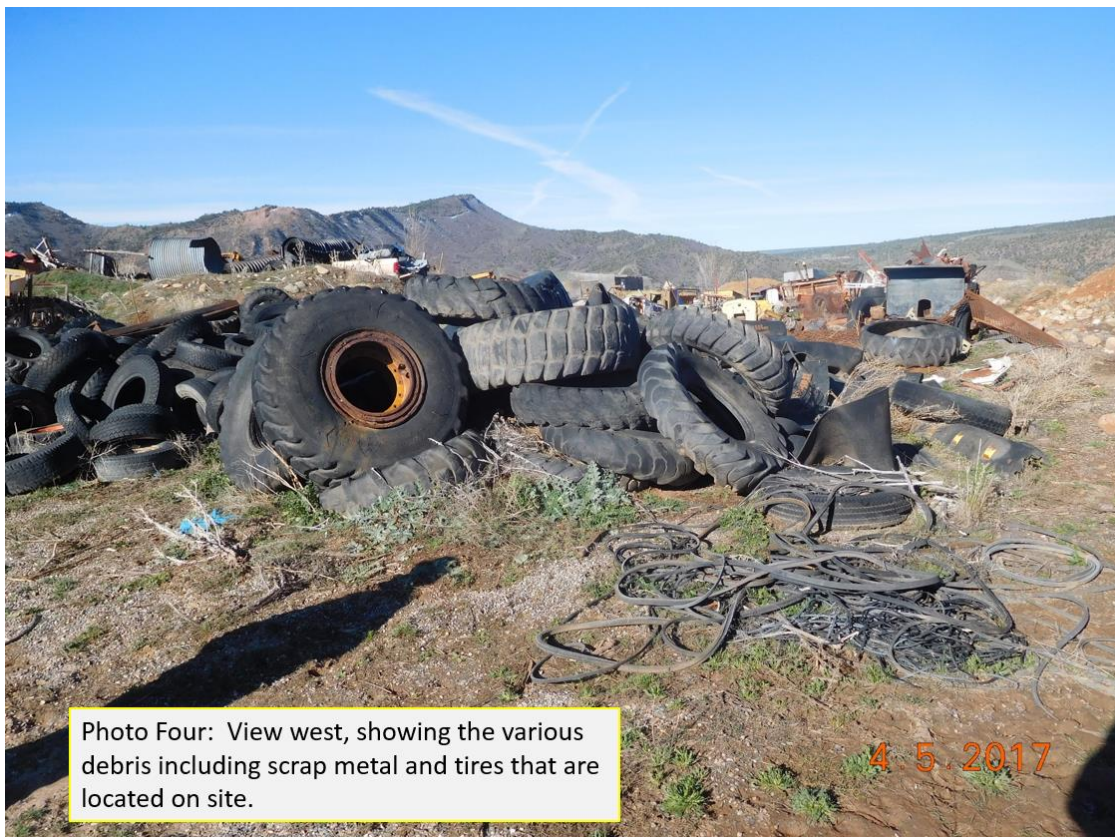
Photo Four shows various debris located within the permitted area including tires and scrap metal. The material is not included in the approved reclamation plan, therefore removal of the 100 cubic yards of material was included in the Reclamation Cost Estimate Update. Discussions with the Operator and his consultant indicate the material is being stored on site for eventual use by the landowner. Storing the materials on site can be addressed through the pending Technical Revision, however so long as the material is within the permitted area, the Reclamation Cost Estimate will include the removal and disposal of the material. On site disposal of the scrap metal or tires will not be approved by the Division.
