Re: King I Mine, C-1981-035
Stoner Engineering: Quarterly Inspection: Water Quality Improvements
1st Quarter 2017

Date: March 28, 2017

Re: King Coal I – Quarterly Water Quality Improvements Inspection

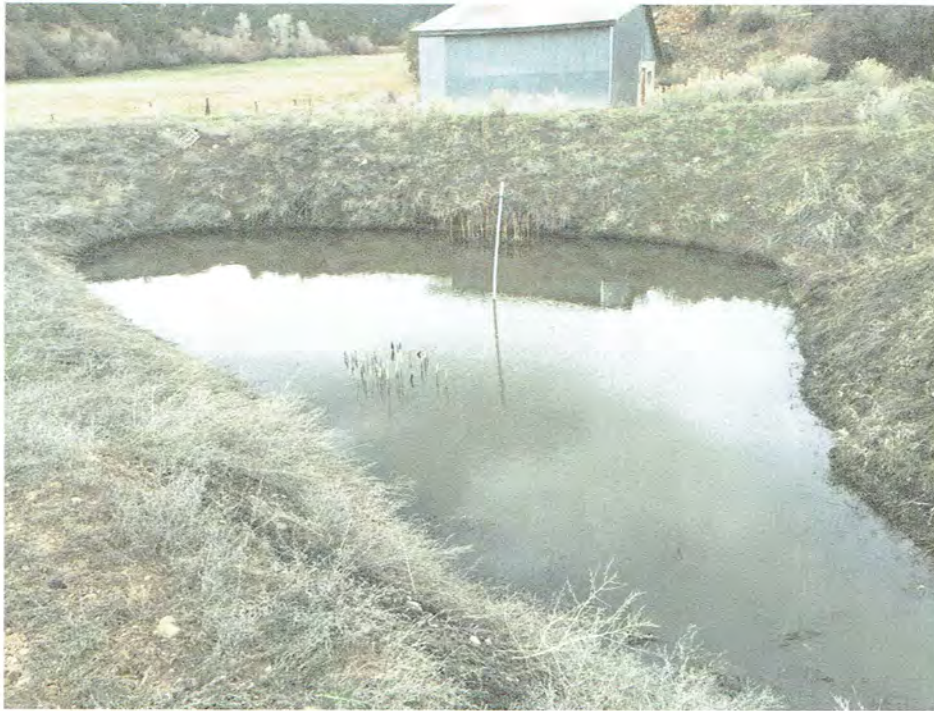
There were approximately 29-inches of water in the west pond and 46-inches of water in the east pond (see Pic. 1) at the time of the inspection. The ponds are both in generally good condition. The required storage volume appears to be adequate at this time based upon the sedimentation gages installed in the ponds. The sedimentation levels of the ponds should be checked after the existing water dissipates from the ponds. The ponds should continue to be monitored after storm events to ensure that excess sediment does not reduce the required storage capacity available for storm water runoff.

Pic. 1 –Water accumulation in east pond.

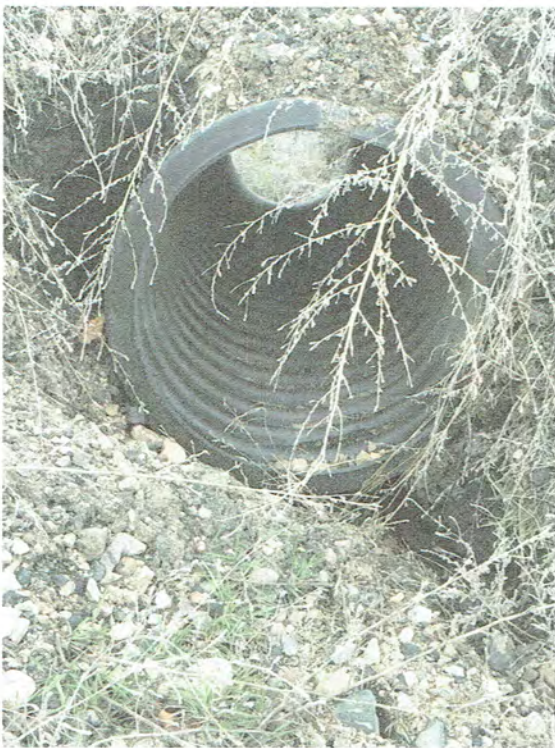
The drainage ditches and pipes were generally in good condition though the inlet pipe into the east pond is experiencing some erosion around the edge of the pipe that should be repaired (see Pics 2). All pipes, ditches and sediment traps should be inspected and repaired as necessary, especially after storm events.

Pic. 2 – Pipe inlet to east pond.

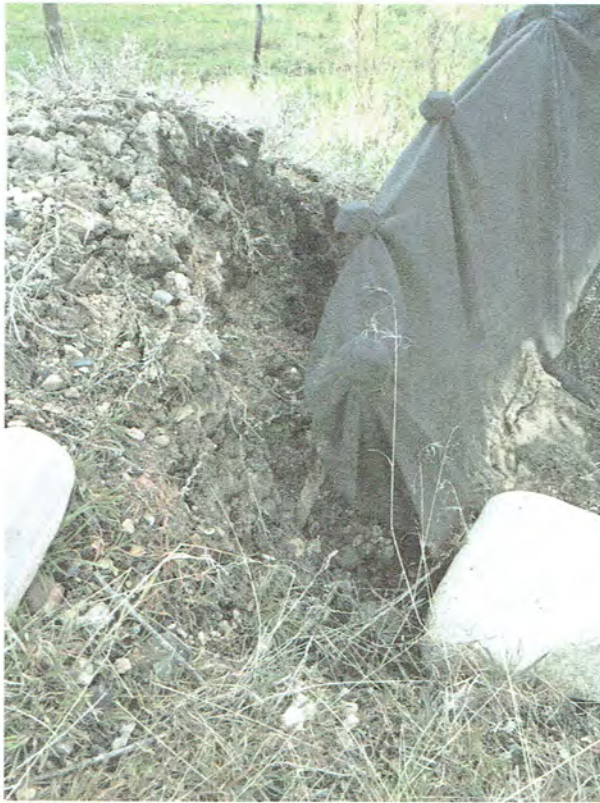
The north sediment trap located along the west side of the driveway at the entrance to the site has experienced some erosion and water can now bypass the sediment trap along the southern edge (see Pic 3). This sediment trap should be repaired as soon as possible.

Pic. 3 – North sediment trap, west side of drive.
