Re: King I Mine, C-1981-035
Stoner Engineering: Quarterly Inspection: Refuse Pile
1st Quarter 2017

Date: March 28, 2017

Re: King Coal I – Quarterly Waste Pile/Embankment Inspection

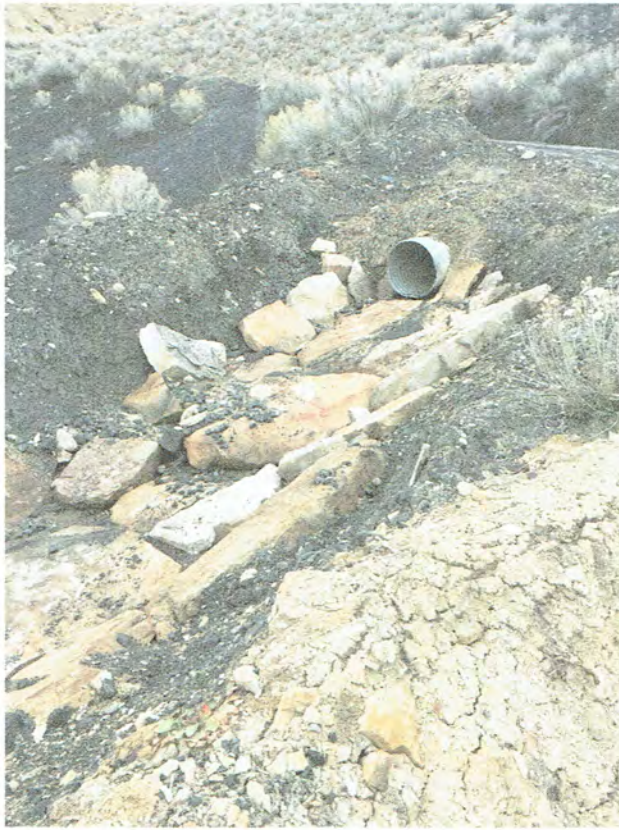
The condition of the perimeter ditches located along the north and south sides of the property were generally in good condition (see Pic. 1). The drainage channels were generally clear of debris and there was no damage observed to any of the channel sections.

Pic. 1 – South channel erosion control improvements.

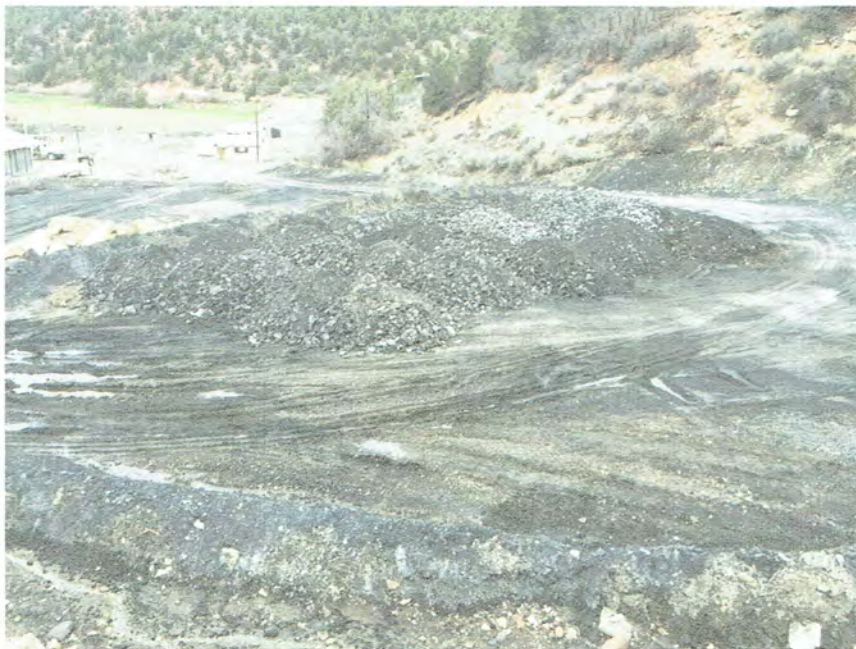
There was material stockpiled at the base of the embankment most likely due to the recent weather (see Pic. 2). The face of the embankment was in good condition and does not show any signs of excessive erosion, instability or weakness.

Pic. 2 –Material stockpiled material at base of embankment.
