**MINERALS PROGRAM INSPECTION REPORT**  
**PHONE: (303) 866-3567**

<b>MINE NAME:</b> Walker Pit	<b>MINE/PROSPECTING ID#:</b> M-1987-044	<b>MINERAL:</b> Sand and gravel	<b>COUNTY:</b> La Plata
<b>INSPECTION TYPE:</b> Monitoring	<b>INSPECTOR(S):</b> Lucas J. West	<b>INSP. DATE:</b> April 5, 2017	<b>INSP. TIME:</b> 10:24
<b>OPERATOR:</b> Elam Construction, Inc. dba Sandco, Inc.	<b>OPERATOR REPRESENTATIVE:</b> Jodie O'rand	<b>TYPE OF OPERATION:</b> 110c - Construction Limited Impact	
<b>REASON FOR INSPECTION:</b> Normal I&E Program	<b>BOND CALCULATION TYPE:</b> Complete Bond	<b>BOND AMOUNT:</b> \$5,848.68	
<b>DATE OF COMPLAINT:</b> NA	<b>POST INSP. CONTACTS:</b> None	<b>JOINT INSP. AGENCY:</b> None	
<b>WEATHER:</b> Clear	<b>INSPECTOR'S SIGNATURE:</b>

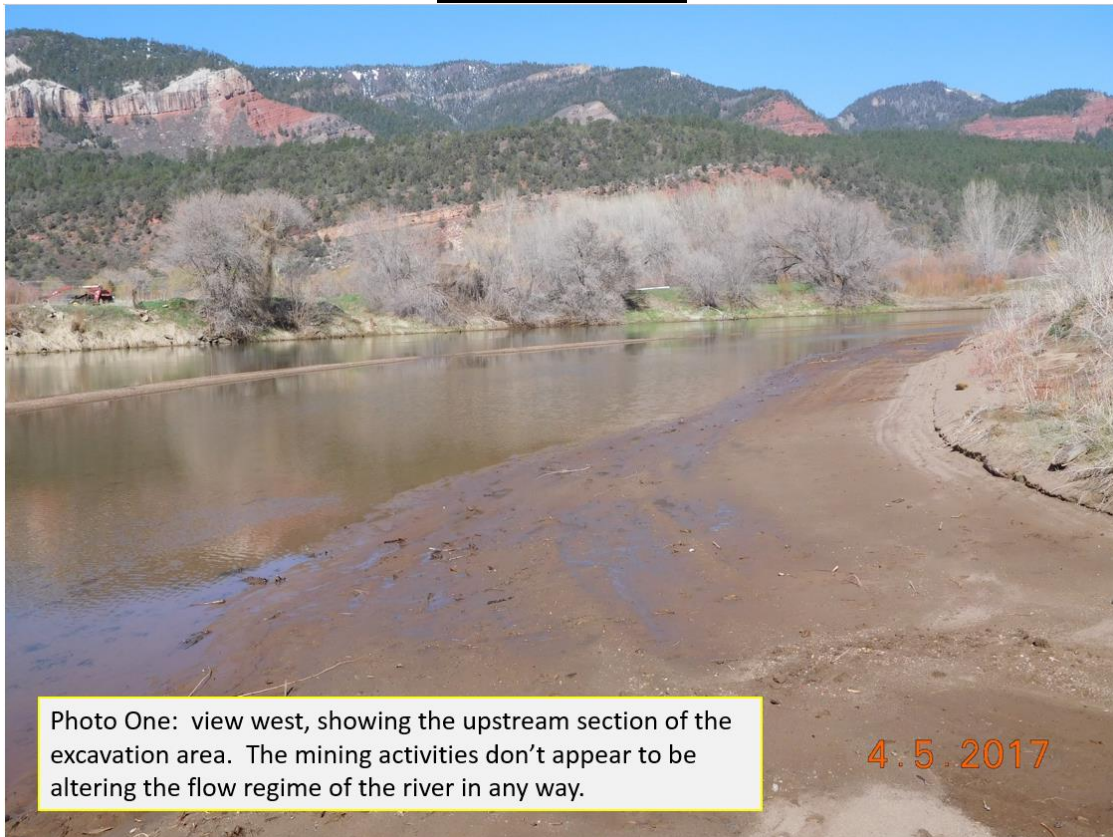
The proper Mine Identification Signage was posted at the entrance to the site, and the permit boundaries were clearly marked. The mining activities consist of removing sand from the point bar in the river during low water, and excavation is only performed once a year. Photo One shows the upstream area of the point bar that has been excavated, and Photos Two and Three show the center and downstream areas of the excavation area. Once the material is removed the area is recharged with sand materials from spring runoff to allow for continued mining. The excavation is performed in a way that does not alter the flow or channel of the river. No signs of significant bank erosion, or re-channelization caused by the mining activities were observed.

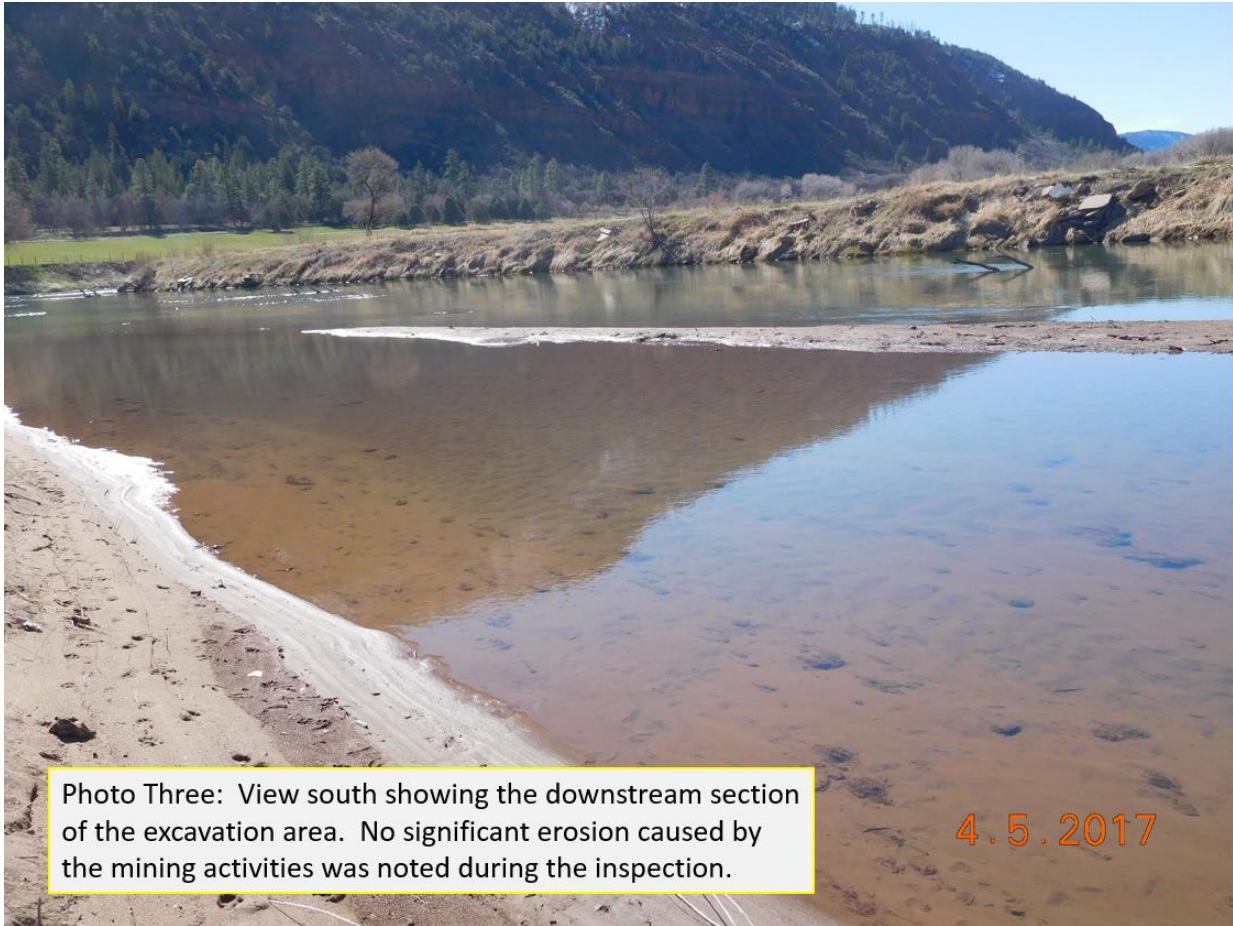
Photo Three: View south showing the downstream section of the excavation area. No significant erosion caused by the mining activities was noted during the inspection.
