MINERALS PROGRAM INSPECTION REPORT
PHONE: (303) 866-3567

| MINE NAME: Willow Bend | MINE/PROSPECTING ID#: M-1986-165 | MINERAL: Sand and gravel | COUNTY: La Plata |
| INSPECTION TYPE: Monitoring | INSPECTOR(S): Lucas J. West | INSP. DATE: April 5, 2017 | INSP. TIME: 11:15 |

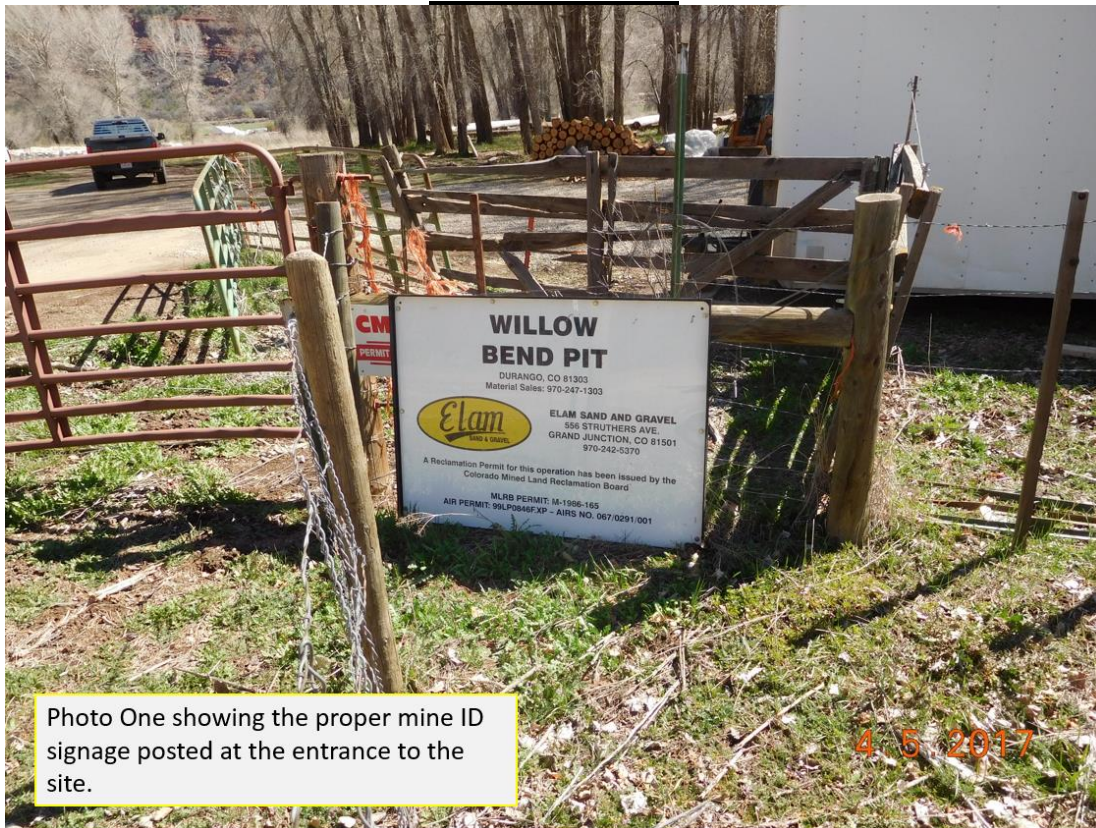
Photo One shows the proper Mine Identification Signage was posted at the entrance to the site, and the permit boundaries were clearly marked. The mining activities consist of removing sand from the point bar in the river during low water, and excavation is only performed once a year. Photo Two shows the upstream area of the point bar that has been excavated, and Photos Three and Four show the center and downstream areas of the excavation area. Once the material is removed the area is recharged with sand materials from spring runoff to allow for continued mining. The excavation is performed in a way that does not alter the flow or channel of the river. No signs of significant bank erosion, or re-channelization caused by the mining activities were observed.

Photo One showing the proper mine ID signage posted at the entrance to the site.

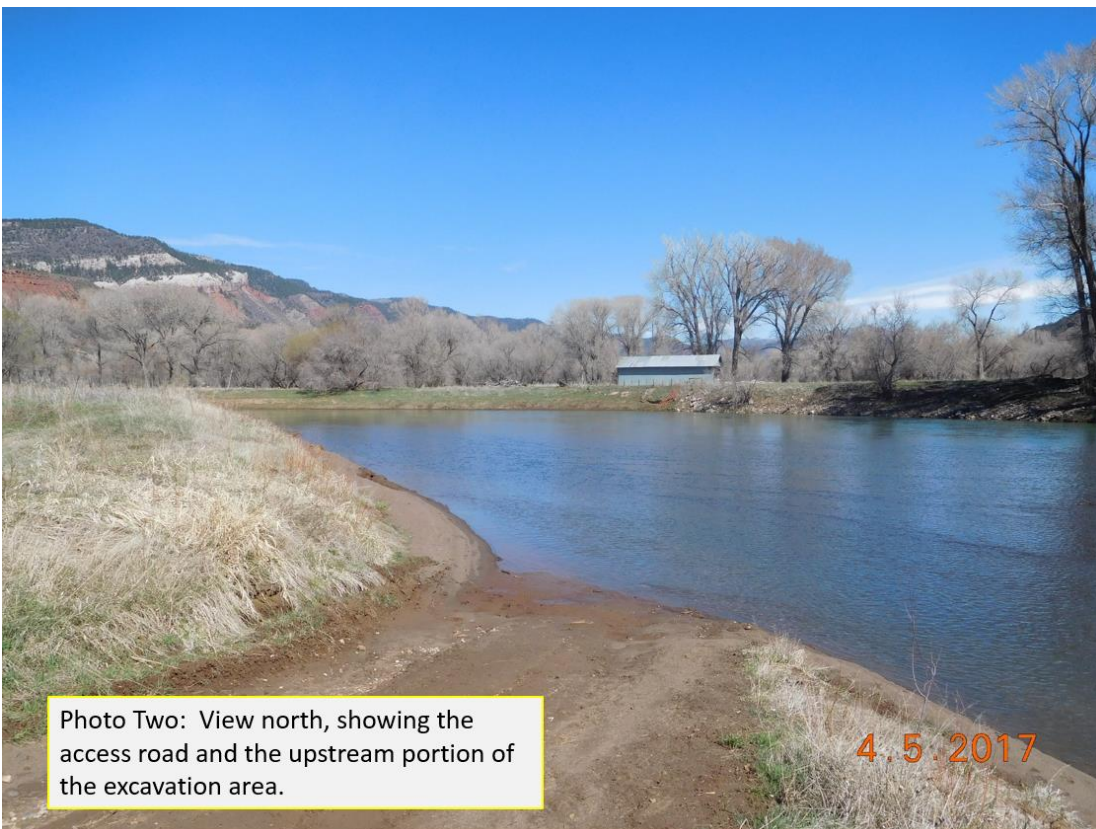
Photo Two: View north, showing the access road and the upstream portion of the excavation area.

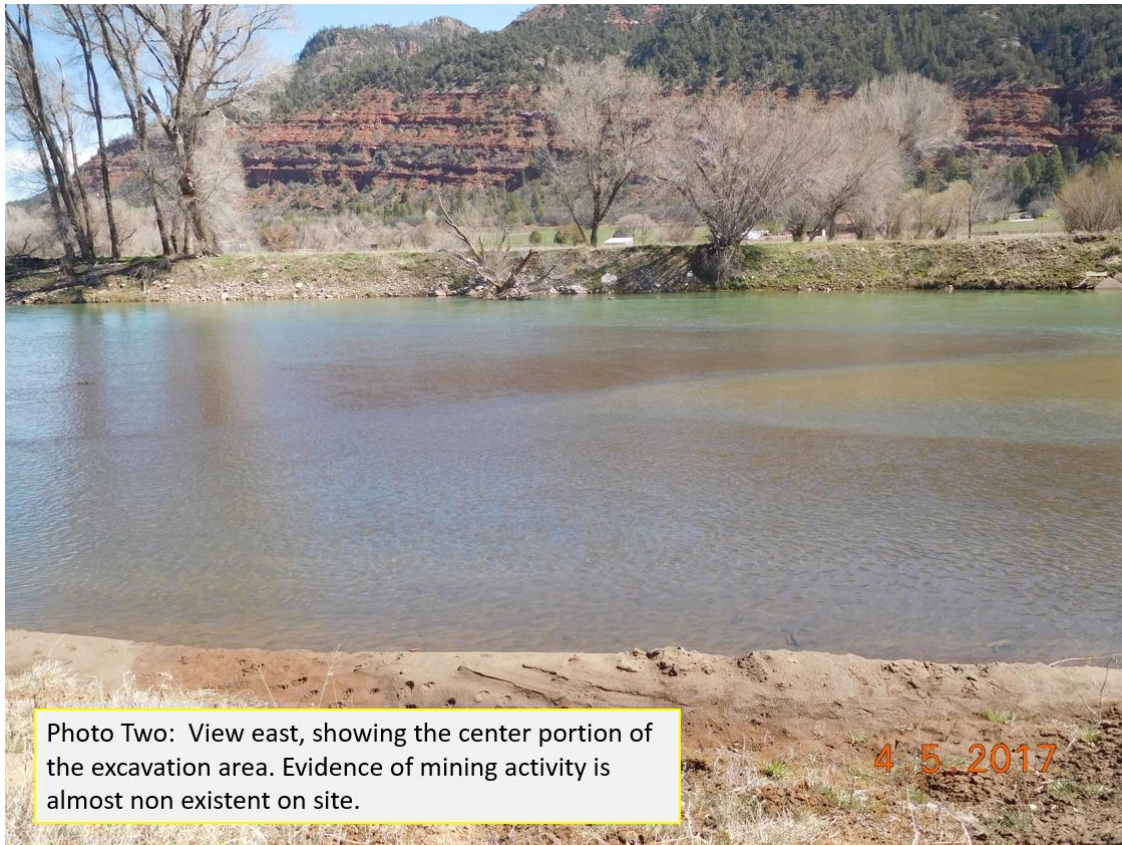
Photo Two: View east, showing the center portion of the excavation area. Evidence of mining activity is almost non-existent on site.

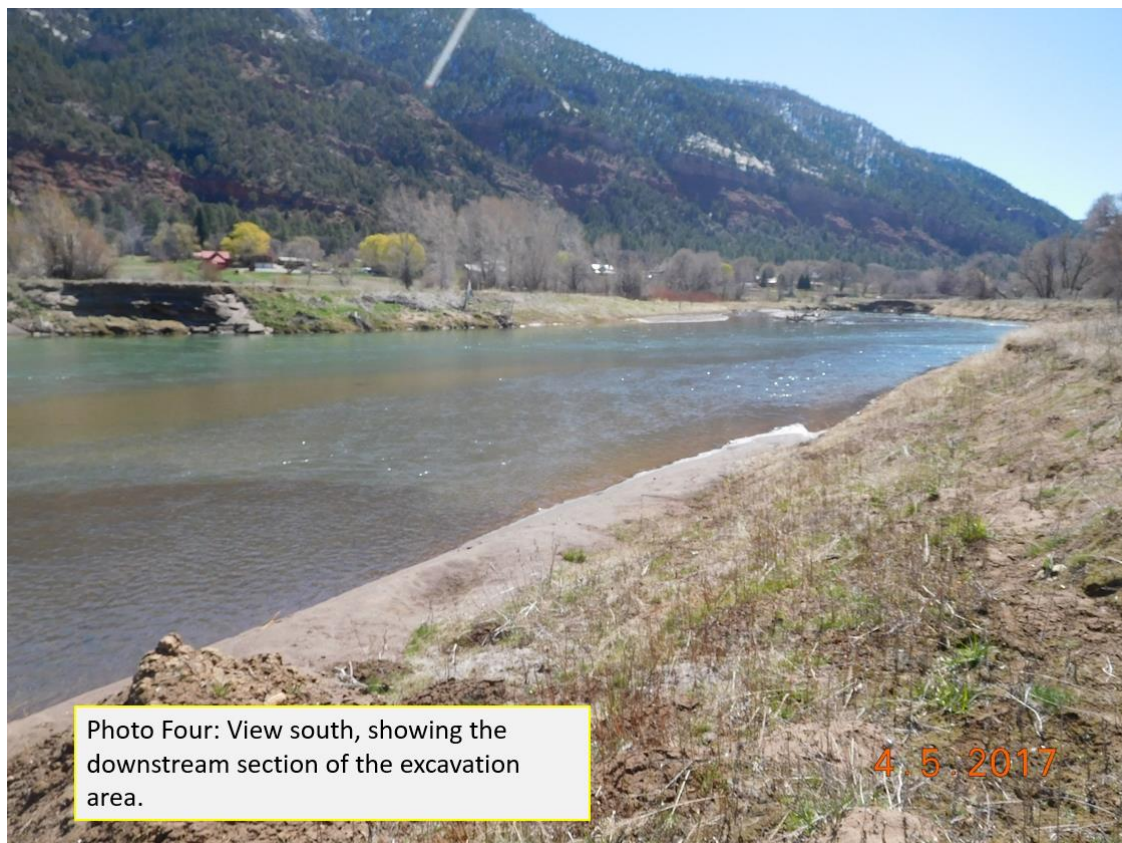
Photo Four: View south, showing the downstream section of the excavation area.
