PERMIT INFORMATION

Permit Number: C-1981-035 Mine Name: King Coal Mine Operator: GCC Energy, LLC Operator Address: Mr. Tom Bird 6473 County Road 120 Hesperus, CO 81326	County: La Plata Operation Type: Underground Permit Status: Active Ownership: Federal
	Operator Representative Present: None
Operator Representative Signature: (Field Issuance Only)

Inspection Start Date: April 11, 2017 Inspection Start Time: 10:00 Inspection End Date: Inspection End Time:	Inspection Type: Aerial Inspection Inspection Reason: Normal I&E Program Weather: Clear		
Joint Inspection Agency: None	Joint Inspection Contacts: 		
Post Inspection Agency: None	Post Inspection Contacts: 		
Inspector(s): Harry B. Ranney	<table border="0"><tr><td>Inspector's Signature:  </td><td>Signature Date: 4/12/2017</td></tr></table>	Inspector's Signature:  	Signature Date: 4/12/2017
Inspector's Signature:  	Signature Date: 4/12/2017

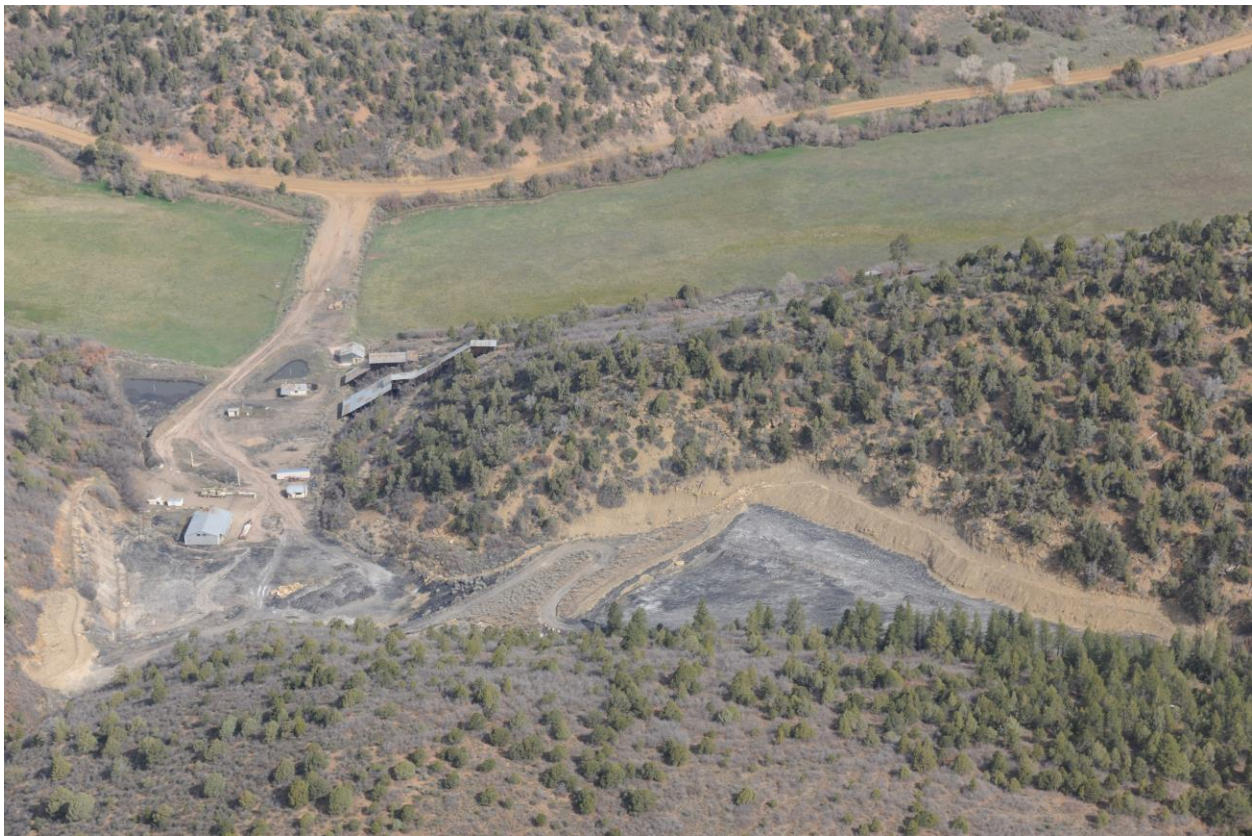
King I Mine and portion of Hay Gulch valley

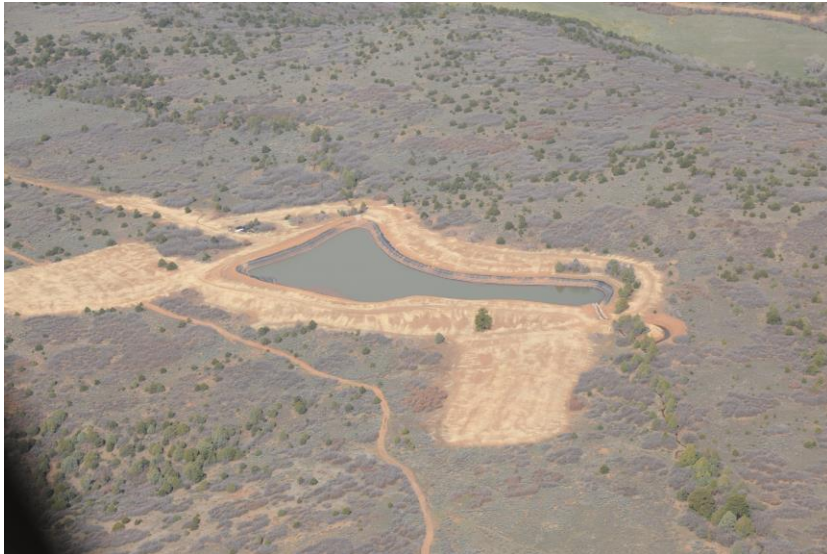
A relatively new reservoir was seen about one half mile south of the King I facilities area, on the Huntington Irrigation Ditch. This structure should be monitored for subsidence impacts. (It should also be discussed in the PAP, both in the description of surface water (Rule 2.04.7) and in the subsidence section (2.05.6); this should be added to the King I PAP as part of upcoming renewal adequacy responses.)

Pond on affected area –part of Huntington irrigation system

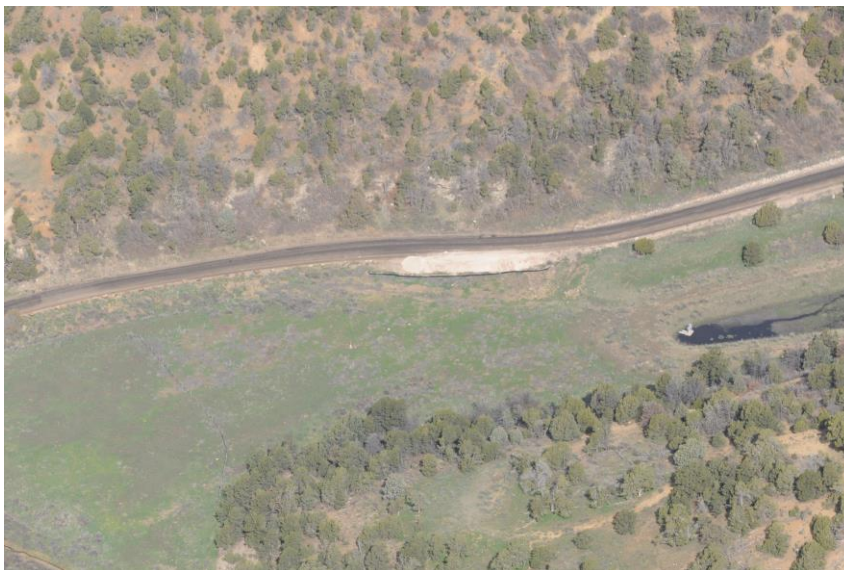
At King II, along the haul road and near the sediment pond, the line of silt fence appears to be effective in preventing material from being washed by runoff into the vegetation below (see photograph).

Portion of King II haul road, with silt fence and pond embankment

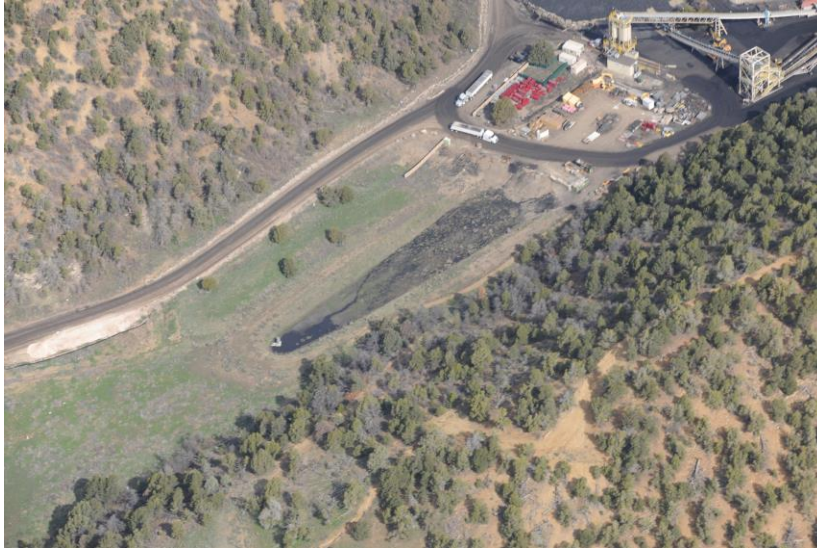
King II lower facilities

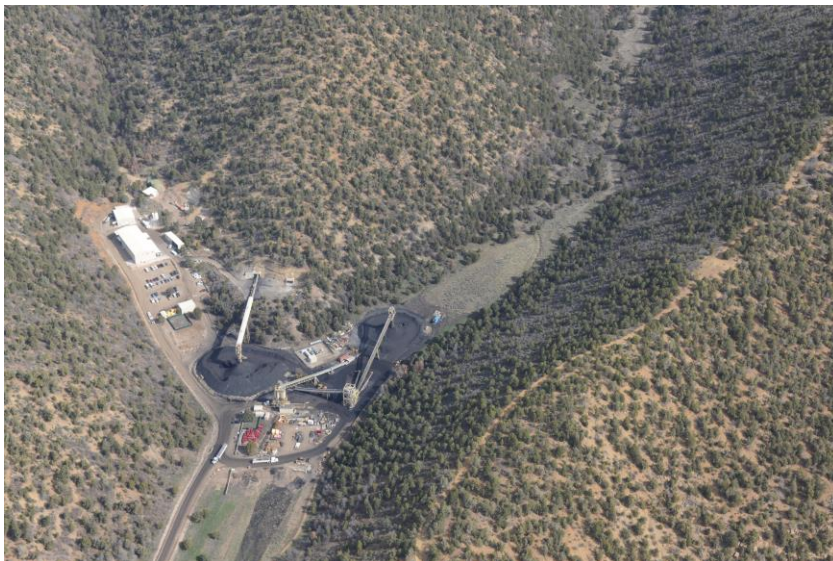
King II upper facilities and portion of affected area
