**COLORADO**Division of Reclamation,  
Mining and Safety

**MINERALS PROGRAM INSPECTION REPORT****PHONE: (303) 866-3567**

| <b>MINE NAME:</b><br>AGRI-DLD Gravel Pit | <b>MINE/PROSPECTING ID#:</b><br>M-2000-030 | <b>MINERAL:</b><br>Sand and gravel | <b>COUNTY:</b><br>La Plata |
| <b>INSPECTION TYPE:</b><br>Monitoring | <b>INSPECTOR(S):</b><br>Lucas J. West | <b>INSP. DATE:</b><br>April 5, 2017 | <b>INSP. TIME:</b><br>12:05 |

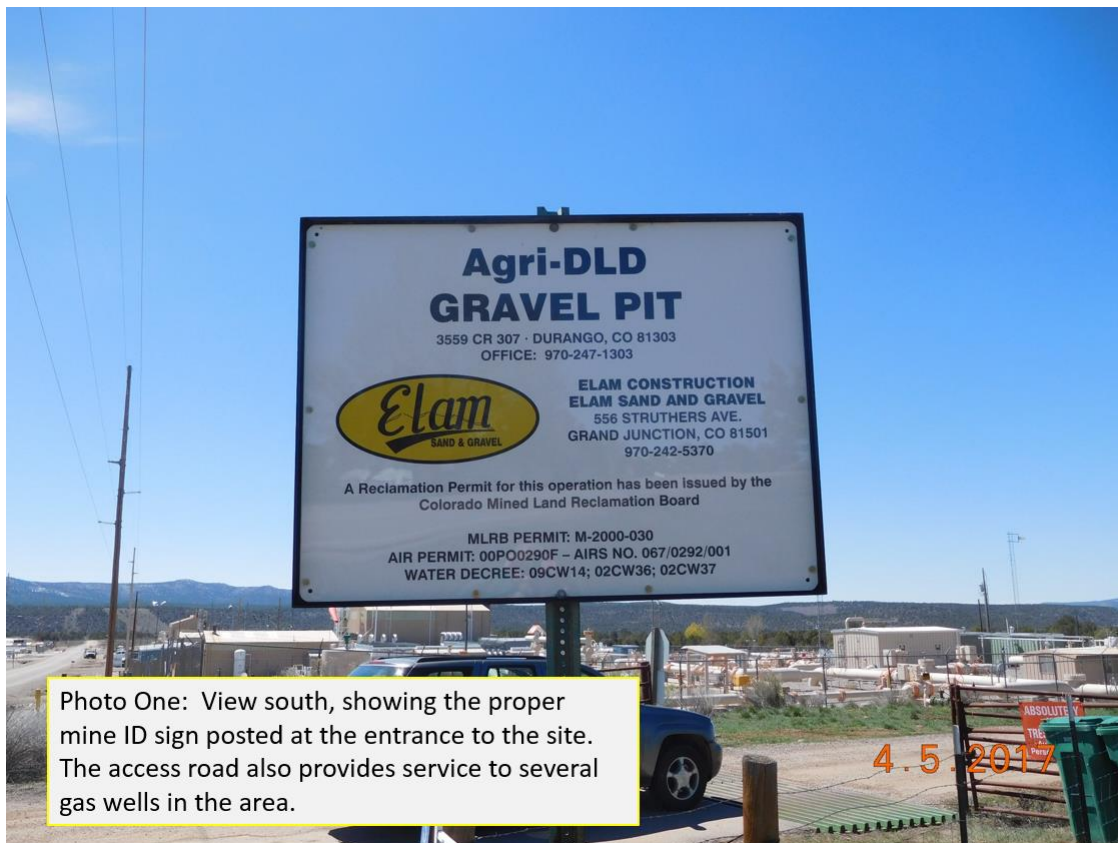
The proper mine identification signage was posted at the entrance to the site which can be seen in Photo One. The site was not active during the inspection and no equipment was observed on site. The mining activities have currently disturbed approximately 26 acres, and is approved for a maximum disturbance of 40 acres. The total permit area consists of 156.27 acres. The current mining activity is focused in the phase three area and a large portion of that has been stripped and is to be mined in the upcoming months. The area that has been stripped as well as the active mining area can be seen in Photo Two. Several stockpiles of material were noted on the pit floor. Examples of the stockpiles can be seen in Photo Three. All of the stockpiles appear to be stable and are in good condition. The stockpiles include various sized materials, overburden and topsoil. The pit floor exhibits positive drainage and no significant impounded storm water was noted on the pit floor. The active area is surrounded by a visual impact berm. The berm is in good condition and no signs of significant erosion were observed. A small pile of trash and rubble was observed on the pit floor, and discussions with the operator indicate that the material is consolidated and removed periodically.

Photo One: View south, showing the proper mine ID sign posted at the entrance to the site. The access road also provides service to several gas wells in the area.

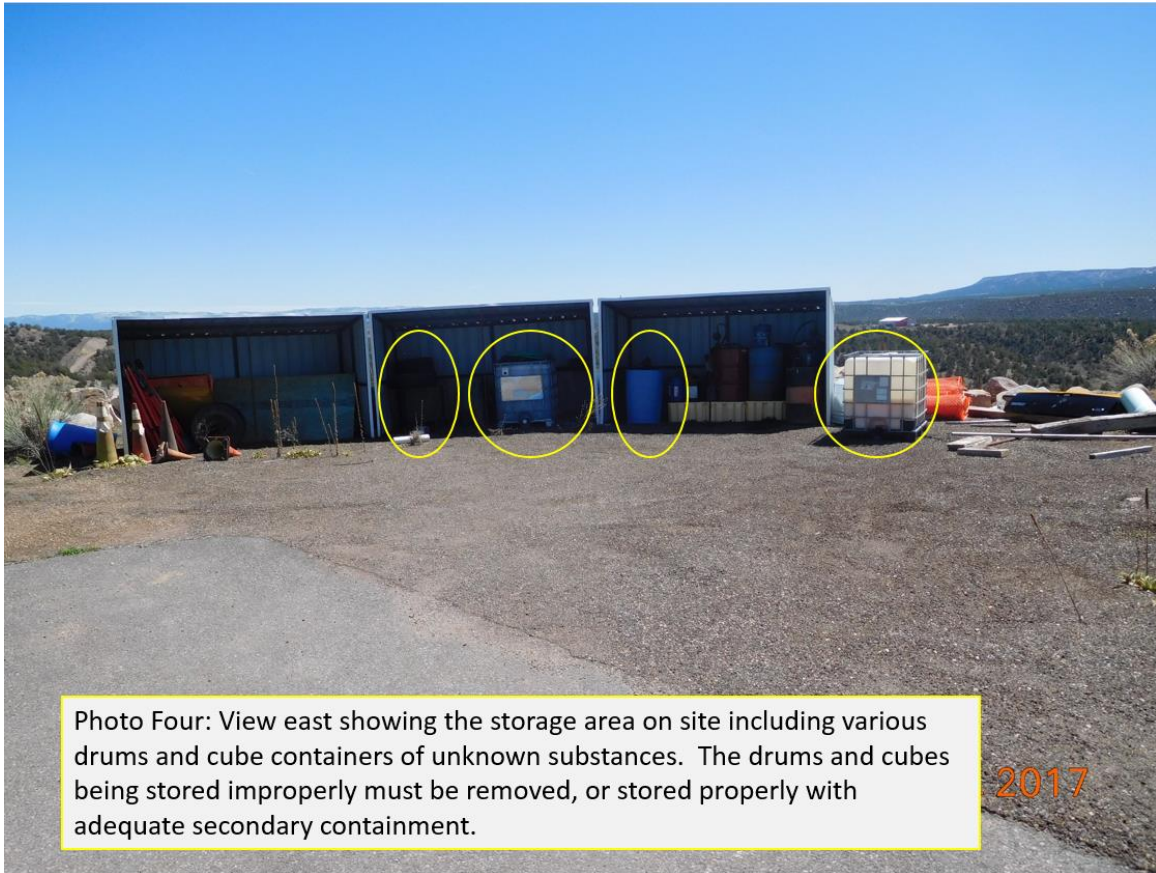
**PROBLEM/POSSIBLE VIOLATION:** Problem: Improper storage and containment of fuels and/or other hazardous materials was present on site. Various containers including 55 gallon drums and cube containers of unknown materials were observed. Also observed was a large trailer that appeared to once contain oil that had no secondary containment and was evidence of spilling was noted at the rear of the trailer.

There was however, two cube containers, and various other drums of unknown substances stored without any secondary containment shown in Photo Four. All storage tanks, petroleum and any hazardous materials on site for any period of time shall have appropriate secondary containment or shall be removed from the site. Please supply photo documentation that any fuel or hazardous materials containers are stored properly or that they have been removed from the site completely. Documentation of compliance must be received within **60 days** of date of this report.

Photo Four: View east showing the storage area on site including various drums and cube containers of unknown substances. The drums and cubes being stored improperly must be removed, or stored properly with adequate secondary containment.

**CORRECTIVE ACTIONS:** All storage tanks, petroleum and any hazardous materials on site for any period of time shall have appropriate secondary containment or shall be removed from the site. Please supply photo documentation that any fuel or hazardous materials containers are stored properly - including applicable secondary containment structures and that the trailer has been removed from the site and disposed of properly within **60 days** of the date of this letter. Note that secondary containment structures shall consist of an impermeable containment which could contain all contents of the tanks and various containers (when full) plus 10% of the total capacity.

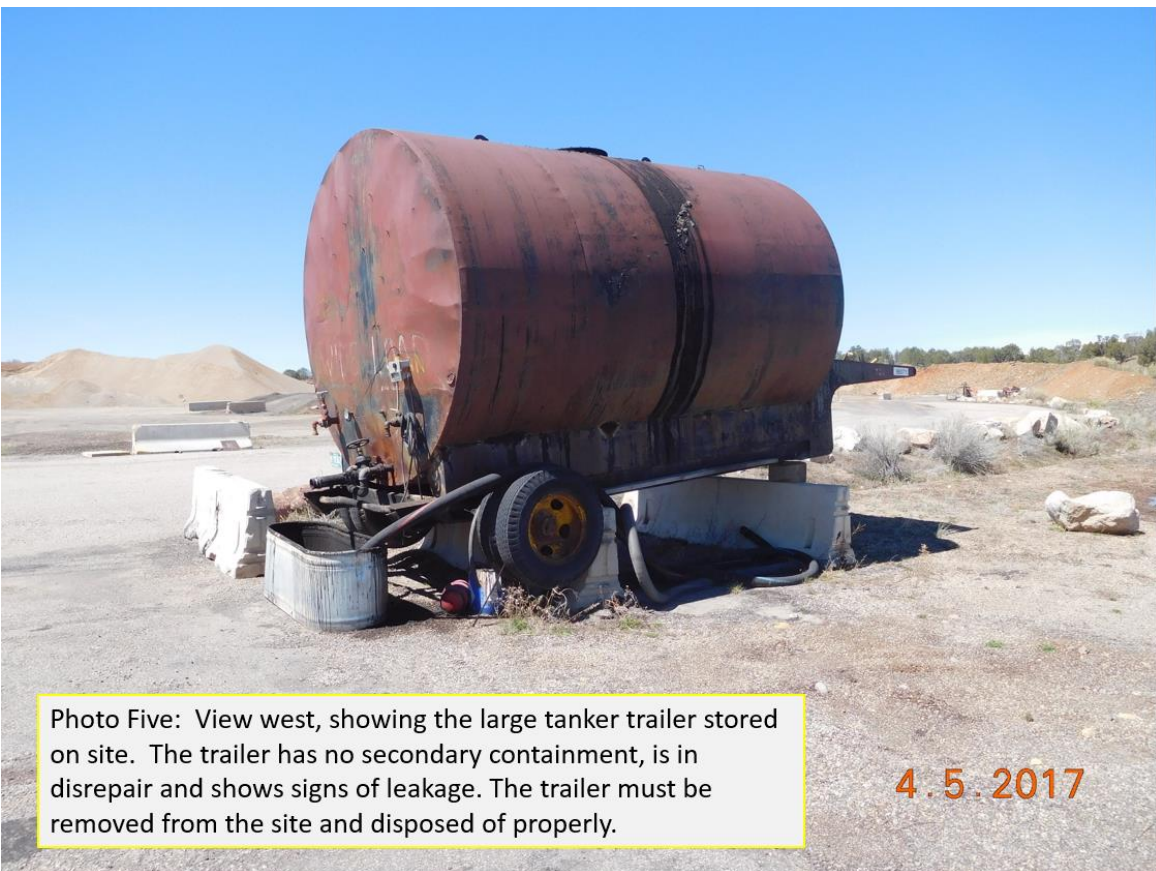
Similarly, adjacent to the storage area an old tanker trailer propped on jersey barriers was observed shown in Photo Five with no secondary containment. The trailer appears to once have contained oil or tar, but discussions with the operator indicate that it has not been used in recent years. The trailer is in disrepair and shows signs of leakage, including stained soil around the rear of the trailer shown in Photo Six. The Operator shall properly remove and dispose of the trailer, as well as remediate and dispose of the contaminated soil within **60 days** of the date of this report.

Photo Five: View west, showing the large tanker trailer stored on site. The trailer has no secondary containment, is in disrepair and shows signs of leakage. The trailer must be removed from the site and disposed of properly.

reclamation cost estimate update, however if compliance is not reached by the above listed date, a secondary estimate will be performed to include these tasks. Including these tasks may cause an adjustment to the required amount of financial warranty. All documentation of compliance including applicable secondary containment structures and that the trailer has been removed from the site and disposed of properly must be received by the Division's Denver Office no later than **Monday June 12, 2017**.

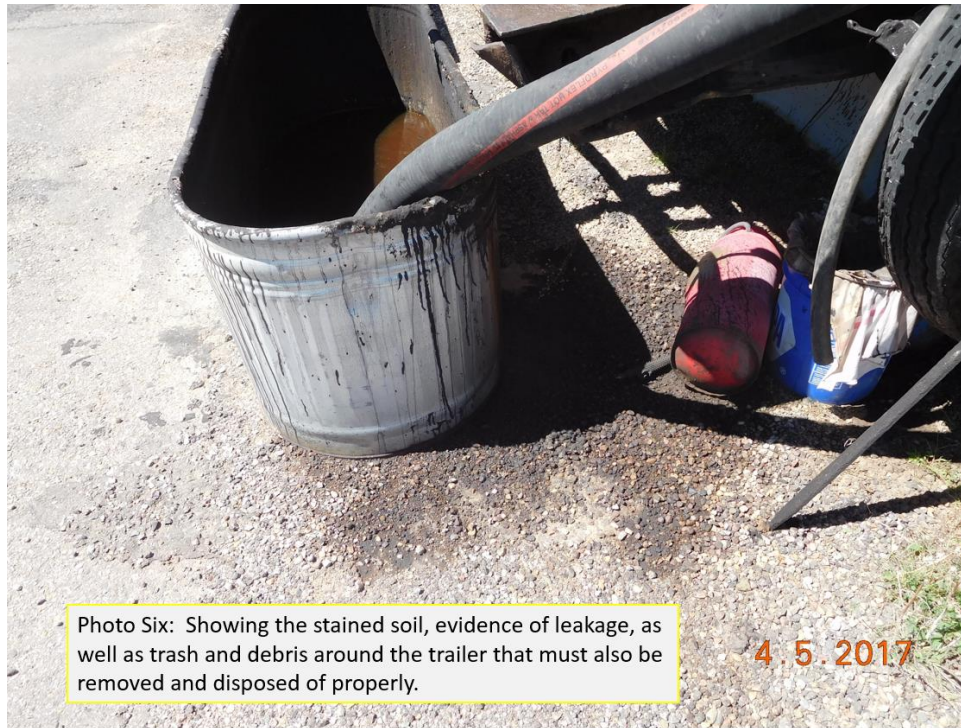
Photo Six: Showing the stained soil, evidence of leakage, as well as trash and debris around the trailer that must also be removed and disposed of properly.
