COLORADO
Division of Reclamation,
Mining and Safety
Department of Natural Resources

PERMIT INFORMATION

Permit Number: C-1981-008 Mine Name: New Horizon Mine Operator: Elk Ridge Mining and Reclamation, LLC Operator Address: Mr. Tony Tennyson 5731 State Highway 13 Meeker, CO 81641	County: Montrose Operation Type: Surface Permit Status: Active Ownership: Private
	Operator Representative Present: None
Operator Representative Signature: (Field Issuance Only)

Inspection Start Date: April 11, 2017 Inspection Start Time: 10:32 Inspection End Date: April 11, 2017 Inspection End Time: 10:33		Inspection Type: Aerial Inspection Inspection Reason: Normal I&E Program Weather: Clear	
Joint Inspection Agency: None		Joint Inspection Contacts: 	
Post Inspection Agency: None		Post Inspection Contacts: 	
Inspector(s): Brock F. Bowles Harry B. Ranney		Inspector's Signature:

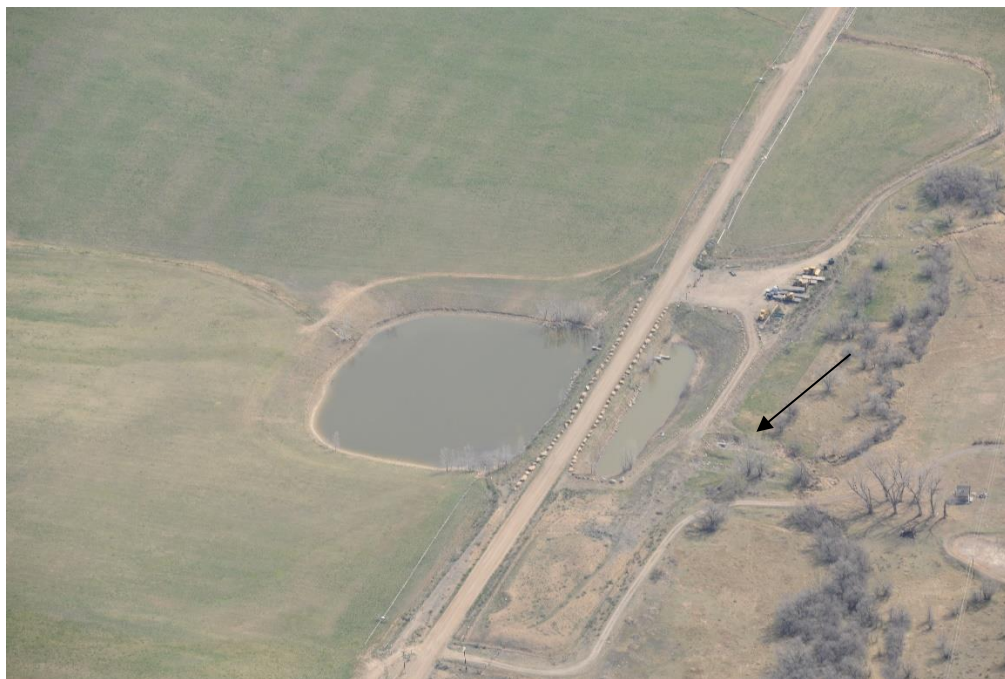
Pond 7 contained water. The pooling area at the discharge pipe did not contain water which means pond 7 was not discharging (photo 1).

Photo 1 – Pond 7 Does Not Appear to be Discharging

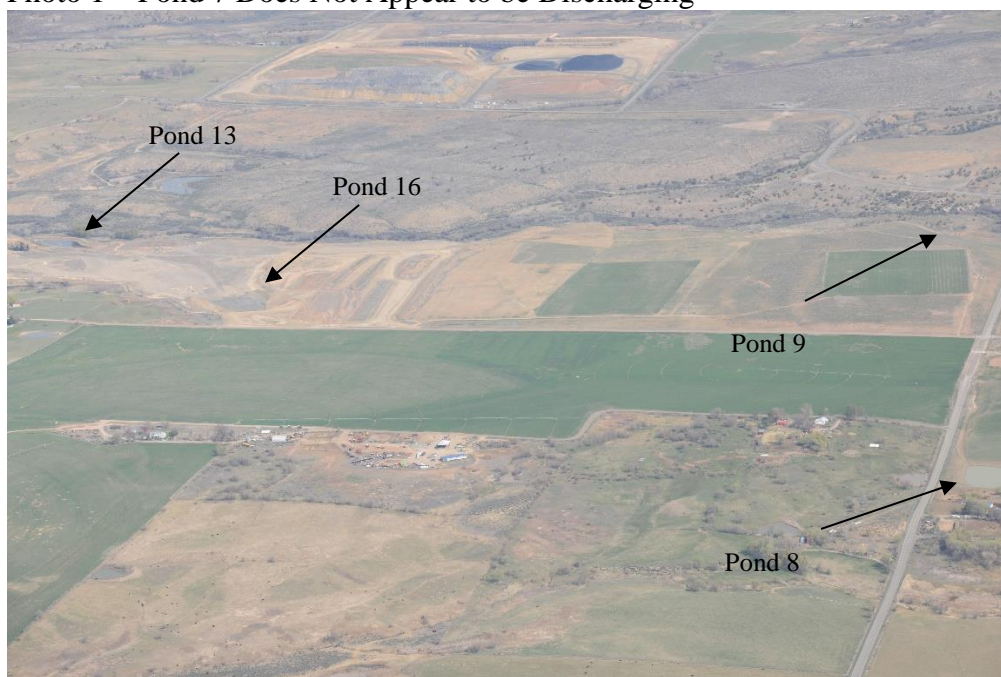
Photo 2 – Ponds on West Side of NH2

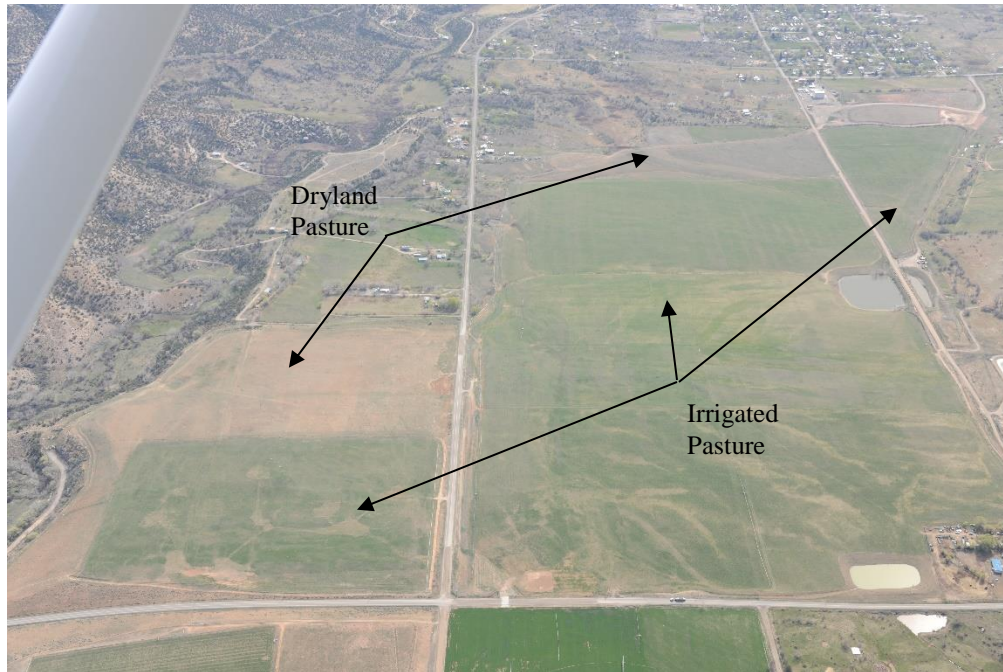
The reclaimed irrigated pasture areas are becoming greener compared to the dryland pasture areas (photo 3). Although, it does not appear that the irrigation siderolls have been in operation. They are in the same position as they were during the last inspection.

Photo 3 – Irrigated And Dryland Pasture Areas
