**COLORADO**  
Division of Reclamation,  
Mining and Safety  
Department of Natural Resources

**PERMIT INFORMATION**

| <b>Permit Number:</b> C-2010-089<br><b>Mine Name:</b> New Horizon North Mine<br><b>Operator:</b> Elk Ridge Mining and Reclamation, LLC<br><b>Operator Address:</b><br>Mr. Tony Tennyson<br>5731 State Highway 13<br>Meeker, CO 81641 | <b>County:</b> Montrose<br><b>Operation Type:</b> Surface<br><b>Permit Status:</b> Active<br><b>Ownership:</b> Private |

| <b>Inspection Start Date:</b> April 11, 2017<br><b>Inspection Start Time:</b> 10:34<br><b>Inspection End Date:</b> April 11, 2017<br><b>Inspection End Time:</b> 10:34 | <b>Inspection Type:</b> Aerial Inspection<br><b>Inspection Reason:</b> Normal I&E Program<br><b>Weather:</b> Clear |

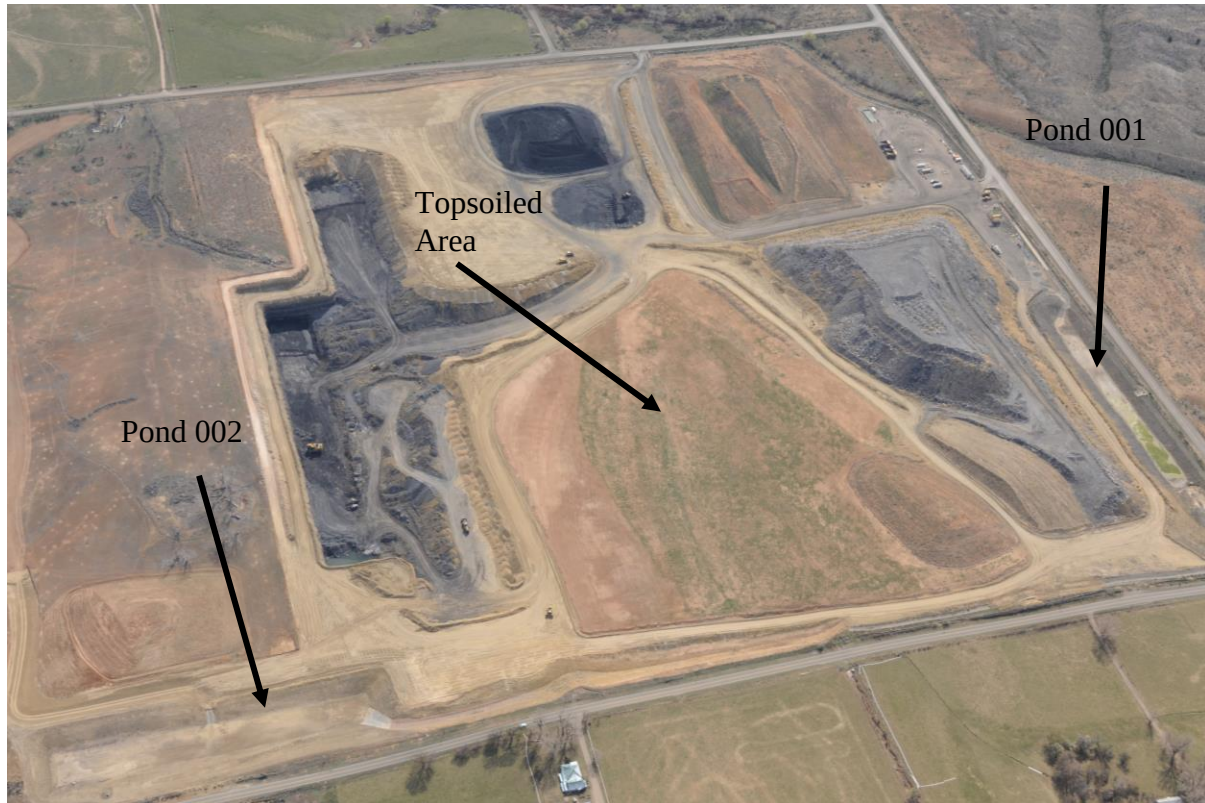
Pond 001 does not appear to contain water. An area on the west end of pond 001 was greener than the surrounding area (photo 1). ERM was contacted and asked about it. ERM submitted a photo showing that a moss had grown on the pond bottom (photo 2). Since pond 001 is currently dry, pit water is not being pumped to it and it has a capacity to contain the water runoff from an area larger than the currently disturbed area, the Division does not have concerns with the moss at this time. ERM said they would monitor the moss. The rock lined portions of the Pond 001 west ditch look to be in good condition.

Pond 002 did not contain water (photo 1).

Photo 1 – Ponds 001 and 002 and Topsoiled Area

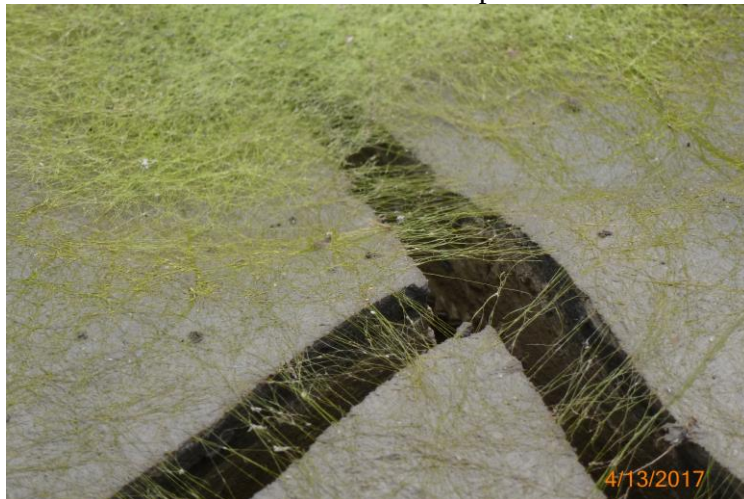
Photo 2 – ERMR Picture of Moss in Pond 001
