MINERALS PROGRAM INSPECTION REPORT
PHONE: (303) 866-3567

MINE NAME: Fountain Pit	MINE/PROSPECTING ID#: M-1981-307	MINERAL: Sand and gravel	COUNTY: El Paso
INSPECTION TYPE: Monitoring	INSPECTOR(S): Timothy A. Cazier	INSP. DATE: May 26, 2016	INSP. TIME: 09:10
OPERATOR: Martin Marietta Materials, Inc.	OPERATOR REPRESENTATIVE: Julie Mikulas, Rusty Cochran	TYPE OF OPERATION: 112c - Construction Regular Operation	
REASON FOR INSPECTION: Normal I&E Program	BOND CALCULATION TYPE: Partial Bond	BOND AMOUNT: \$1,369,462.00	
DATE OF COMPLAINT: NA	POST INSP. CONTACTS: None	JOINT INSP. AGENCY: None	
WEATHER: Cloudy	INSPECTOR'S SIGNATURE:

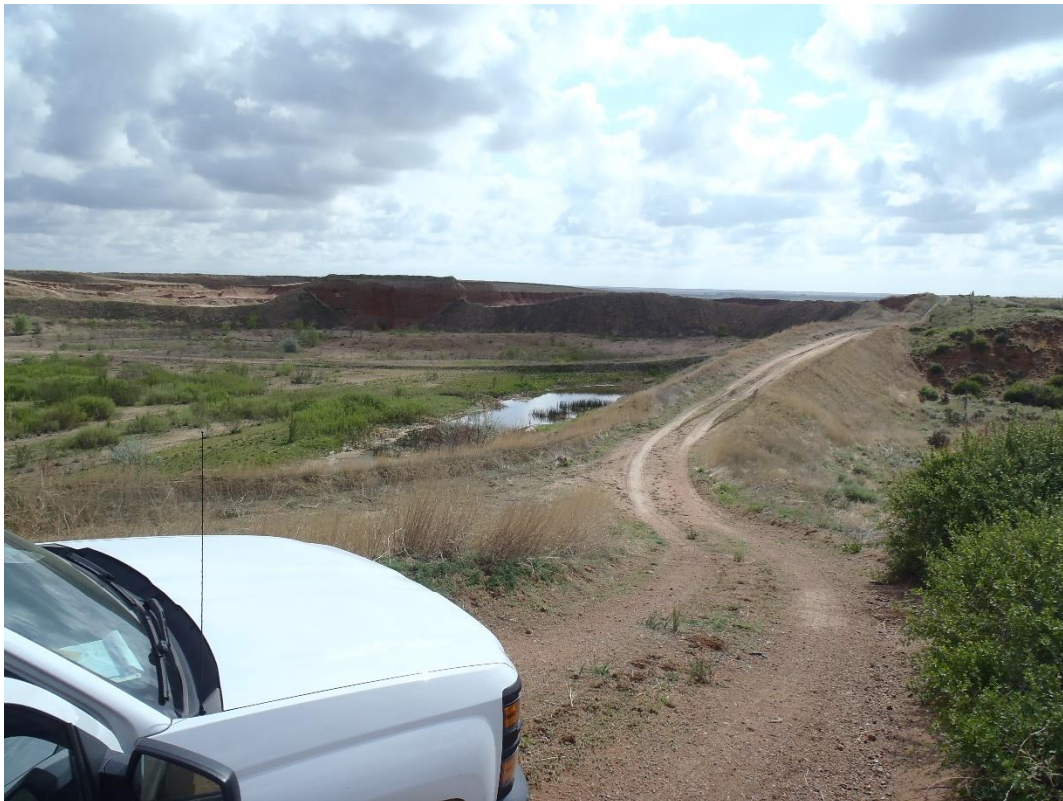
Hydrologic Balance: A small amount of standing water was observed in the south end of the older east pit where the previous wash or "mud" pond was (see **Photo 1**). This is being filled in and did not appear to be groundwater as the natural ground south of the embankment was dry and appeared to be lower in elevation. Other observed exposed water consisted of the fresh water storage pond and the existing mud pond in the southwest corner of the permit area.

Photo 1. Small amount of water observed in south end of the older east pit wash pond (looking east).

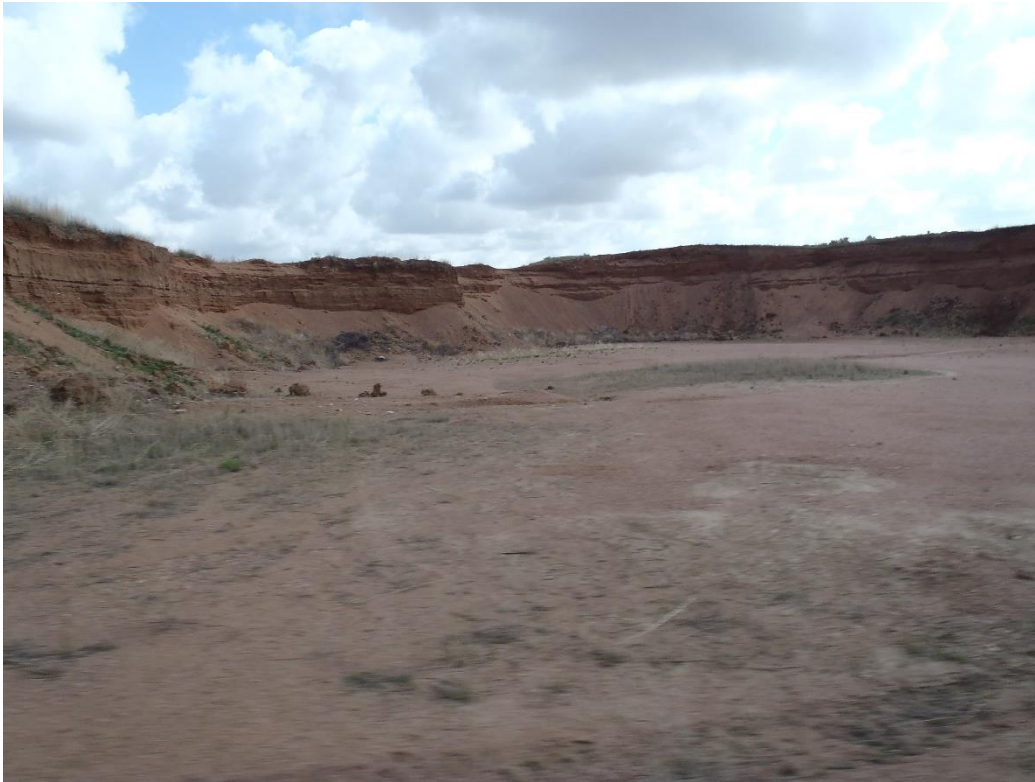
Gen. Compliance with Mine Plan: Site representatives indicated they are in the final phase of mining. Some more excavation was planned in the east portion of the site, but they were nearing final excavations at the time of the inspection. The anticipated final excavations were expected in the July/August time frame of 2016. Highwalls appeared to vary between 15 and 30 feet in height (see **Photo 2**).

Photo 2. Typical active highwalls.

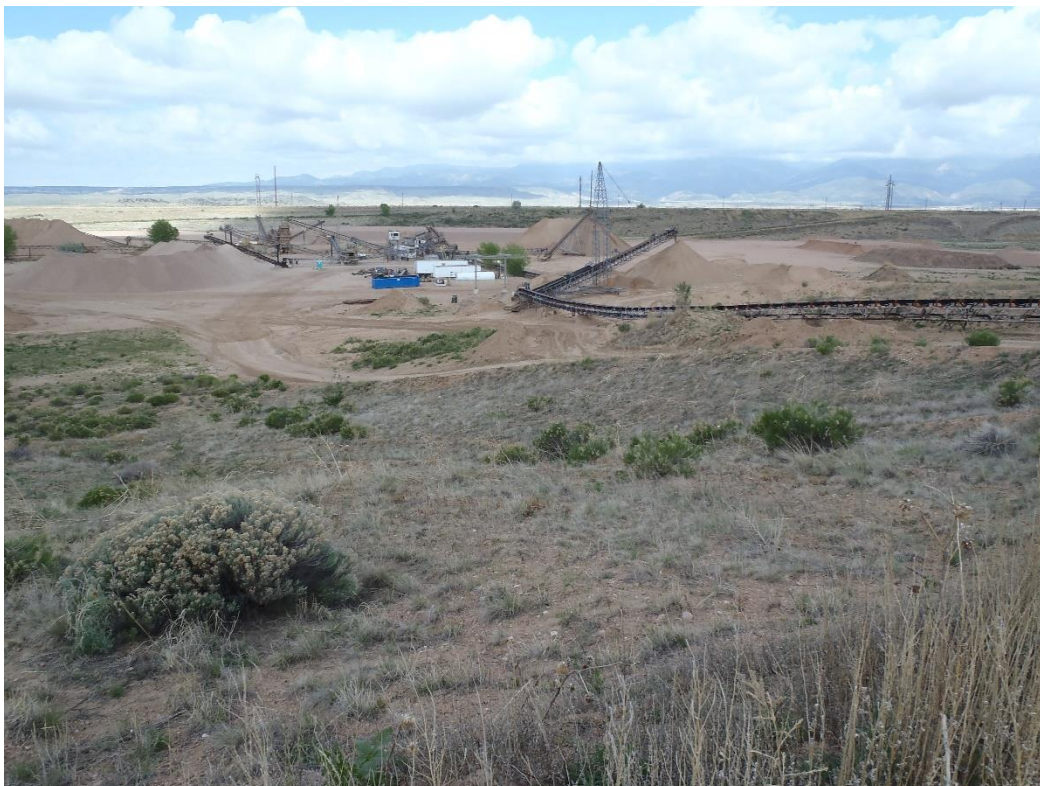
Support Facilities On-site: Conveyors and screen plants observed on site (see **Photo 3**).

Photo 3. Conveyors and screen plants (SW side, looking SE).

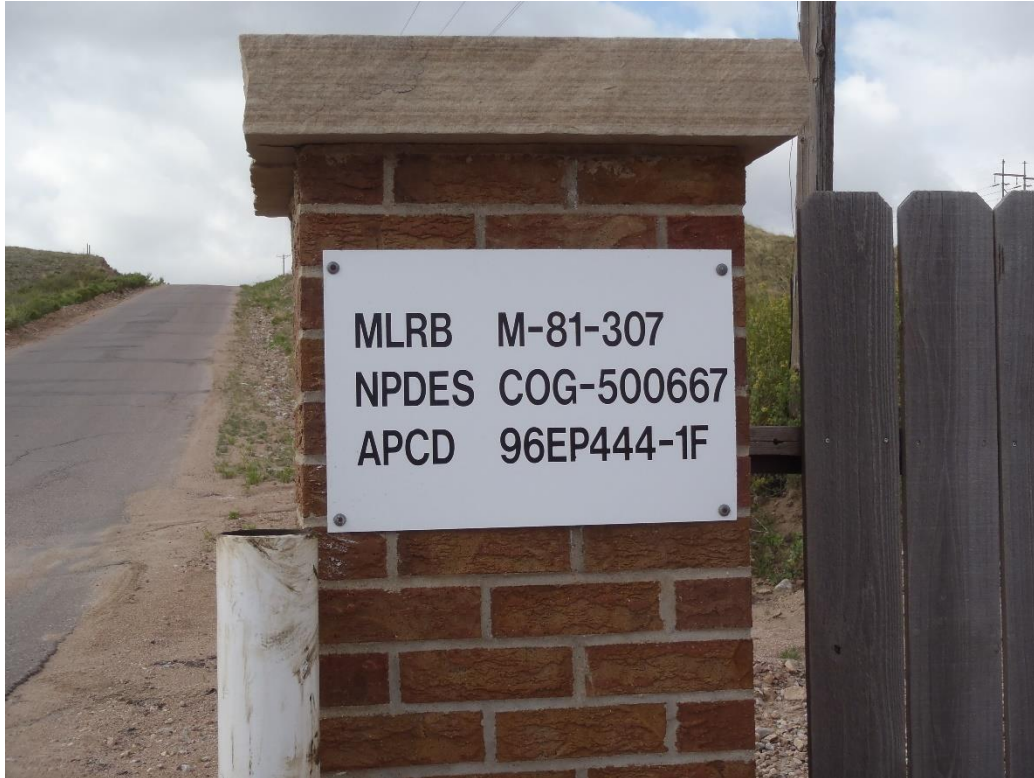
Signs and Markers: The permit sign was properly posted (see **Photo 4**) and fences serving as boundary markers were observed to delineate the permit boundary (see **Photo 5**).

Photo 4. Permit sign.

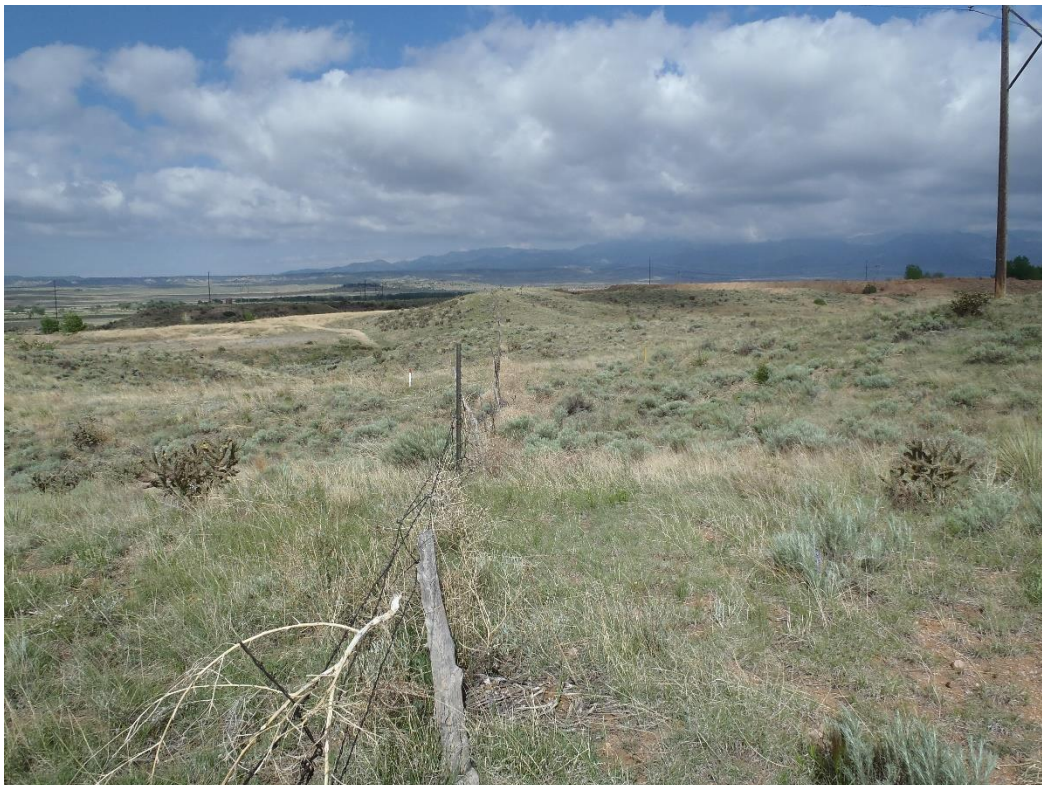
Photo 5. Fence serving as south permit boundary (looking west).

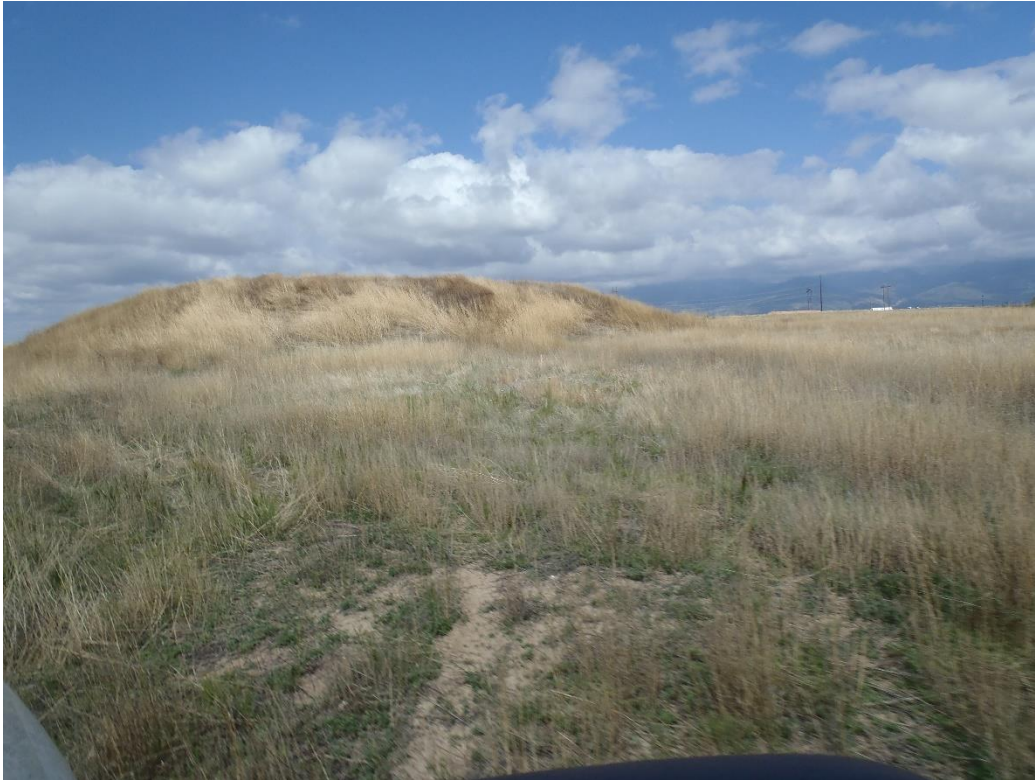
Topsoil: Topsoil stockpiles were observed above the excavation on site appeared stable (see **Photo 6**).

Photo 6. Typical topsoil stockpile.
