**MINERALS PROGRAM INSPECTION REPORT****PHONE: (303) 866-3567**

<b>MINE NAME:</b> Bottomless Pit	<b>MINE/PROSPECTING ID#:</b> M-2001-068	<b>MINERAL:</b> Gravel and sand	<b>COUNTY:</b> Las Animas
<b>INSPECTION TYPE:</b> Surety-Related Inspection	<b>INSPECTOR(S):</b> Michael A. Cunningham	<b>INSP. DATE:</b> April 11, 2017	<b>INSP. TIME:</b> 11:30
<b>OPERATOR:</b> Tamrock Gravel LLC	<b>OPERATOR REPRESENTATIVE:</b> Brent Tamburelli	<b>TYPE OF OPERATION:</b> 112c - Construction Regular Operation

Bottomless Pit (M-2001-068)

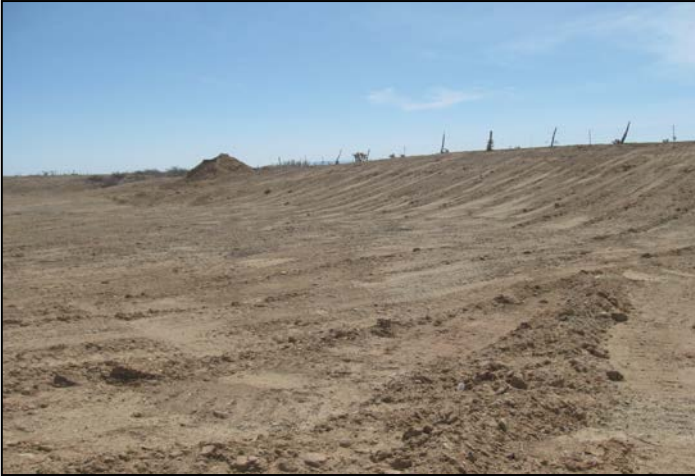
1. Reclaimed slope along southern portion of affected area.

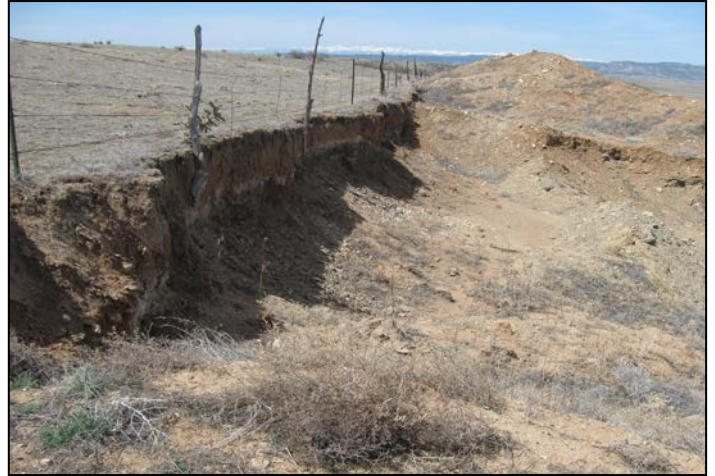
2. Unreclaimed slope along southern portion of affected area.

During the inspection, a copy of the Reclamation Plan was provided to the Operator. The establishment of vegetation in the location of the Bottomless pit is difficult due factors such as limited topsoil and drought conditions. The Operator is encouraged to follow the Reclamation Plan for the best chance of successfully establishing vegetation on reclaimed areas.

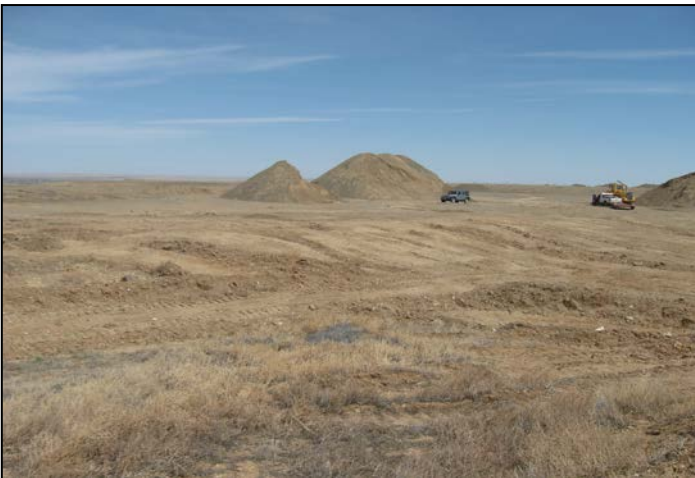
3. Overview of mine site from southern limit of affected area.

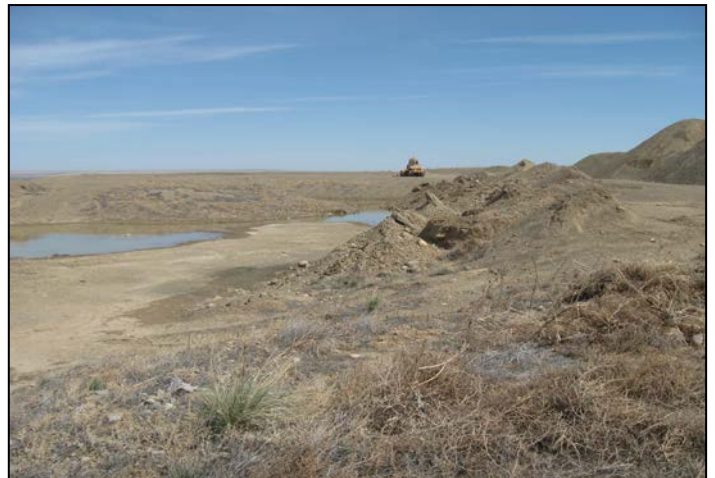
4. Additional areas requiring grading.

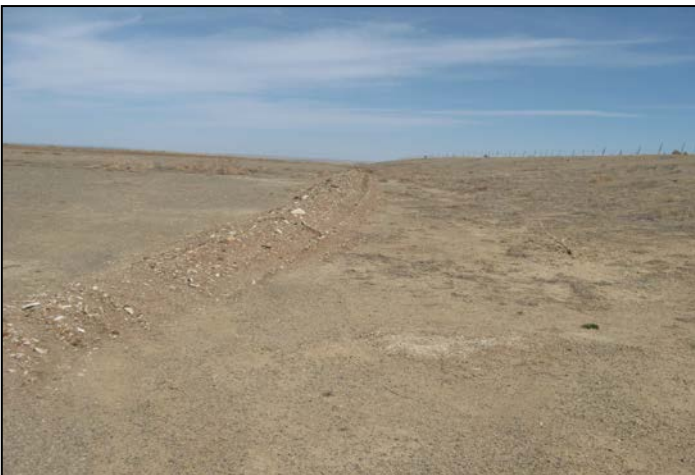
5. Graded slope along eastern permit boundary.

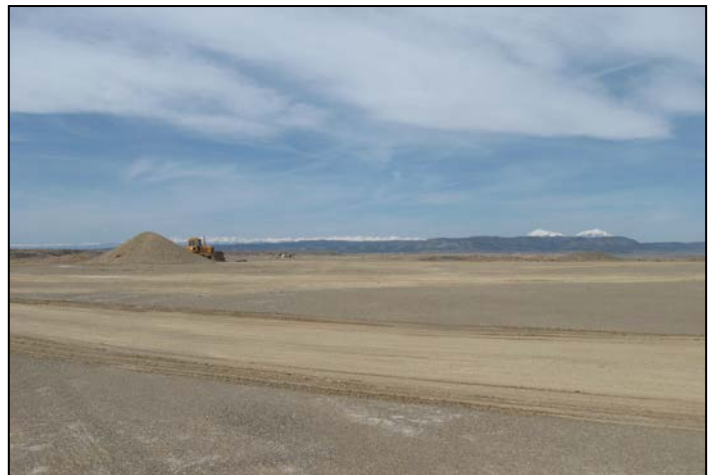
6. Overview of pit floor.

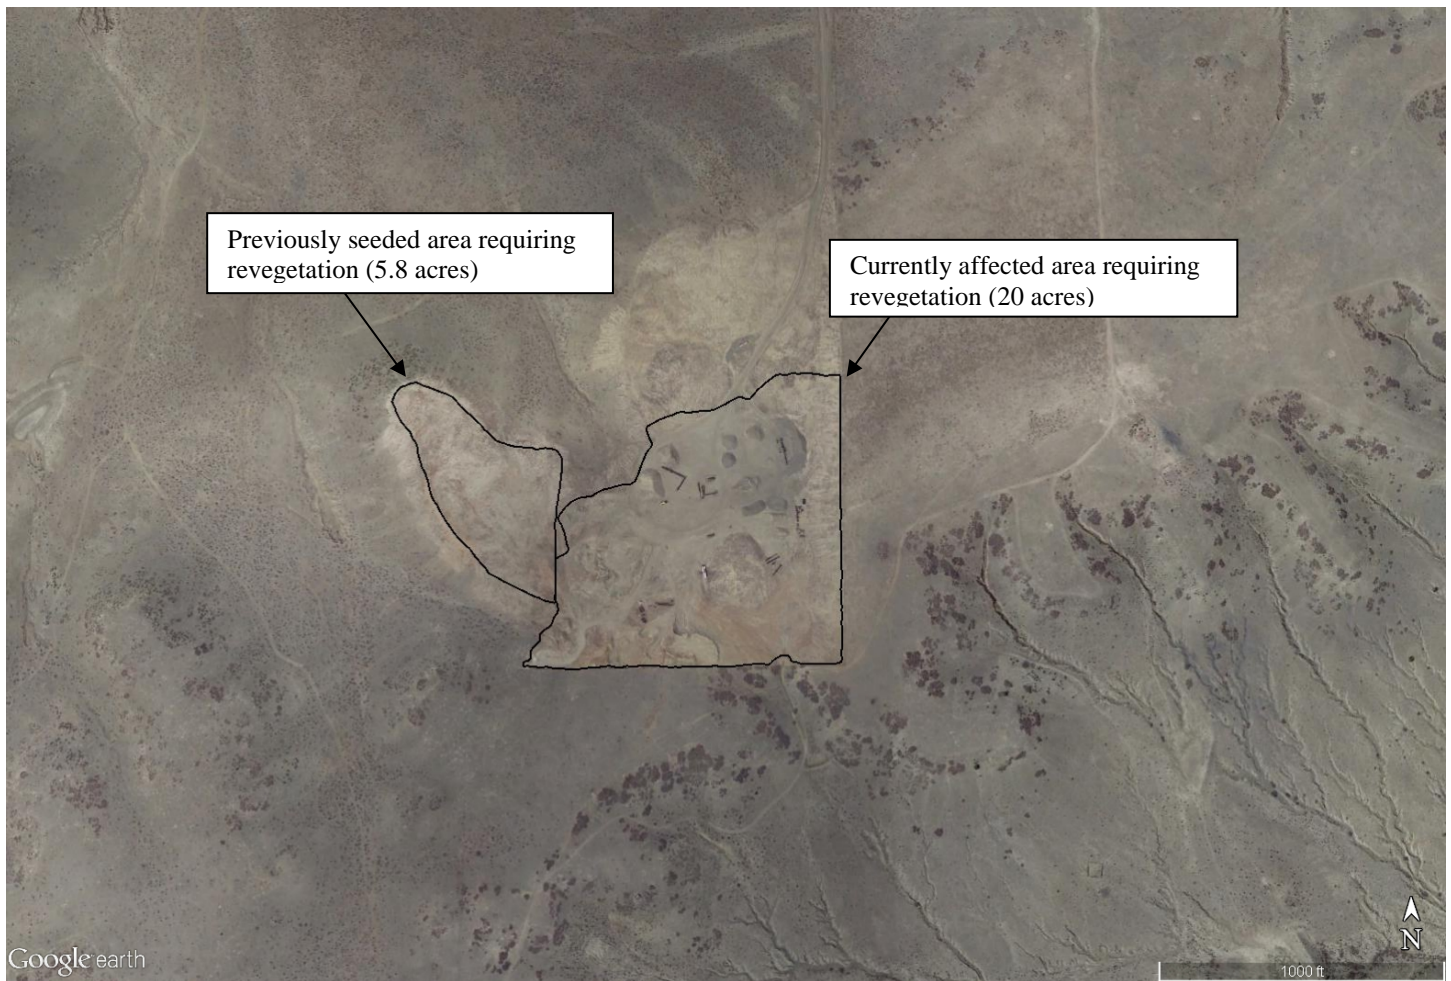
Following the inspection, the Division downloaded the data from the GPS unit and determined the area requiring revegetation is 25.8 acres (see attached map). The financial warranty estimate was adjusted to account for a smaller area requiring revegetation. In addition, the financial warranty estimate was revised to account for approximately 200' of highwall which was reclaimed along the southern portion of the affected area. Notice of the financial warranty increase will be sent under separate cover.
