# MINERALS PROGRAM INSPECTION REPORT PHONE: (303) 866-3567

MINE NAME:		MINE/PROSPECTING ID#:	MINERAL:	COUNTY:
Arkins Park Quarries		M-1985-212	Sandstone (silica, sto	Larimer
			quartzite)	
INSPECTION TYPE:		INSPECTOR(S):	INSP. DATE:	INSP. TIME:
Monitoring		Jared L. Ebert	April 17, 2017	09:30
OPERATOR:		OPERATOR REPRESENTATIVE:	TYPE OF OPERATION:	
ARKINS PARK STONE CORPORATION		Dewey Chandler and David Sprague	112c - Construction Regular Operation	
DE LOON FOR MIGRE OFFICE		DON'D GLI GUI LEVON ENIDE	DOME ALCONOMI	
REASON FOR INSPECTION:		BOND CALCULATION TYPE:	BOND AMOUNT:	
Normal I&E Program		Partial Bond	\$137,600.00	
DATE OF COMPLAINT:		POST INSP. CONTACTS:	JOINT INSP. AGENCY:	
NA		None	None	
WEATHER:	INSPECTOR'S SIGNATURE:		SIGNATURE DATE:	
Cloudy	0 0 0 0		April 18, 2017	
	()	ind Ebox		
		-		
<u>L</u>	V

This was a partial inspection of the Arkins Park Quarries, DRMS Permit No. M-1985-212, operated by Arkins Park Stone Corporation (Arkins). I, Jared Ebert of the Colorado Division of Reclamation, Mining and Safety (Division) conducted the inspection. Mr. David Sprague and Dewey Chandler with Arkins accompanied me during the inspection. The weather was partly cloudy and cool.

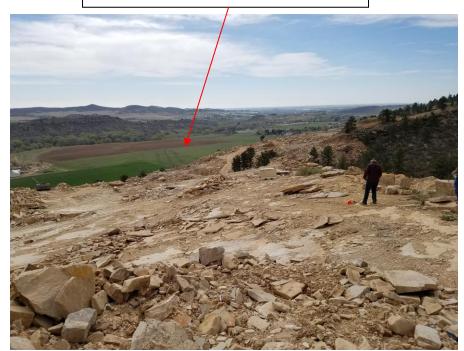
Akins prepared a blast in "B" quarry on the north end of the site. They drilled eighteen blast holes, each about two inches in diameter and six feet deep. According to Mr. Sprague they put about one pound of ANFO in each of the blast holes. They stemmed each blast hole with dirt and rock from the drilling operation. They use an electric initiation system and there are no delays so each hole detonates at the same time. The blast was initiated and air blast was fairly minimal and flyrock was not observed. Quarrying is occurring on a ridge above County Road 27, there are powerlines along County Road 27 and there are several houses and other structures located east of the quarry. It appears that these structures vary in distance from each of the active quarry faces but on average are 1,500 feet to 2,000 feet away from the active quarry face where blasting occurs.

Approximate Location of Blast

Figure 1. West end of "B" quarry.

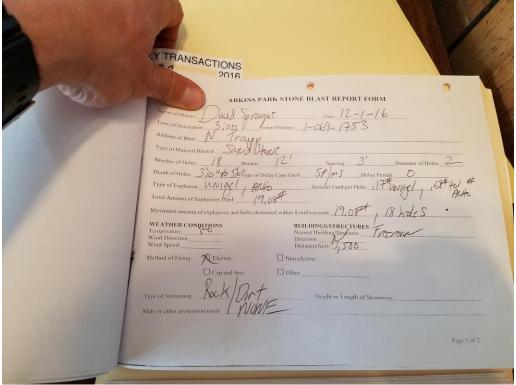
Arkins is required to maintain a log of each of the blasting events. I observed the blast logs maintained in the mine office. These logs documented the blasts from February 16, 2016 to December 1, 2016. According to the office employees, Mr. Sprague maintains the current years blast logs. According to the AM03 revised mine plan, blast logs are to include a specific list of information for each blast. Based on the blast logs observed during this inspection, the log forms contain a space to document each of the required pieces of information. However, many of the log forms were not filled out in their entirety. The information missing for many of the logs observed was: wind direction, wind speed and the height and length of stemming used. This information should be tracked. One of the spaces on the form requests the "Address of Blast". The Division assumes this is meant to document the location of the blast. Most of the blast forms observed did not have a physical address but some type of an identifier like "N Troupp". Based on this information, it is unknown where the specific location of each blast occurred. Future blast records should cite the specific location of the blast. A

Figure 2. Example blast log.

common accepted practice is to list the location of the blast hole that is closest to a structure not owned or controlled by the operator. The location should be listed in latitude and longitude or using Universal Transverse Mercator (UTM) coordinates. Also, this hole should be shown on the blast sketch and the sketch should have a north arrow.

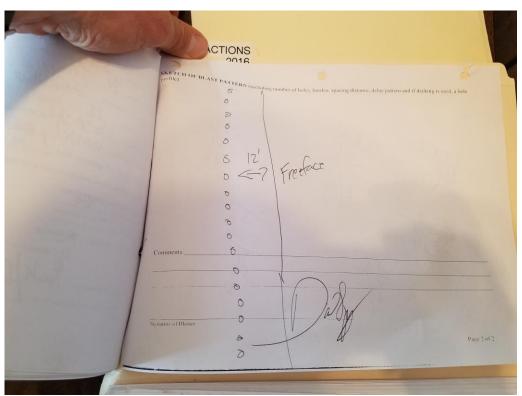
Figure 3. Example blast log continued.
