MINERALS PROGRAM INSPECTION REPORT

MINE NAME: Berthoud Pink Quarry	MINE/PROSPECTING ID#: M-1985-211	MINERAL: Sandstone (silica, st quartzite)	COUNTY: Larimer
INSPECTION TYPE: Monitoring	INSPECTOR(S): Jared L. Ebert	INSP. DATE: April 17, 2017	INSP. TIME: 11:11
OPERATOR: ARKINS PARK STONE CORPORATION	OPERATOR REPRESENTATIVE: Dewey Chandler and David Sprague	TYPE OF OPERATION: 110c - Construction Limited Impact

Berthoud Pink Quarry, M-1985-211

April 17, 2017 Inspection

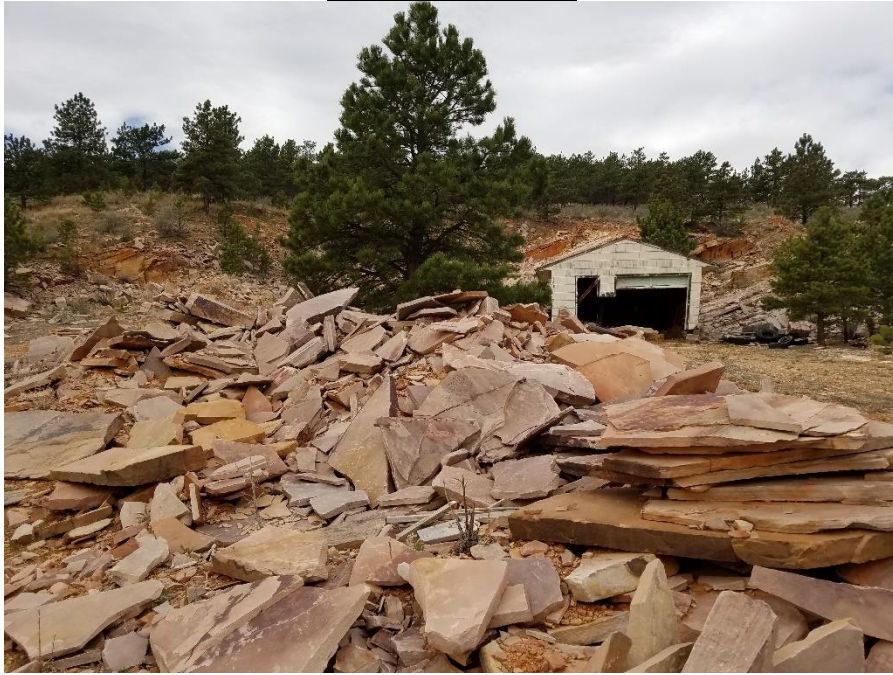
The north site consists of two primary working faces of the quarry. Various piles of sandstone are stockpiled throughout the area. The working faces of the north site are fairly shallow. A small depressions catches runoff from the north site on the northeast end of the affected area.

Figure 1. North site, on the east end looking west.

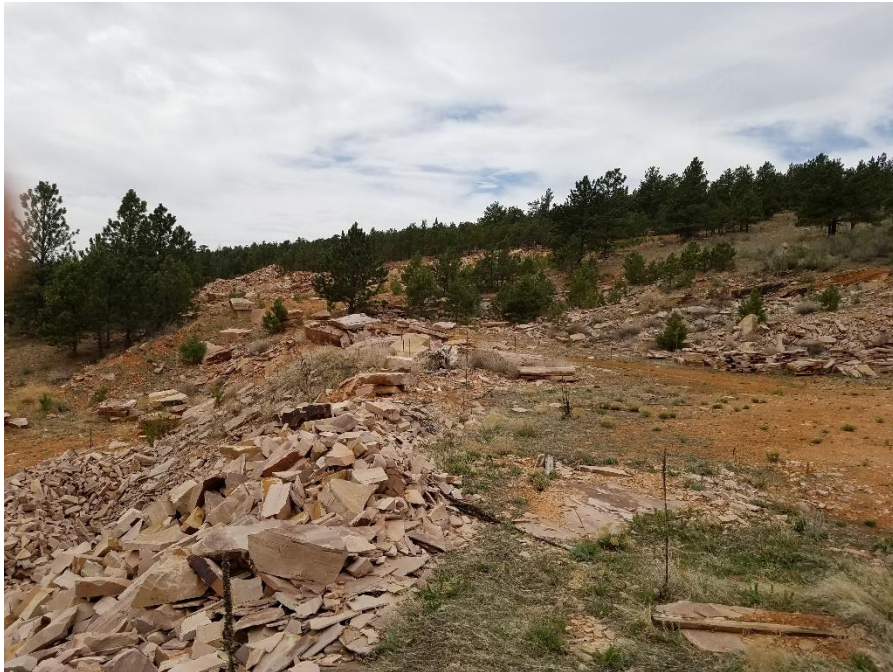
Figure 2. From the center of the north site looking south.

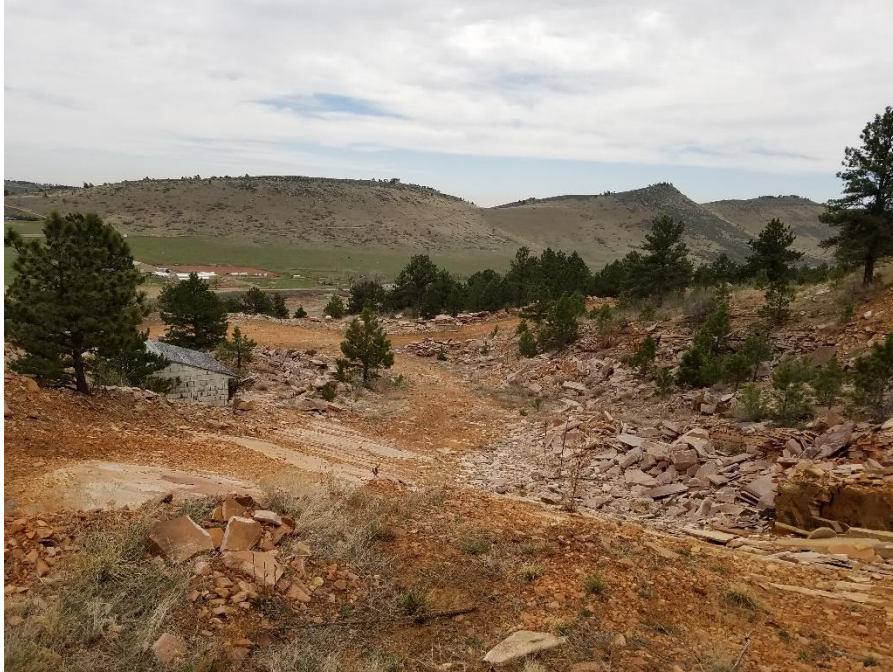
Figure 3. From the west end of the site looking east.

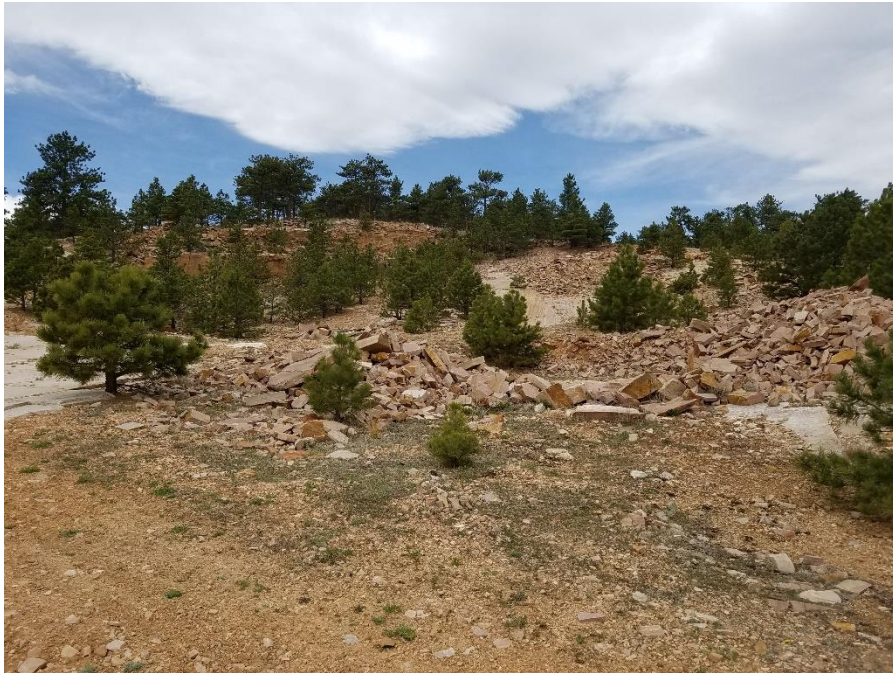
PROBLEM: The affected area boundary markers are missing from the south area. This is a problem for failure to maintain boundary markers around the affected area as required by Section 3.1.12(2) of the rule.

The south site consist of one working face. The working face has a northeastern aspect with a solid rock highwall about 5 to 10 feet in height and is about 70 feet in length. Some wasterock/soil material is located in various piles north east of the working face.

The south site (Gold Stain Quarry), was not marked with boundary markers. Based on a recent Google earth image, the affected area is about 1.5 acres in size. The permit area is 2.5 acres in size at this location. The operator will need to mark the permit boundary of the south site. This issue is cited as a problem at the beginning of the report.

Figure 4. South Site, from the access road looking northwest.

CORRECTIVE ACTIONS: The operator shall conduct a survey and replace the boundary markers in the correct location(s). The operator shall provide proof to the Division that this has been done by the corrective action date.

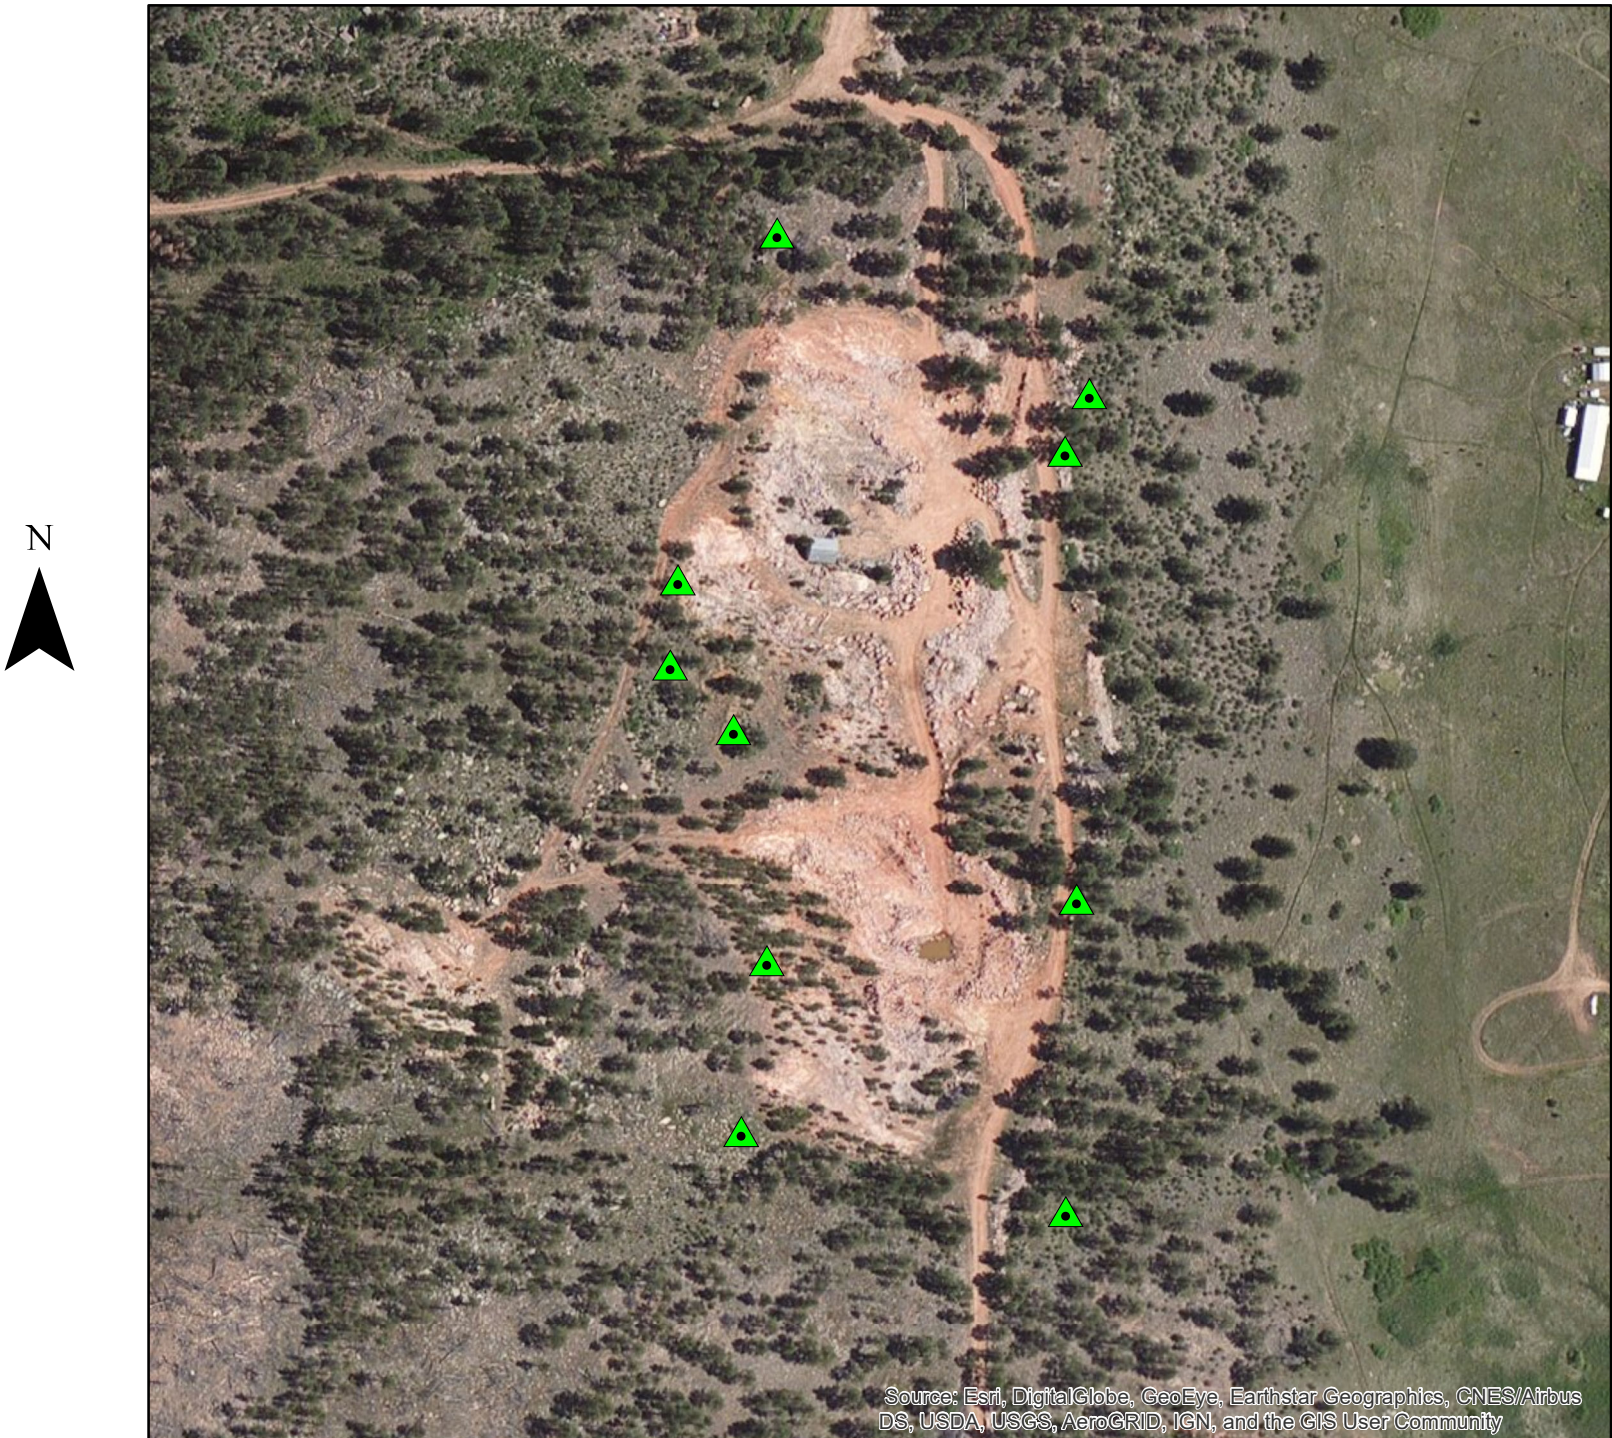
North Site

The mine entrance sign was observed. The north site affected area was marked with a number of T-Posts. Using the ArcCollector application, the location of these boundary markers was collected and mapped. Please see the enclosed map. The boundary markers observed delineated an area that is about 6.5 acres in size.
