## MINERALS PROGRAM INSPECTION REPORT

<b>MINE NAME:</b> Berthoud Sunset	<b>MINE/PROSPECTING ID#:</b> M-1994-080	<b>MINERAL:</b> Sandstone (silica, stone quartzite)	<b>COUNTY:</b> Larimer
<b>INSPECTION TYPE:</b> Monitoring	<b>INSPECTOR(S):</b> Jared L. Ebert	<b>INSP. DATE:</b> April 17, 2017	<b>INSP. TIME:</b> 12:00
<b>OPERATOR:</b> ARKINS PARK STONE CORPORATION	<b>OPERATOR REPRESENTATIVE:</b> Dewey Chandler and David Sprague	<b>TYPE OF OPERATION:</b> 110c - Construction Limited Impact

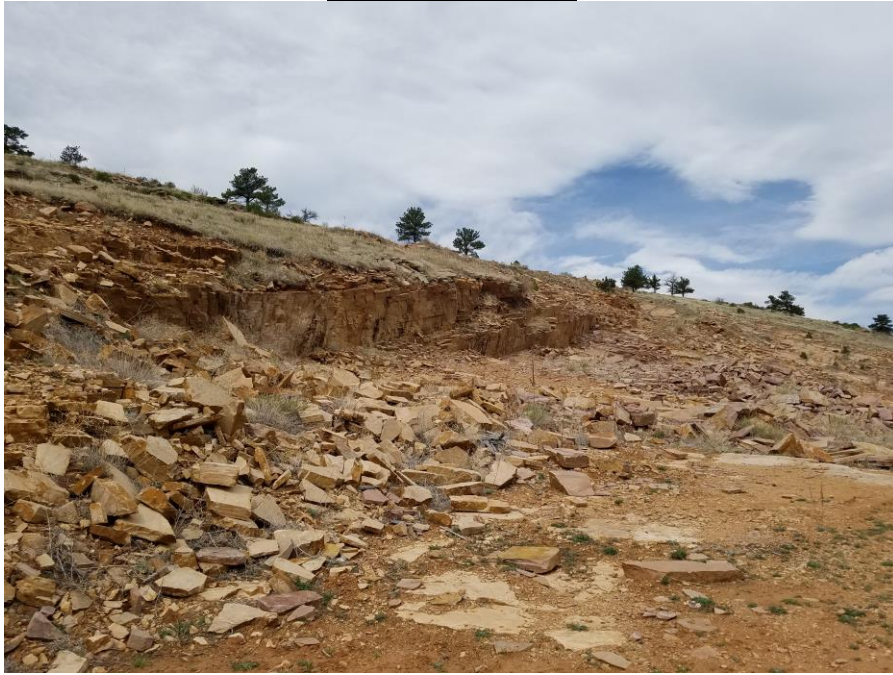
Figure 1. Working face at the west end of the affected area.

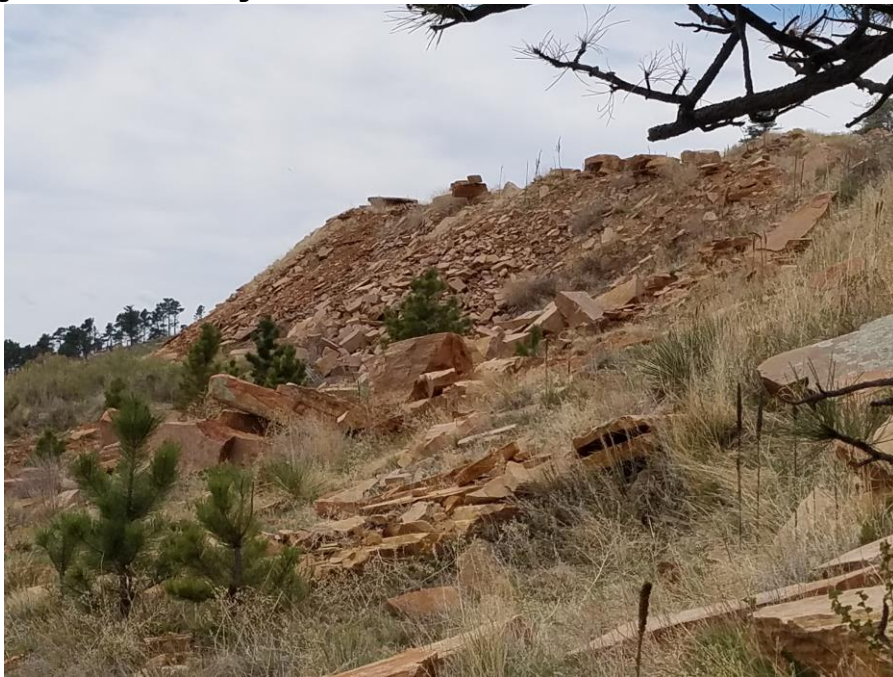
Figure 2. From the east end of the affected area looking south at the base of the 1st bench.

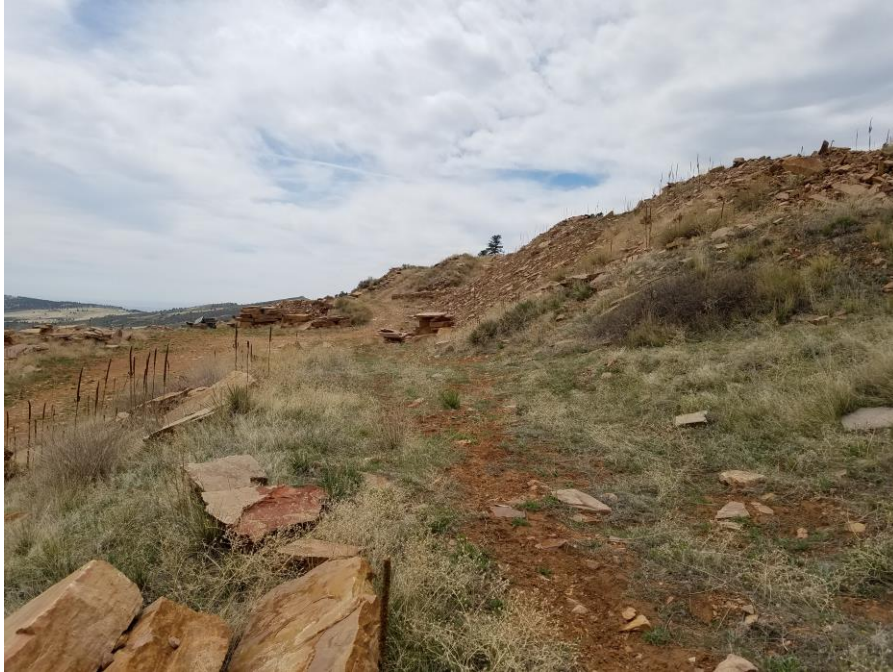
Figure 3. From the base of the 2nd bench on the access road looking south.

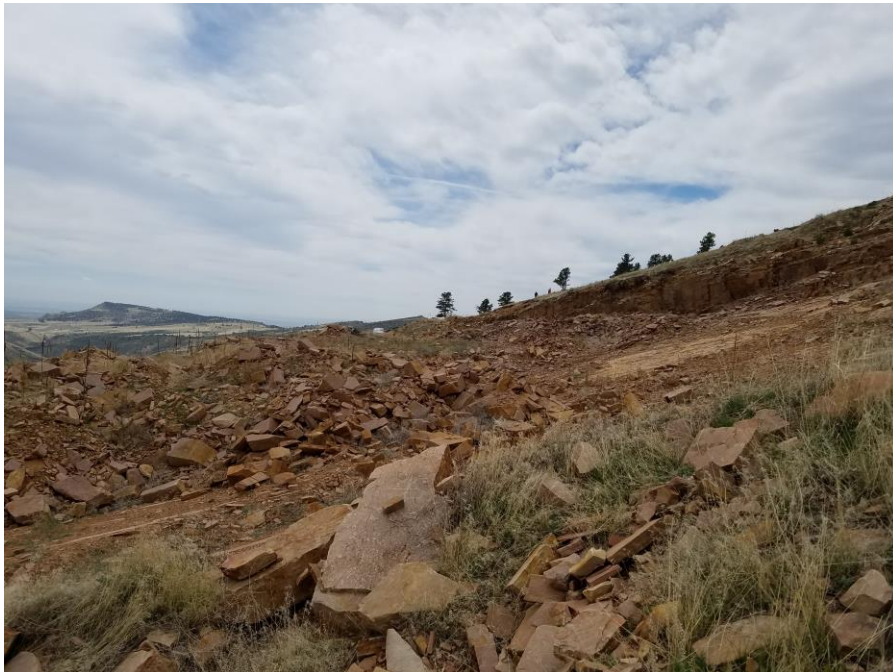
Figure 4. From on top of the 3rd bench looking south.
