**COLORADO**Division of Reclamation,
Mining and Safety

MINERALS PROGRAM INSPECTION REPORT**PHONE: (303) 866-3567**

MINE NAME: Lyons Pit	MINE/PROSPECTING ID#: M-1974-015	MINERAL: Sand and gravel	COUNTY: Boulder
INSPECTION TYPE: Monitoring	INSPECTOR(S): Amy Eschberger	INSP. DATE: March 22, 2017	INSP. TIME: 14:00
OPERATOR: Martin Marietta Materials, Inc.	OPERATOR REPRESENTATIVE: Julie Mikulas, Josh Kruchten	TYPE OF OPERATION: 112c - Construction Regular Operation

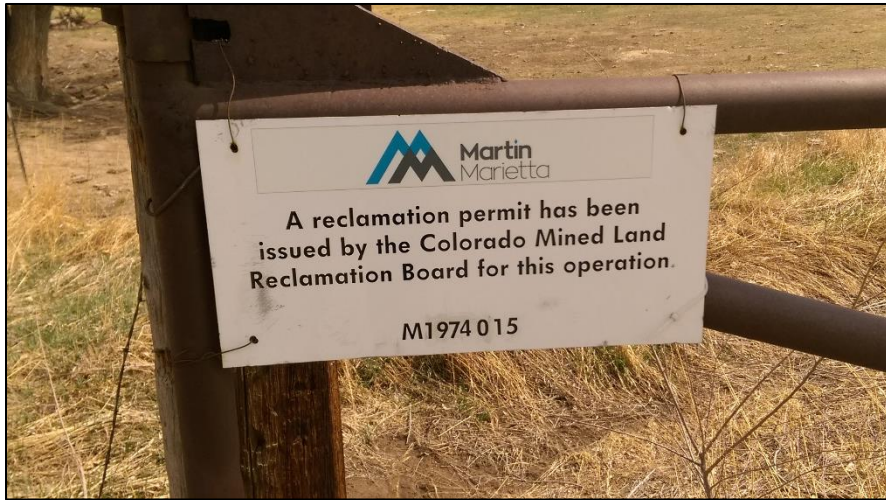
At the time of the inspection, the site was not active. A proper permit sign was posted at the gated entrance to the site off of CO-66 (**Photo 1**). Currently, disturbed land on site includes four excavated pits, a central processing plant, an equipment boneyard, and associated haul roads (see enclosed Google Earth image of site showing close-up of disturbed area). The processing plant is approximately 9.5 acres in size, and includes 6 concrete load out silos on the north end, a small shed, a conveyor, and various pieces of mining related equipment scattered around the perimeter of the area (**Photos 2-6**). The four excavated pits consist of three unlined lakes (Lakes 1-3) and a lined reservoir (Lake 4). The southern portion of the permit area located south of the South Branch has not yet been disturbed by the operation. The approved mining and reclamation plans indicate that 2-3 additional lakes will be created in the southern portion of the site. Lake 1 (unlined) is located just east of the processing plant, and north of St. Vrain Creek. This lake was reclaimed years ago. The shorelines have slopes of 3H:1V or flatter and are well vegetated (**Photos 7 and 8**). The only exception is a

Photo 1. View of permit sign posted at main site entrance off of CO-66.

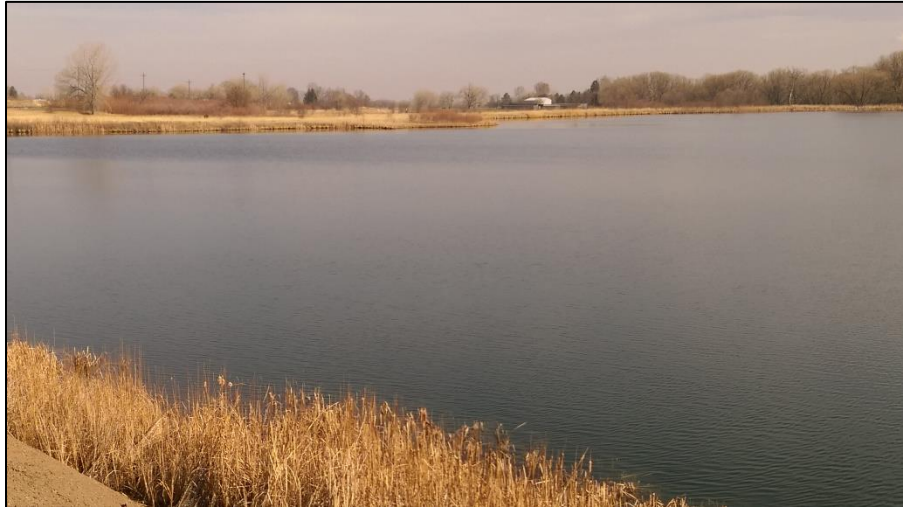
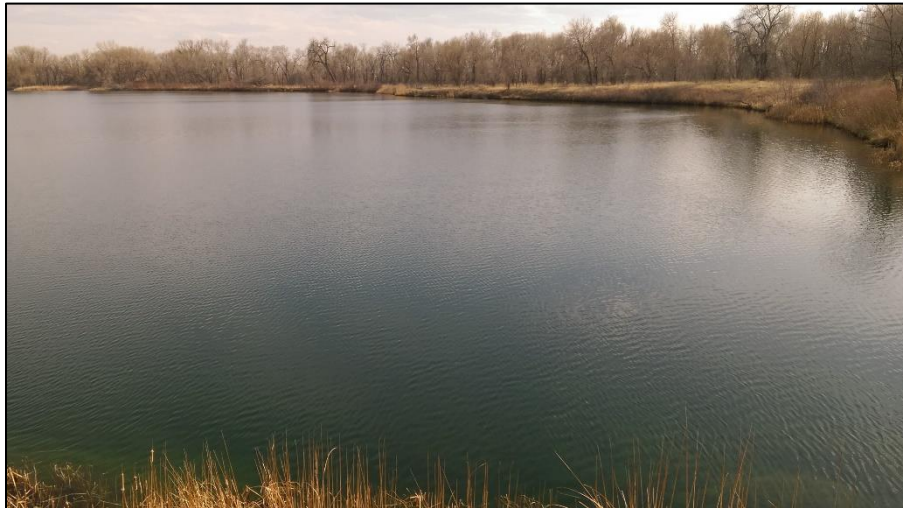
Photo 7. View looking northeast across Lake 1 from western shoreline. Lake shorelines are graded to 3H:1V or flatter with established vegetation.

Photo 8. View looking southeast across Lake 1 from western shoreline. Lake shorelines are graded to 3H:1V or flatter with established vegetation.

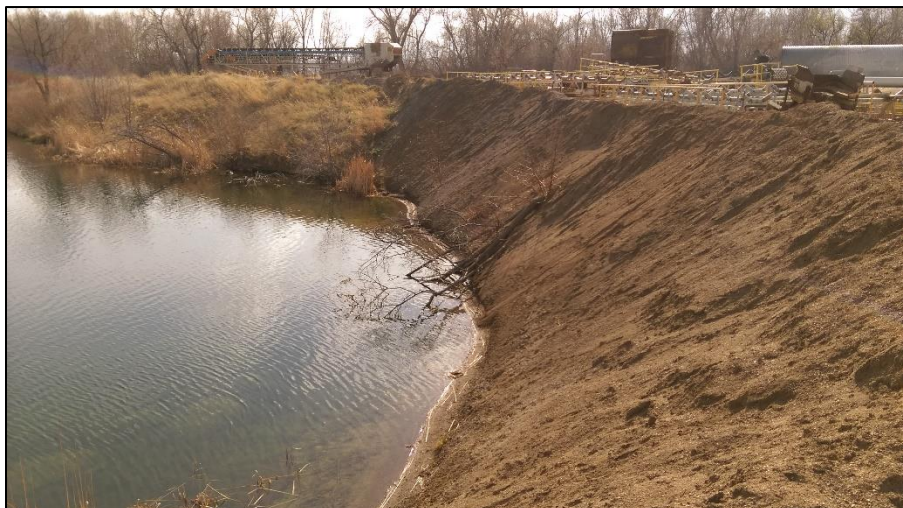
section of the western shoreline where the operation has extended the pad for the processing plant, leaving slopes of approximately 1.5H:1V (**Photo 9**). For final reclamation, the western shoreline of this lake will need to be graded to 3H:1V or flatter and revegetated in accordance with the approved reclamation plan. Lake 1 appeared to have not been affected by the historic flooding that occurred in the region during September 2013, and its shorelines are stable at this time. The Division estimates the surface area of Lake 1 to be approximately 17 acres in size.

Photo 9. View of portion of western shoreline of Lake 1, showing slopes of approximately 1.5H:1V.

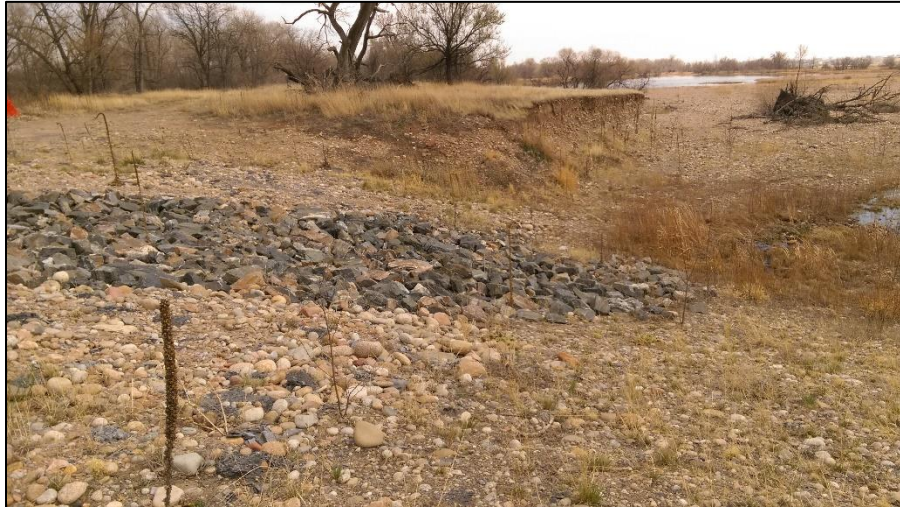
The other problem cited in this report is for the excessive erosion observed on site, particularly along portions of Lakes 2, 3, and 4 shorelines. The Division realizes the lake shorelines had been reclaimed, but were damaged by the September 2013 flooding. However, the Division believes the operator has had a reasonable amount of time to repair this damage. Rule 3.1.6(3) requires all surfaces of the affected land to be stabilized and protected so as to effectively control erosion. The operator will need to repair and stabilize the lake shorelines, grading them to the approved 3H:1V or flatter slope gradient. By the corrective action due date, the operator shall provide photo documentation to the Division verifying this work has been completed. The operator will also need to demonstrate that the current flood protection plan is adequate to protect the site from stream capture and associated flood damage in the future. This may include submitting a Technical Revision to revise the approved mining and reclamation plans to include an updated flood protection plan for the site. The Division recommends the operator consult with Boulder County and Urban Drainage and Flood Control District in developing an adequate flood protection plan for the mine site.

Photo 10. View of northwestern bank of Lake 2 where St Vrain Creek entered the pit during September 2013 flooding. Boulder County has repaired some of the flood damage in this area.

CORRECTIVE ACTIONS: By the corrective action due date, the operator shall provide photo documentation to the Division demonstrating the pond bank erosion has been repaired and the slopes graded to the approved 3H:1V gradient, and the site has been reconstructed and stabilized to prevent erosion damage. The operator shall also demonstrate by the corrective action due date that the current flood protection plan is adequate to protect the site from stream capture and associated flood damage in the future. This may include submitting a Technical Revision to revise the approved mining and reclamation plans to include an updated flood protection plan for the site.

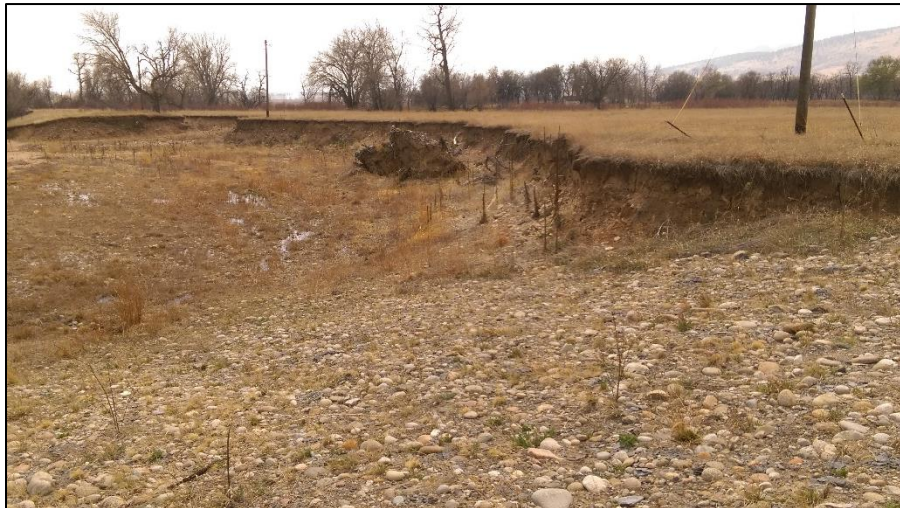
PROBLEM: Excessive erosion was observed on the affected land attributed mainly to regional flooding that occurred during September 2013. This is a problem at this time pursuant to Rule 3.1.6(3), which requires all

Photo 11. View of northwestern shoreline of Lake 2 damaged by September 2013 flooding. Bank slopes are steeper than approved 3H:1V gradient.

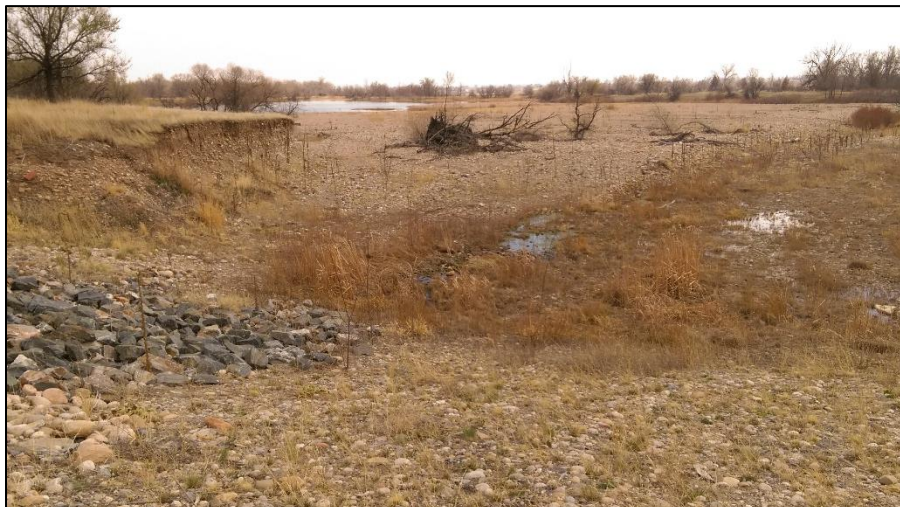
Photo 12. View of northeastern shoreline of Lake 2 (at left) damaged by September 2013 flooding.

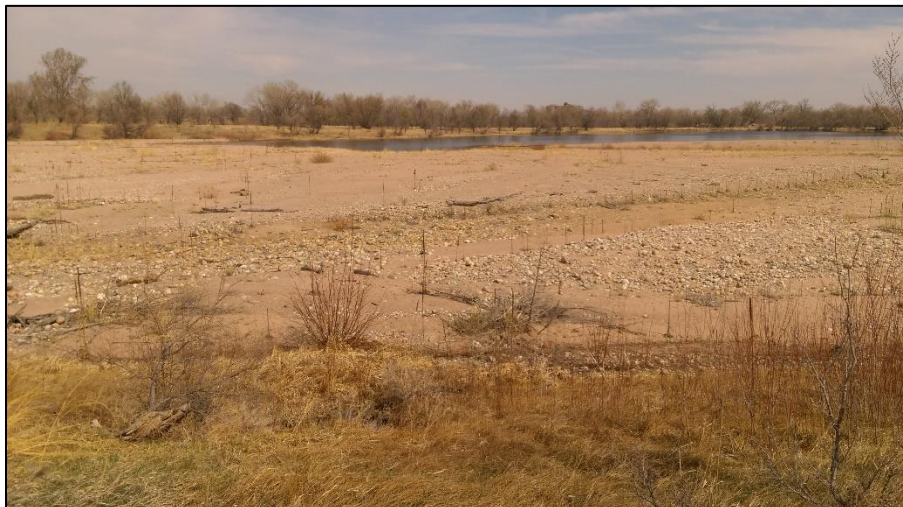
Photo 13. View of sediment deposited in Lake 2 by September 2013 flooding.

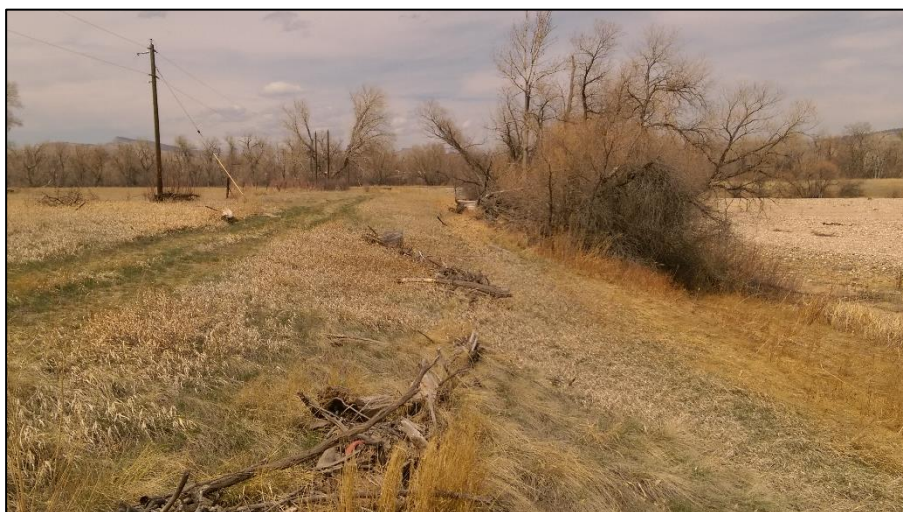
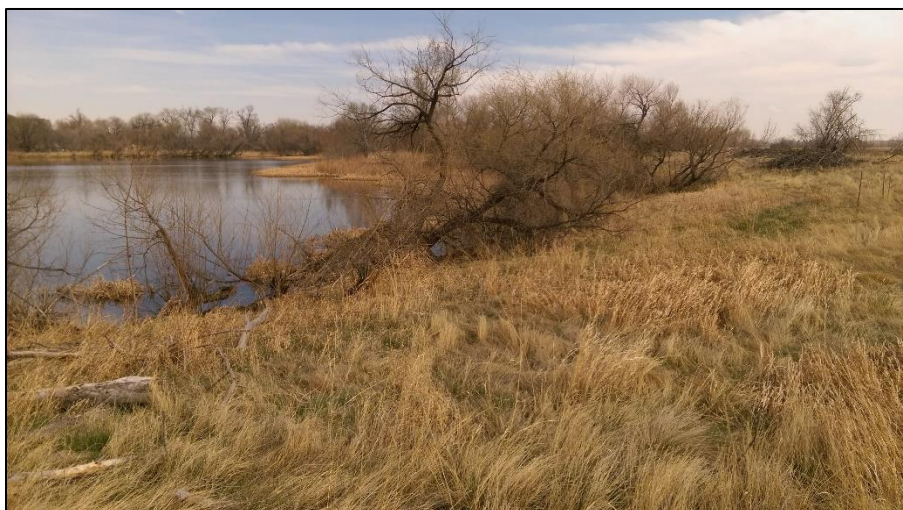
Photo 14. View of southwestern shoreline of Lake 2 graded to 3H:1V or flatter, stable with vegetative cover.

Photo 15. View of southern shoreline of Lake 2 graded to 3H:1V or flatter, stable with vegetative cover.

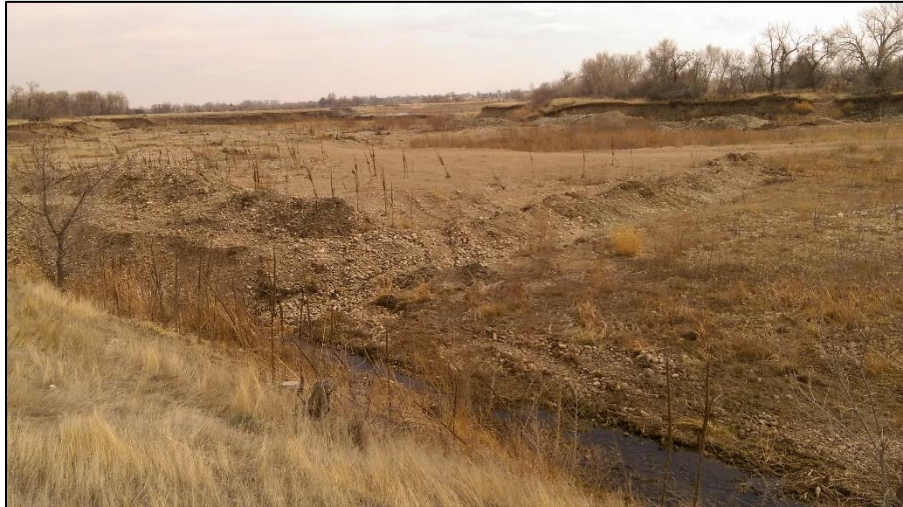
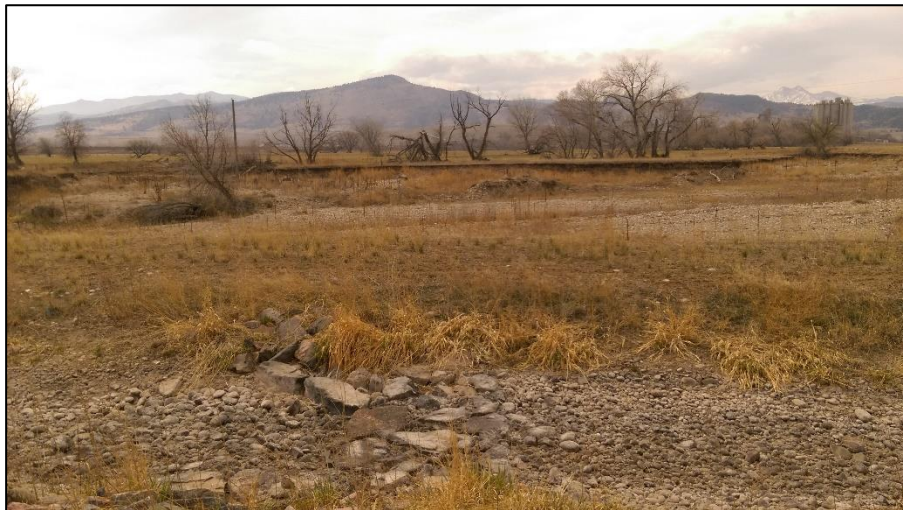
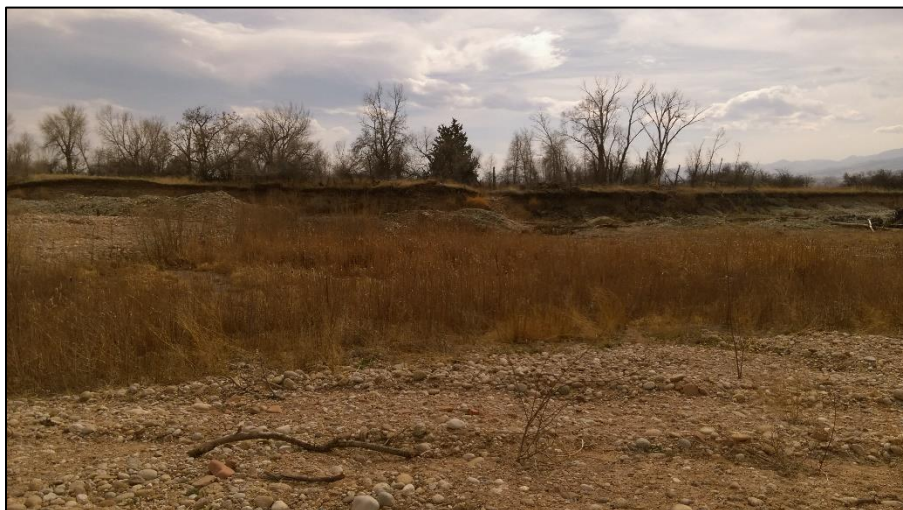
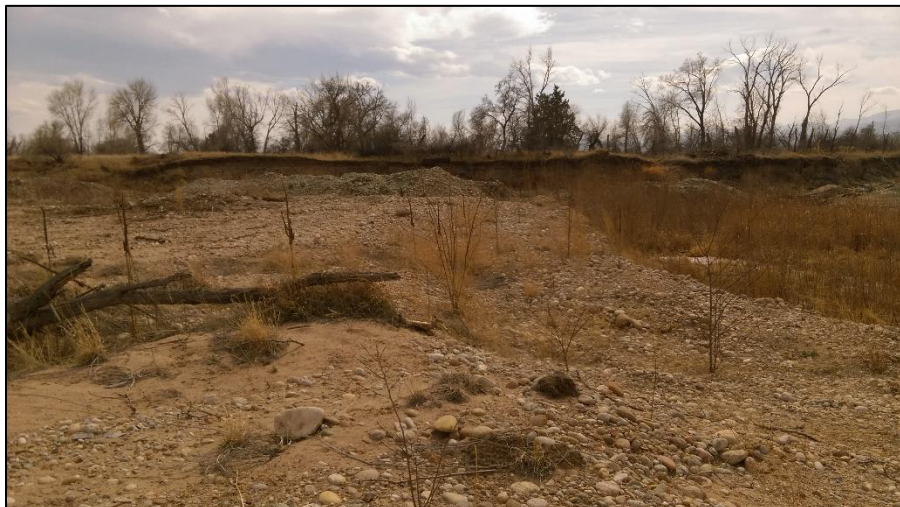
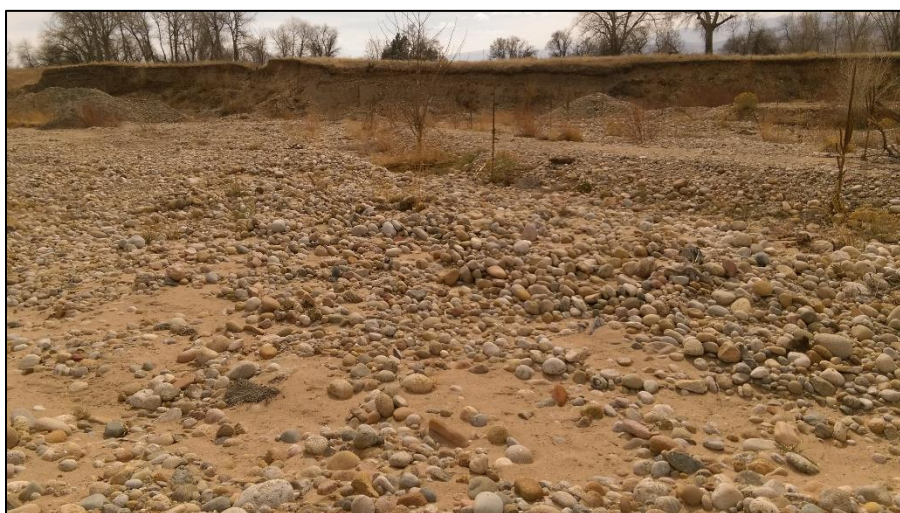
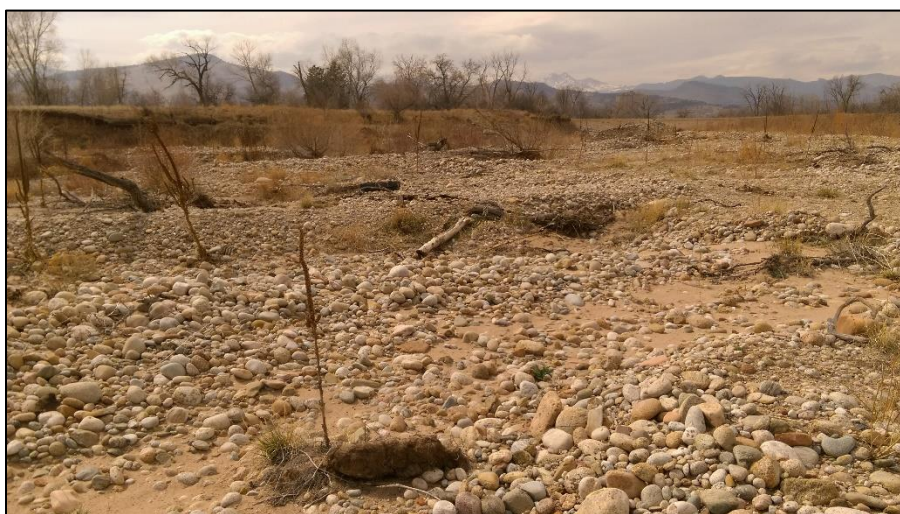
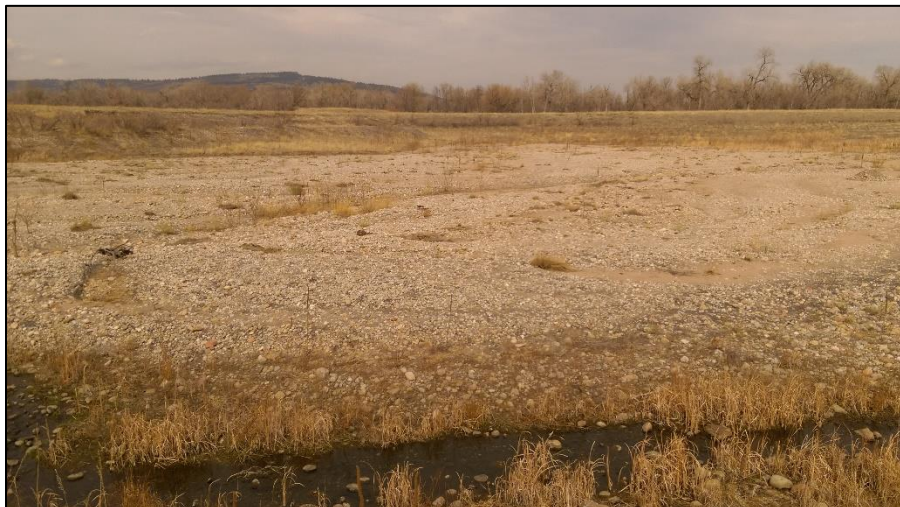
Much of the Lake 3 shorelines were scoured by the flooding, leaving slope gradients of near vertical. The pit was dry during the inspection, with grasses, forbs, and some weeds volunteering across the rocky pit floor (**Photos 16-22**). The operator expressed a desire to mine the rock deposited on the pit floor by the flood. The Division would not object to this activity as it would be consistent with the approved mining plan. However, it should be noted that the approved reclamation plan on file has this pit being backfilled and potentially turned into a public park. This plan could be revised at any time through the submittal of a Technical Revision.

Photo 16. View of sediment deposited in Lake 3 by September 2013 flooding.

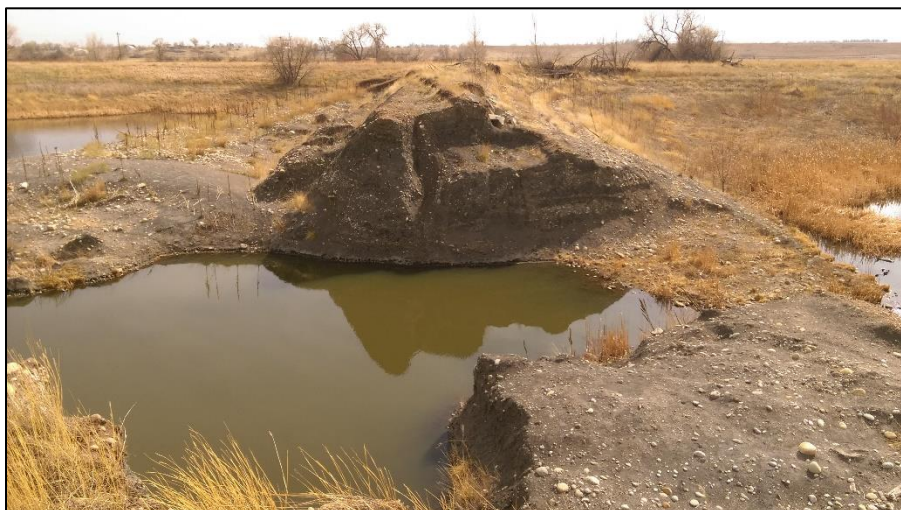
PROBLEM: The Division has no evidence the operator has a valid well permit, substitute water supply plan, or approved water augmentation plan for the exposed groundwater at the site. This is a problem related to C.R.S. 34-32.5-116(4)(h) and Construction Materials Rule 3.1.6(1)(a) governing injury to existing water rights. Specifically, the slurry wall installed around Lake 4 (as approved in Technical Revision No. 1) has been breached in two locations, so that the lake is now connected to the alluvial groundwater system.

such that it could store water in accordance with Case No. 88CW074. However, now that the slurry wall has been breached in two locations (**Photos 26 and 27**), Lake 4 is no longer considered to be isolated from the alluvial groundwater system. Ms. Mikulas informed the Division the County of Boulder is currently taking bids to repair the damaged liner. The September 2013 flooding created an alluvial fan in the western portion of Lake 4, filling almost half the pit with sediment (**Photo 28**). The Division estimates the surface area of water held in Lake 4 to be approximately 15 acres at this time. This water is currently hydrologically connected to the off-site lake located east of the permit boundary (**Photo 29**). Portions of the northern and southern shorelines of Lake 4 appear to be graded to 3H:1V or flatter with established vegetation (**Photos 30 and 31**). However, much of the western shoreline (**Photo 32**) and the portion of the eastern shoreline where the berm and slurry wall were breached (as mentioned above) were scoured by the flood waters.

The Division is citing two problems in this report (see pages 1 and 2) which are associated with damage caused by the September 2013 flooding. One problem is cited for the breached slurry wall around Lake 4. As mentioned above, this lake is no longer considered a sealed reservoir. The operator will need to demonstrate that the site is in compliance with the SEO with regard to exposed groundwater on site, or that the operator is taking measures to bring the site into compliance with the SEO. Once the liner has been repaired, tested, and approved by the SEO, the operator will need to submit to the Division the 90-day performance test final report and the SEO's approval letter. By the corrective action due date, the operator shall provide to the Division an estimated schedule for repairing the damaged portions of the slurry wall.

Photo 26. View of southeastern breached portion of berm and slurry wall liner around Lake 4. Lake 4 (at right) now connected to offsite lake (at left).

CORRECTIVE ACTIONS: By the corrective action due date, the operator shall demonstrate the operation is in compliance with the Office of the State Engineer (SEO), show evidence the operator is taking measures to bring the site into compliance with the SEO, or backfill the pit to at least two feet above the groundwater surface. For a slurry wall to be accepted by the Division as adequate mitigation of exposed groundwater, the Division must receive documentation from the SEO demonstrating the slurry wall meets the SEO's design criteria. This is typically provided after the operator has performed the required 90-day performance test on the liner. By the corrective action due date, the operator shall provide an estimated schedule for repairing the damaged portions of the slurry wall liner.

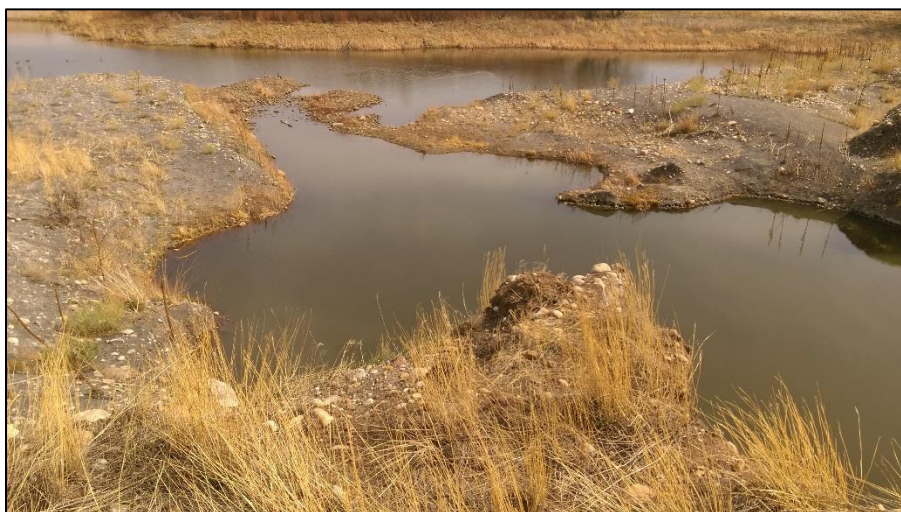
Photo 27. View looking southeast, downgradient from Lake 4 slurry wall breach, showing channel connecting Lake 4 to offsite lake.

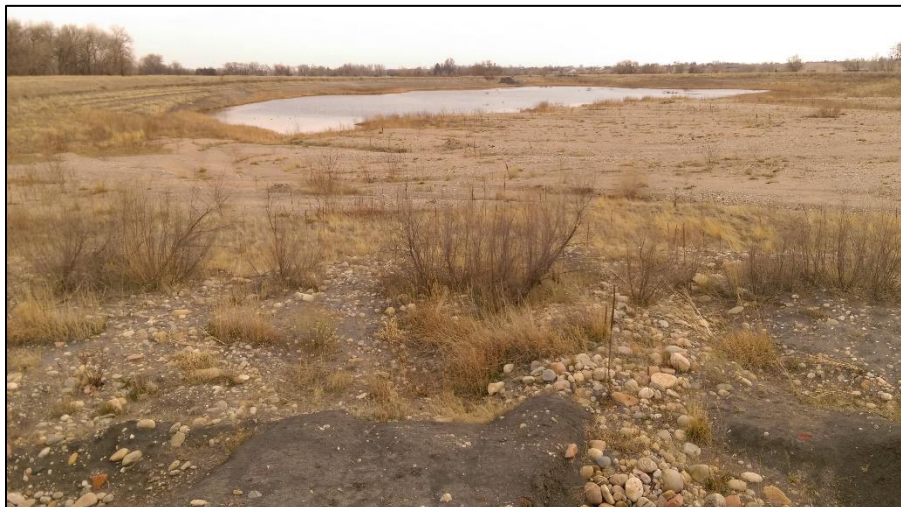
Photo 28. View looking east across Lake 4, showing sediment filling in northwestern portion of lake and western shoreline (in foreground) damaged by flooding.

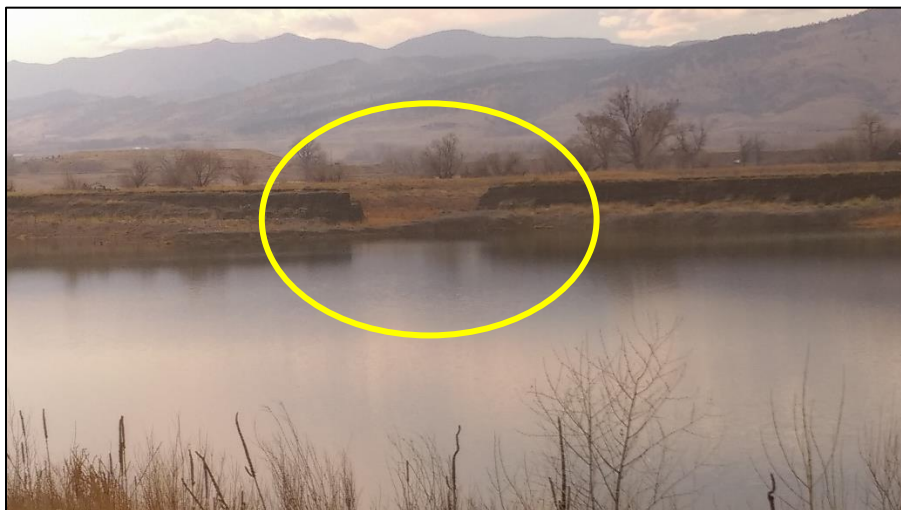
Photo 29. View looking west from eastern shoreline of offsite lake, showing breach in berm/slurry wall liner (circled) that had separated Lake 4 from the offsite lake.

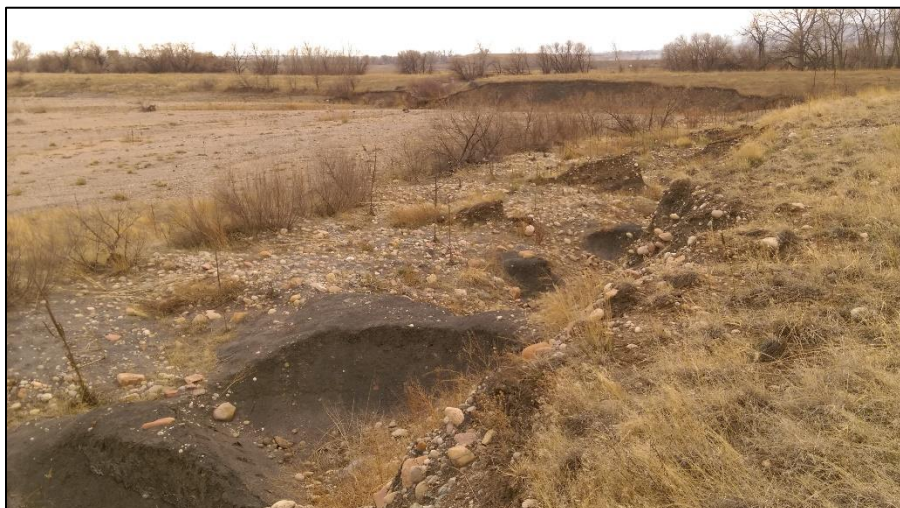
Photo 32. View of western shoreline of Lake 4 damaged by September 2013 flooding.

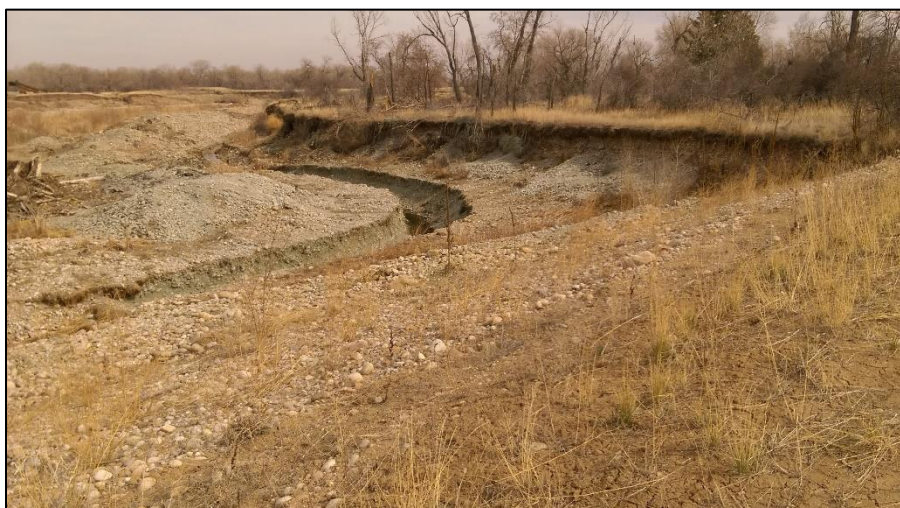
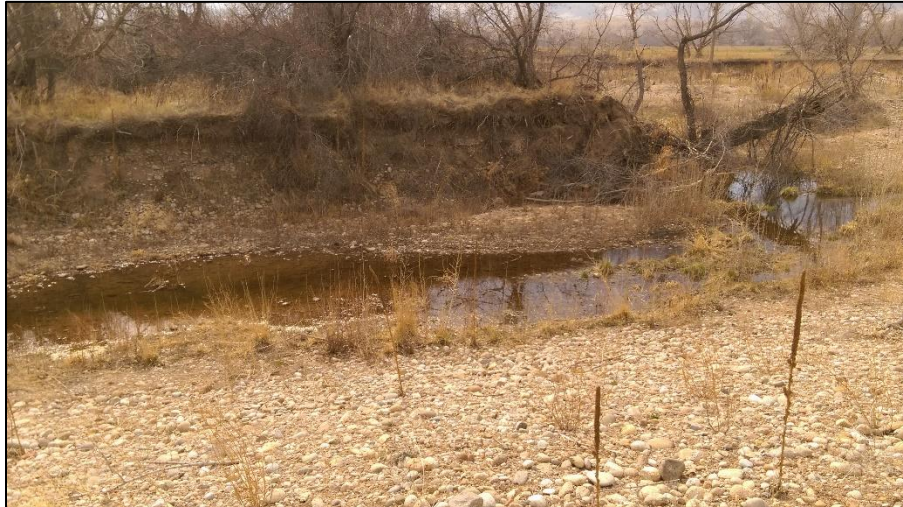
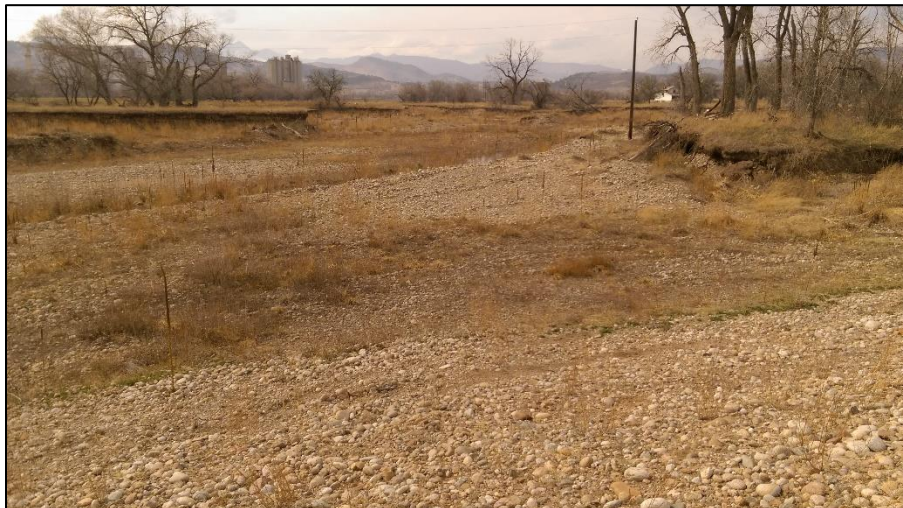
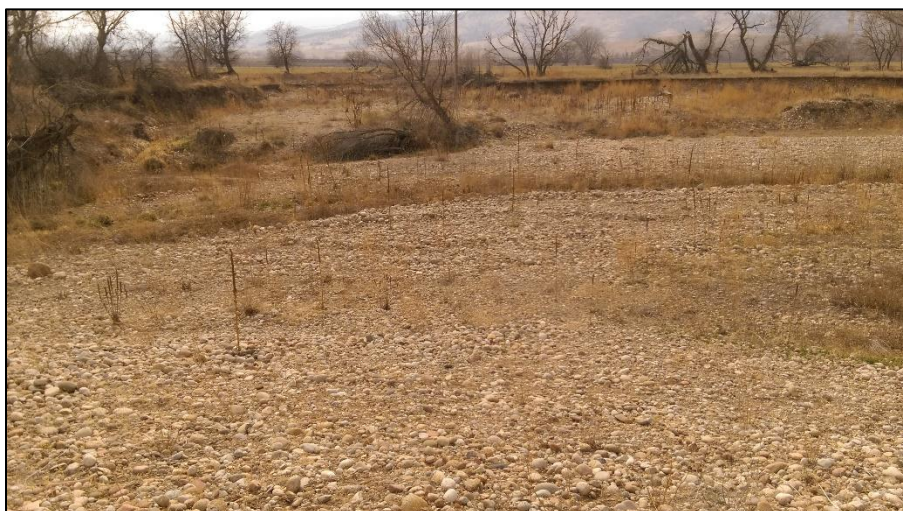
During the inspection, the Division walked northwest up the South Branch, and observed the damage caused to this ditch by the September 2013 flooding (**Photos 33-36**). The flood waters had significantly widened the ditch, leaving washouts with steep banks approximately 4-5 feet in height and depositing a fairly large amount of rocky sediment. The ditch had some minor flow during the inspection. The Division discussed with Ms.

Mikulas and Mr. Kruchten what reclamation responsibility the operator has for the flood damage that occurred west of the disturbed area, but within the approved permit area. The Division informed them that if the land had not been disturbed by the operation prior to the flooding and would not be disturbed by the operation in the future, the operator would not be required to repair the flood damage. However, if any portion of the approved permit area is disturbed by the operation (e.g., haul roads, stockpiling, mining, equipment storage), such land must be reclaimed to its approved post-mining land use. Additionally, if the flood damaged land within the approved permit area in any way reduces the effectiveness of the operator's flood protection and/or stormwater management plans for the site, the damage may need to be repaired and the land stabilized, regardless of whether it was disturbed by the operation.

Photo 33. View of flood damage located west of disturbed area but within approved permit area.

Photo 34. View of flood damage located west of disturbed area but within approved permit area. Note ditch carrying some water during inspection.

Photo 35. View looking northwest across washout created by September 2013 flooding, west of disturbed area, but within approved permit area.

Photo 36. View looking south across washout created by September 2013 flooding, west of disturbed area, but within approved permit area.
