**MINERALS PROGRAM INSPECTION REPORT**  
**PHONE: (303) 866-3567**

<b>MINE NAME:</b> Hard Rock 291 Pit	<b>MINE/PROSPECTING ID#:</b> M-1977-195	<b>MINERAL:</b> Sand and gravel	<b>COUNTY:</b> Chaffee
<b>INSPECTION TYPE:</b> Monitoring	<b>INSPECTOR(S):</b> Dustin M. Czaplá	<b>INSP. DATE:</b> April 18, 2017	<b>INSP. TIME:</b> 13:45
<b>OPERATOR:</b> Hard Rock Paving and Redi-Mix, Inc.	<b>OPERATOR REPRESENTATIVE:</b> None	<b>TYPE OF OPERATION:</b> 110c - Construction Limited Impact	
<b>REASON FOR INSPECTION:</b> Normal I&E Program	<b>BOND CALCULATION TYPE:</b> Complete Bond	<b>BOND AMOUNT:</b> \$26,823.65	
<b>DATE OF COMPLAINT:</b> NA	<b>POST INSP. CONTACTS:</b> None	<b>JOINT INSP. AGENCY:</b> None	
<b>WEATHER:</b> Clear	<b>INSPECTOR'S SIGNATURE:</b>

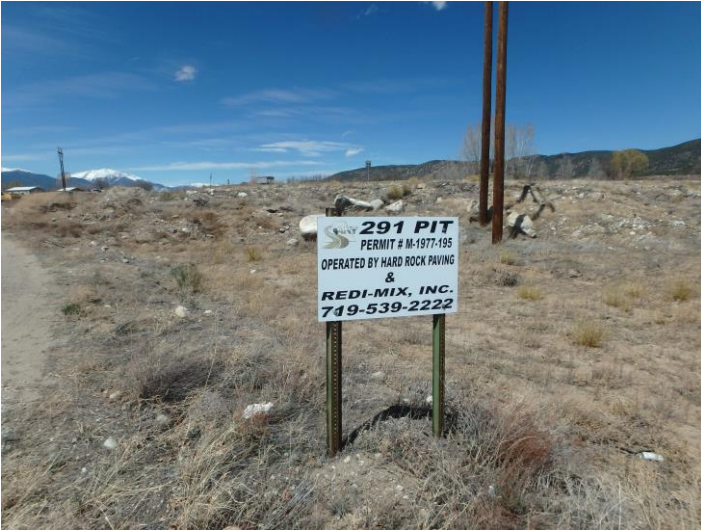
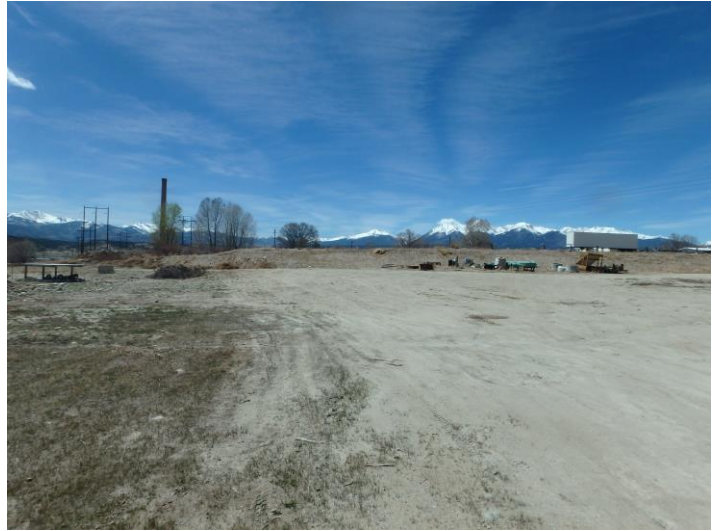
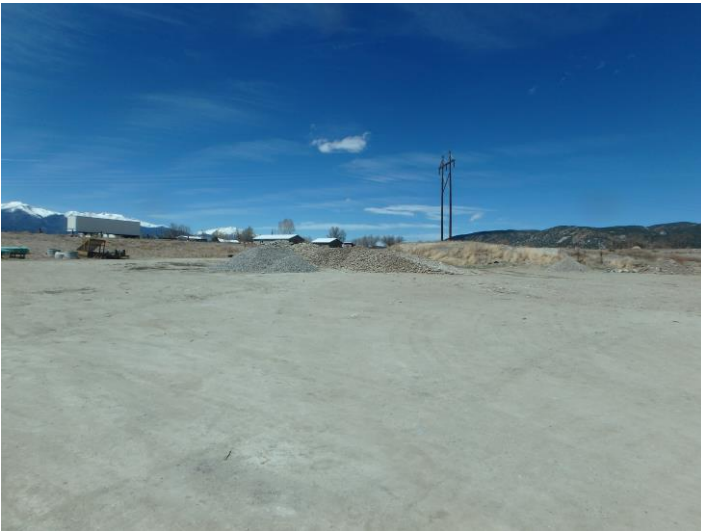
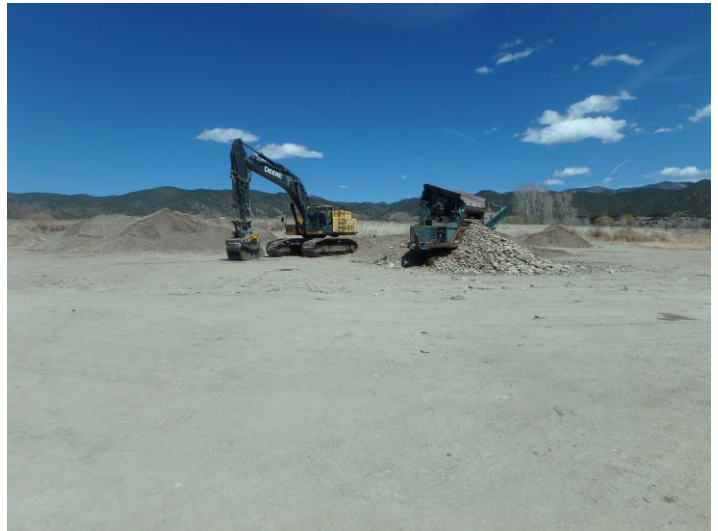
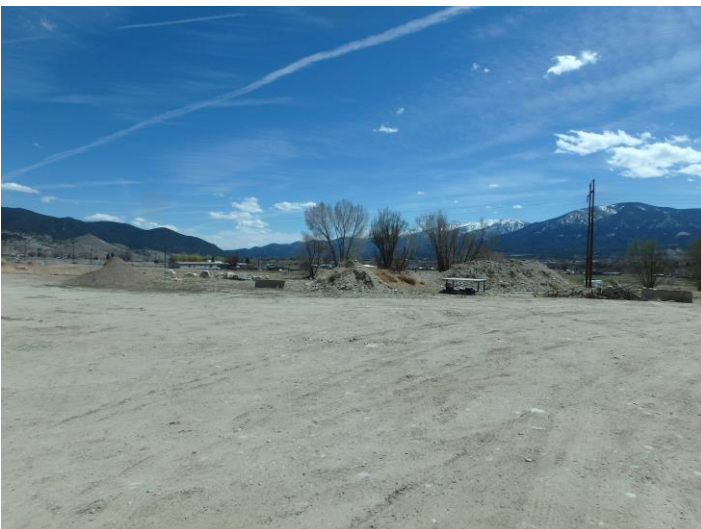
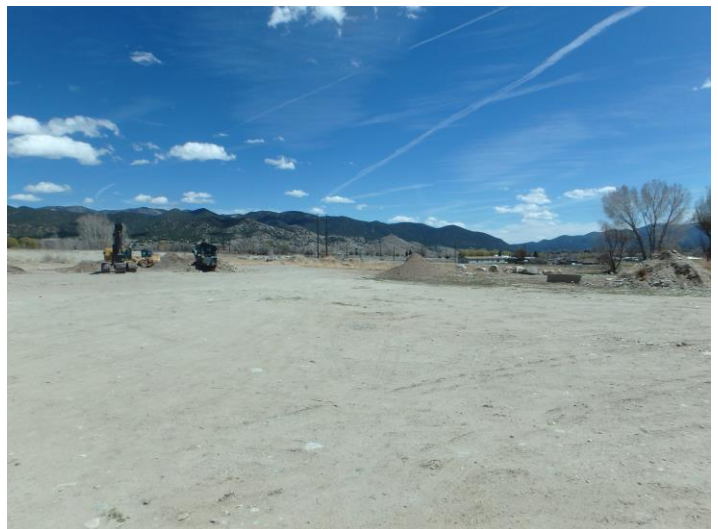
Adequate mine identification signage was noted at the entrance to the site.

The affected area was marked by fencing that was clearly visible and adequate to delineate the affected area boundary.

The final land use for this site was changed in August 2015, through AM-1, to industrial/commercial. The site is mined out and in final reclamation at this time. Final grading is complete and adequate. The slopes are stable and no erosion issues were noted. Vegetation is not yet established on the slopes. The pit floor is graded to a flat gravel surface. No standing water was noted on the pit floor. Several pieces of equipment and small gravel stockpiles were located at the site.
