MINERALS PROGRAM INSPECTION REPORT

MINE NAME: Arnold Gulch	MINE/PROSPECTING ID#: M-1998-091	MINERAL: Sand and gravel	COUNTY: Chaffee
INSPECTION TYPE: Monitoring	INSPECTOR(S): Dustin M. Czaplá	INSP. DATE: April 19, 2017	INSP. TIME: 10:15
OPERATOR: Joseph L and Arlene Cogan DBA B.B.L. CO	OPERATOR REPRESENTATIVE: None	TYPE OF OPERATION: 110c - Construction Limited Impact	
REASON FOR INSPECTION: Normal I&E Program	BOND CALCULATION TYPE: Complete Bond	BOND AMOUNT: \$17,500.00	
DATE OF COMPLAINT: NA	POST INSP. CONTACTS: None	JOINT INSP. AGENCY: None	
WEATHER: Clear	INSPECTOR'S SIGNATURE:

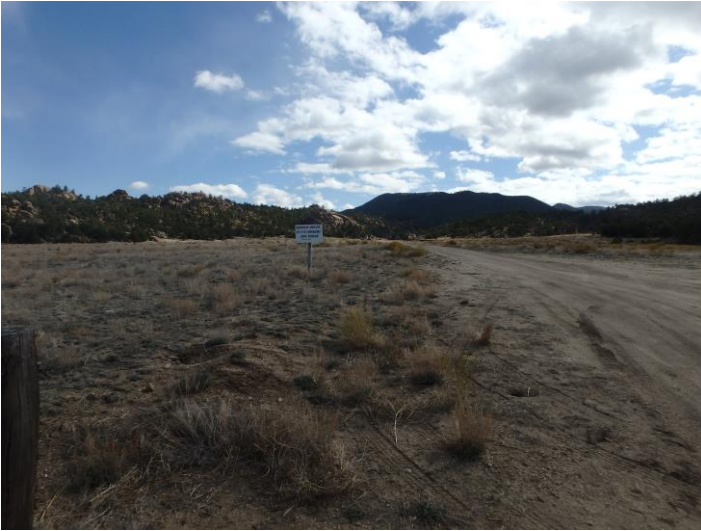
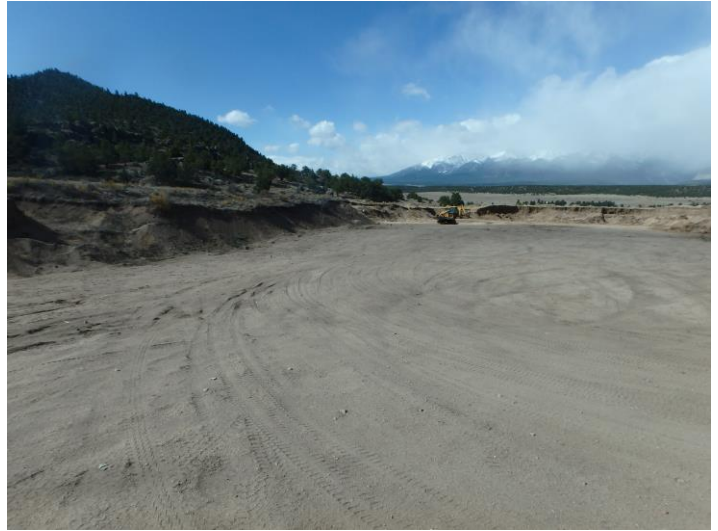
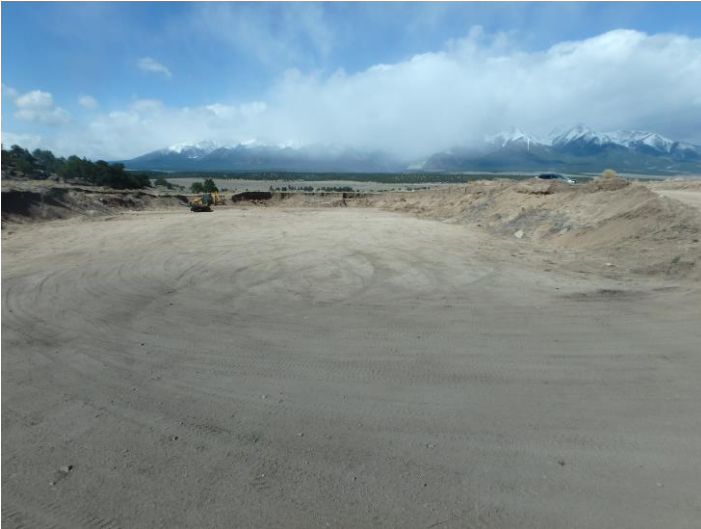
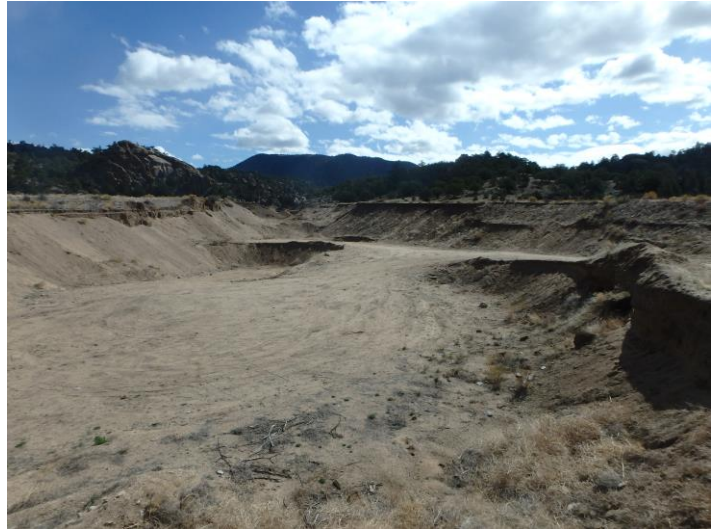
Adequate mine identification signage was noted at the entrance to the site.

The affected area was marked by t-posts that were clearly visible and adequate to delineate the affected area boundary.

The operation is active. A backhoe was parked on site. The depth of the pit is approximately twenty feet, with the excavation advancing toward the southwest. The highwalls have sloughed to approximately 1H:1V. There are no stockpiles stored on site. There is no salvageable topsoil at the site, and therefore no topsoil stockpiles.
