**MINERALS PROGRAM INSPECTION REPORT**  
**PHONE: (303) 866-3567**

<b>MINE NAME:</b> Topsoil Pit	<b>MINE/PROSPECTING ID#:</b> M-2012-027	<b>MINERAL:</b> Overburden	<b>COUNTY:</b> Chaffee
<b>INSPECTION TYPE:</b> Monitoring	<b>INSPECTOR(S):</b> Dustin M. Czaplá	<b>INSP. DATE:</b> April 19, 2017	<b>INSP. TIME:</b> 10:00
<b>OPERATOR:</b> B & L Cogan, L.L.C.	<b>OPERATOR REPRESENTATIVE:</b> None	<b>TYPE OF OPERATION:</b> 112c - Construction Regular Operation	
<b>REASON FOR INSPECTION:</b> Normal I&E Program	<b>BOND CALCULATION TYPE:</b> Complete Bond	<b>BOND AMOUNT:</b> \$9,400.00	
<b>DATE OF COMPLAINT:</b> NA	<b>POST INSP. CONTACTS:</b> None	<b>JOINT INSP. AGENCY:</b> None	
<b>WEATHER:</b> Clear	<b>INSPECTOR'S SIGNATURE:</b>

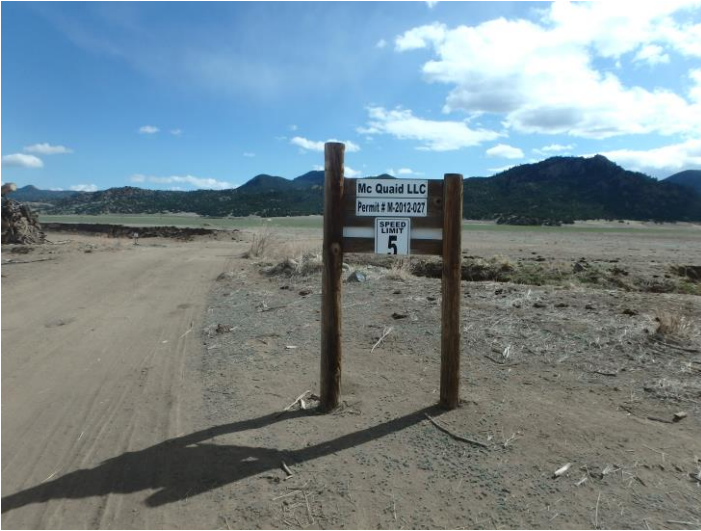
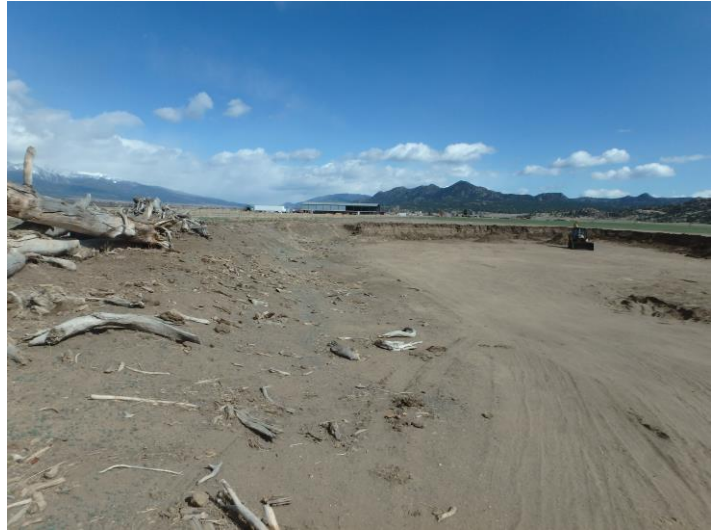
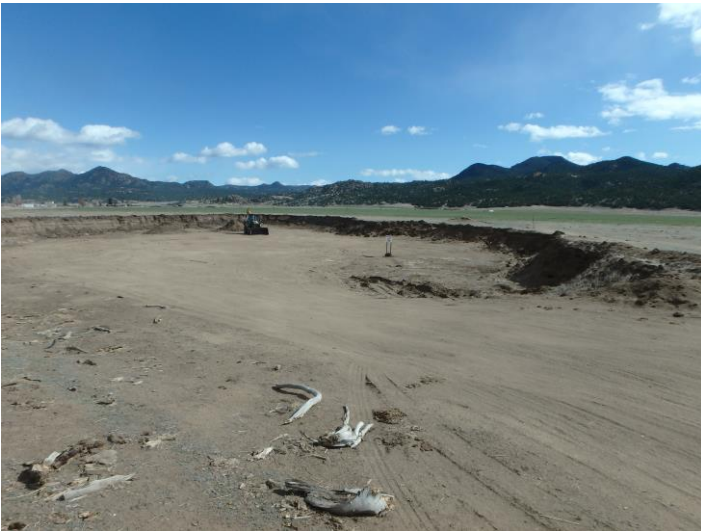
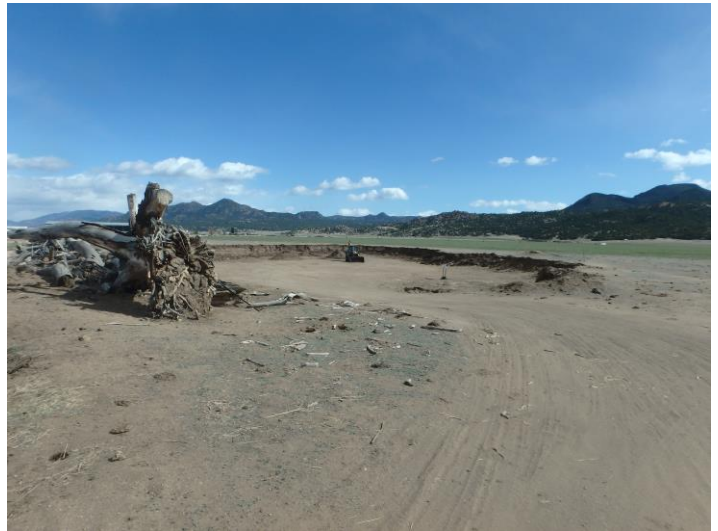
Adequate mine identification signage was noted at the entrance to the site.

The affected area was marked by fencing that was clearly visible and adequate to delineate the affected area boundary.

There is currently less than one acre disturbed at this site. The pit has been excavated to a depth of approximately five feet. Slopes are approximately 2H:1V.
