MINERALS PROGRAM INSPECTION REPORT
PHONE: (303) 866-3567

MINE NAME: Krehmeyer Pit	MINE/PROSPECTING ID#: M-2005-070	MINERAL: Gravel and sand	COUNTY: Phillips
INSPECTION TYPE: Pre-Operation Inspection	INSPECTOR(S): Elliott R. Russell	INSP. DATE: March 28, 2017	INSP. TIME: 11:45
OPERATOR: Ritchey's Redi-Mix Concrete, Inc.	OPERATOR REPRESENTATIVE: Jerry Ritchey	TYPE OF OPERATION: 110c - Construction Limited Impact	
REASON FOR INSPECTION: Pre-Operation Inspection	BOND CALCULATION TYPE: Complete Bond	BOND AMOUNT: \$7,400.00	
DATE OF COMPLAINT: NA	POST INSP. CONTACTS: None	JOINT INSP. AGENCY: None	
WEATHER: Raining	INSPECTOR'S SIGNATURE:

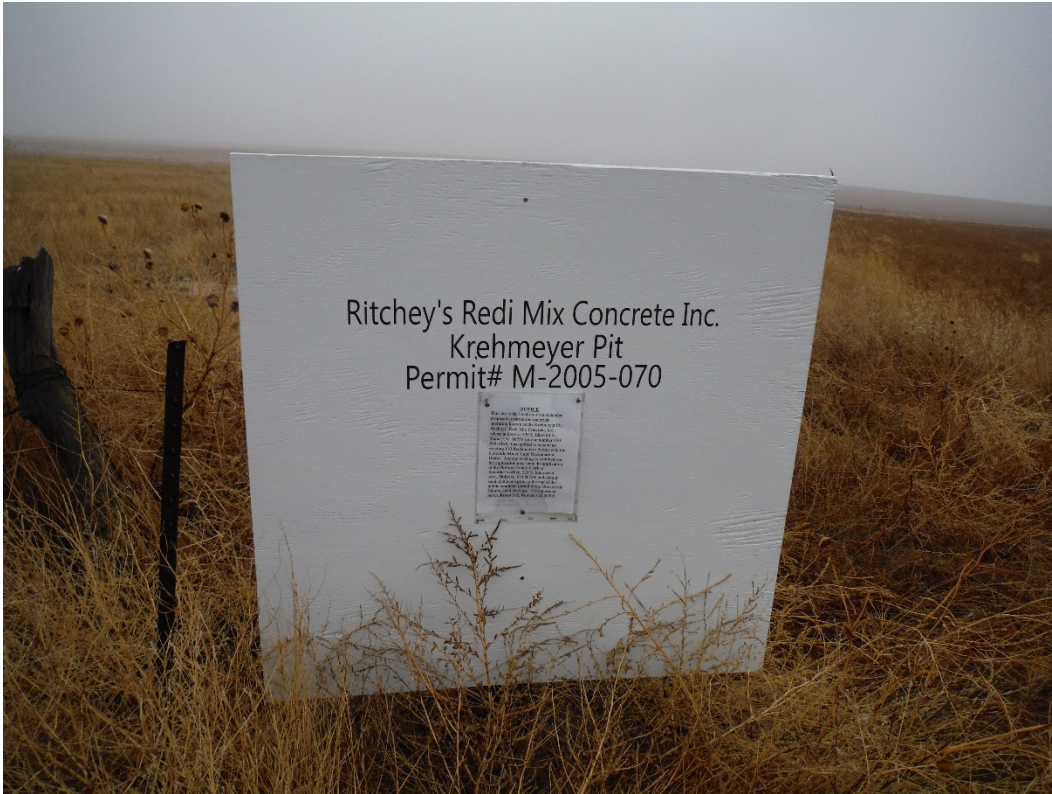
The Division met Mr. Ritchey at the mine site on the north side of County Road 15, approximately 1.5 miles east of County Road 7. The mine site identification sign and the required CN-02 site notice were posted at the entrance to the site (**Photo 1**). The site was not active at the time of the inspection and the only piece of equipment on the site was a harrow implement used for reclamation.

Photo 1. Mine identification sign and required site notice; looking north.

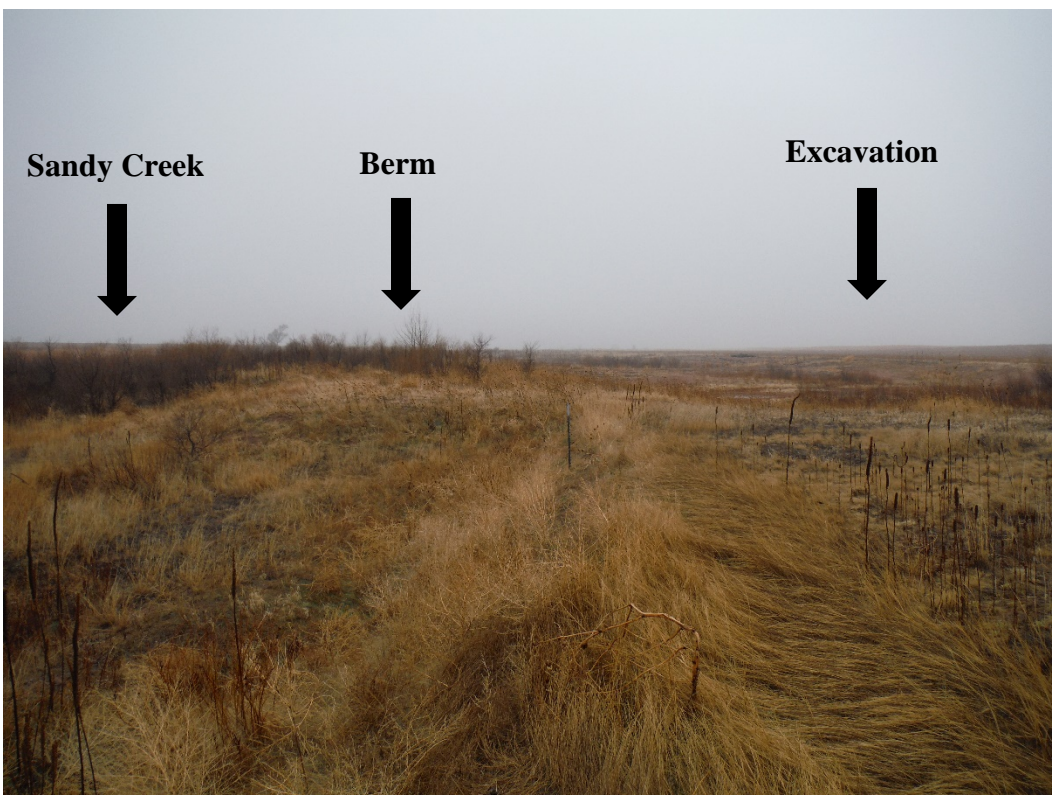
During the inspection, the Division discussed its concerns with Mr. Ritchey regarding the current configuration of the site. The excavation created which starts in Sandy Creek, an ephemeral channel, goes north of the creek and may cause flooding damage as flows do not have a way to return to the creek channel. Mr. Ritchey stated that portion the berm (**Photos 2 and 3**) located between the excavation and the creek channel could be removed to allow potential storm water flows to continue down Sandy Creek. The Operator's consultant will submit new maps which show the removal of the downstream section of the berm.

Photo 2. Berm located between creek channel (left) and excavation (right); looking southwest.

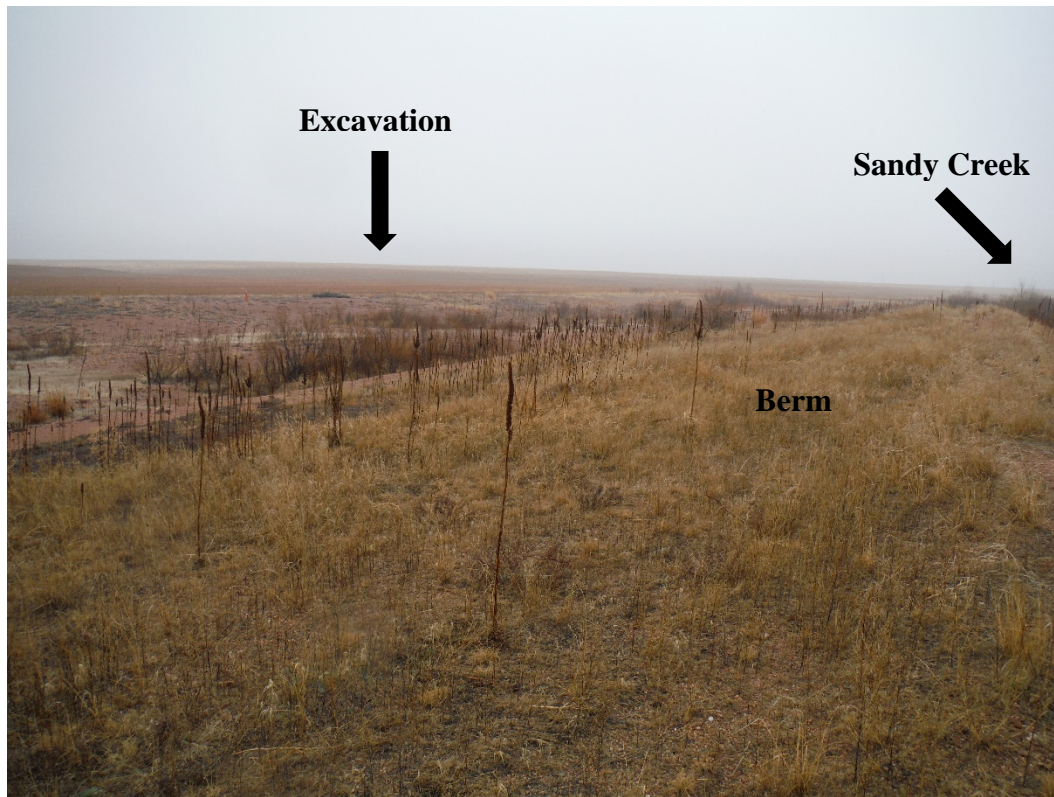
Photo 3. Berm located between excavation (left) and creek channel (right); looking northeast.
