**COLORADO**  
Division of Reclamation,  
Mining and Safety  
Department of Natural Resources

<b>Permit Number:</b> C-1981-012 <b>Mine Name:</b> New Elk Mine <b>Operator:</b> New Elk Coal Company, LLC <b>Operator Address:</b> Mr. Louis Head 12250 Highway 12 Weston, CO 81091	<b>County:</b> Las Animas <b>Operation Type:</b> Underground <b>Permit Status:</b> Active <b>Ownership:</b> Private
	<b>Operator Representative Present:</b>  Vince Massarotti
<b>Operator Representative Signature: (Field Issuance Only)</b>

<b>Inspection Start Date:</b> April 27, 2017 <b>Inspection Start Time:</b> 08:00 <b>Inspection End Date:</b> <b>Inspection End Time:</b>		<b>Inspection Type:</b> Coal Partial Inspection <b>Inspection Reason:</b> Normal I&E Program <b>Weather:</b> Clear	
<b>Joint Inspection Agency:</b>  None		<b>Joint Inspection Contacts:</b>  	
<b>Post Inspection Agency:</b>  None		<b>Post Inspection Contacts:</b>  	
<b>Inspector(s):</b>  Robert D. Zuber, P.E.	<b>Inspector's Signature:</b>

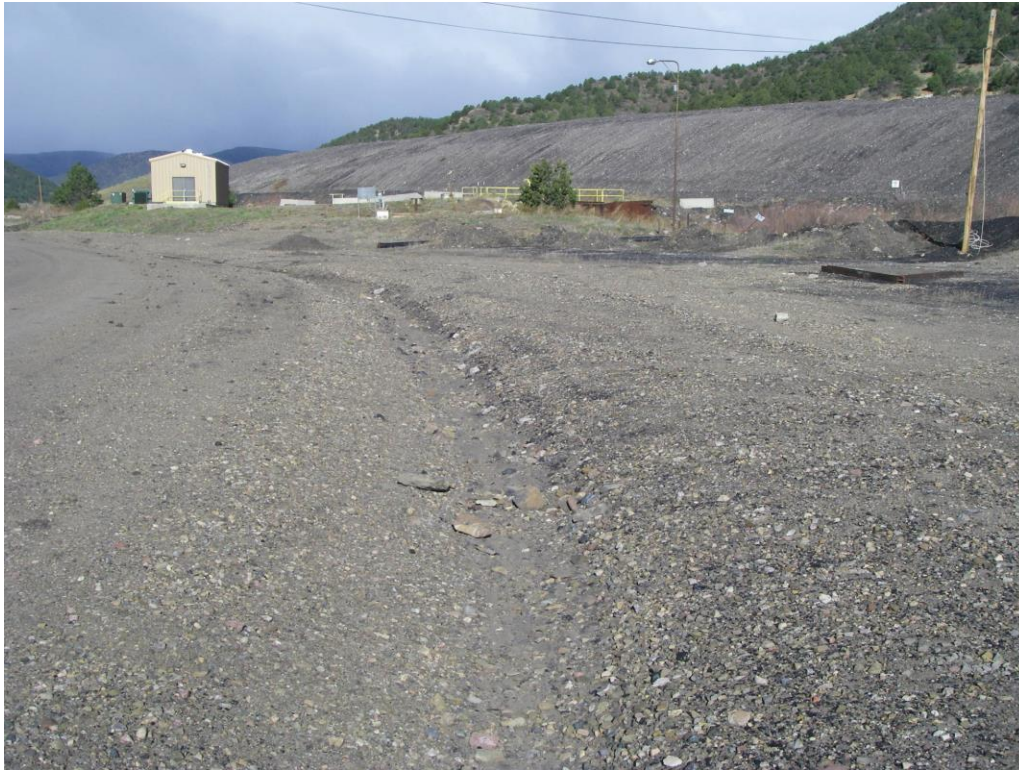
**Ditch D 22**

- D15 - 1.2 feet deep and 6.2 feet wide
- D22 - 1.8 feet deep and 8.9 feet wide
- D32 – 2.0 feet deep and 8.0 feet wide.

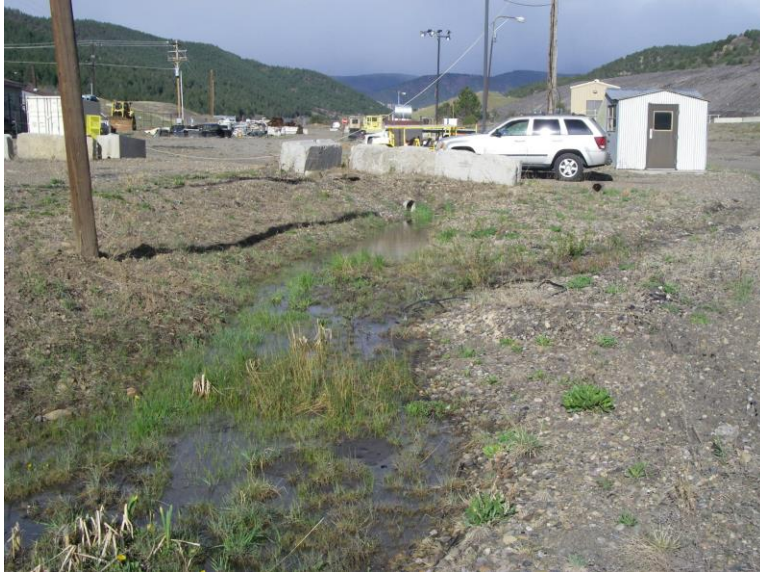
**Flow from Industrial Building Sump**

Flow was seen in Culvert C16C. Per Vince Massarotti, this was due to discharge from the sump from the industrial building, and this discharge point is shown on Map 13.

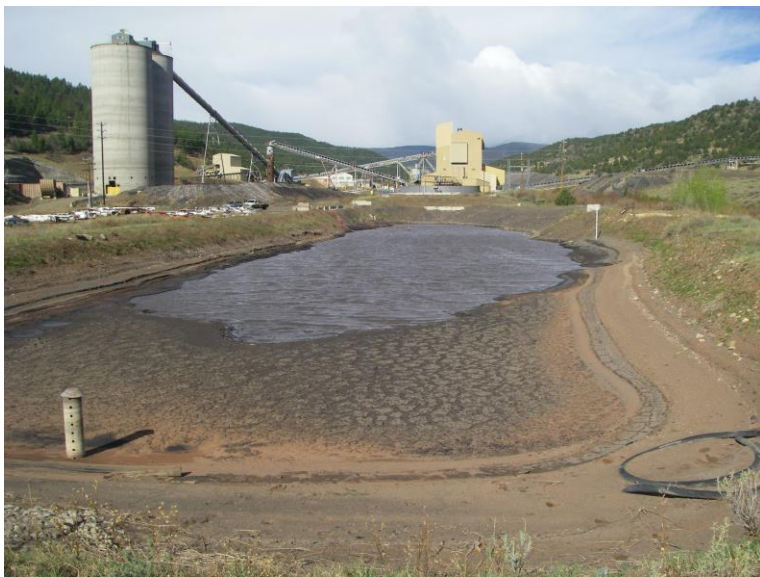
**Pond 007A**

Ponds 001A, 006A, 007A, and 08 were holding significant amounts of water due to recent precipitation, but this water was well below the spillways, and none of the ponds were discharging. No flow into Pond 006A from the prep plant was seen, but a pipe system is in place for this pond to receive water from Pond 08, and a pump is in place for filling water trucks. At Pond 001A, the liner looked good where it was visible. Pond 004A was mostly empty. No problems were seen with the pond spillways or embankments.

The berm and silt fence by the SAE by Pond 007A appeared to be functioning well. (It appears that the depiction of the SAE on Map 13 may be wider (north/south direction) than in reality; NECC should address this as part of updating this map to reflect the on-the-ground conditions.) No problems were identified with the SAE at the water tanks; sediment control BMPs are functioning well. The berm along the SAE by Topsoil Stockpile #2 has no low spots or other problems. No problems were seen with the SAE nearest to the Allen Mine portal and the SAE at the slurry injection area.

The ramp into Pond 007A (used for pond cleaning) has seen minor vegetation growth. If necessary, this area should be reseeded.

The material from cleaning Pond 007A remains on the clean coal storage area. This should be moved to the RDA as soon as it is dry enough.

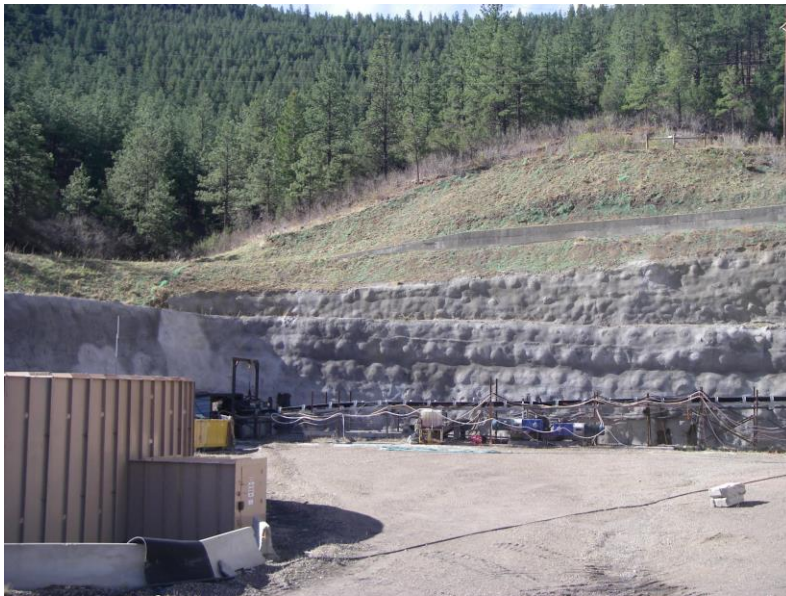
No significant issues were seen with the facility areas, including the tall cut bank above the portal area. The Division recommends the removal of trash (likely historical) in the West Portal area, especially near Containment Areas 1 and 2.

**Slope cut near East Portal**

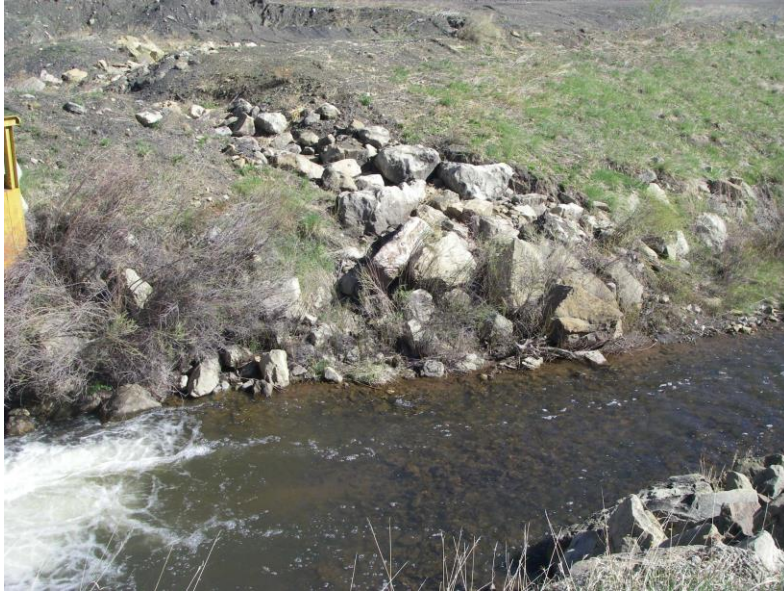
The lower portion of Ditch D11 appears to be stable. Due to the very large rock in this channel (boulder size rather than typical riprap size), it should be closely monitored to determine if any erosion is present.

**Low end of Ditch D11, at discharge to river**

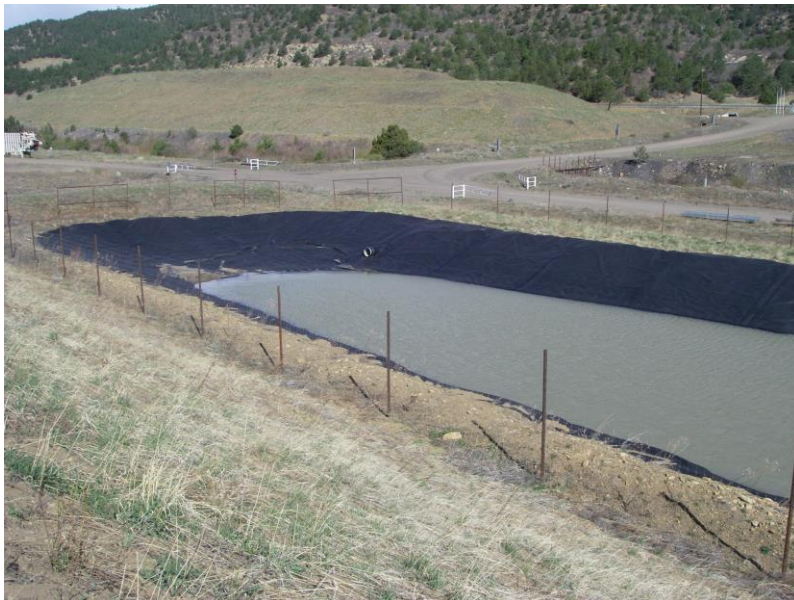
**Pond 001A (west end) and Development Coal Waste Pile (east end)**

The following observations were made related to DWDA#2. The wind was blowing fairly hard, but no material was being transported by wind off of the pile. The sump at the east end is not overly large.

No problems were seen with the Development Coal Waste Pile.

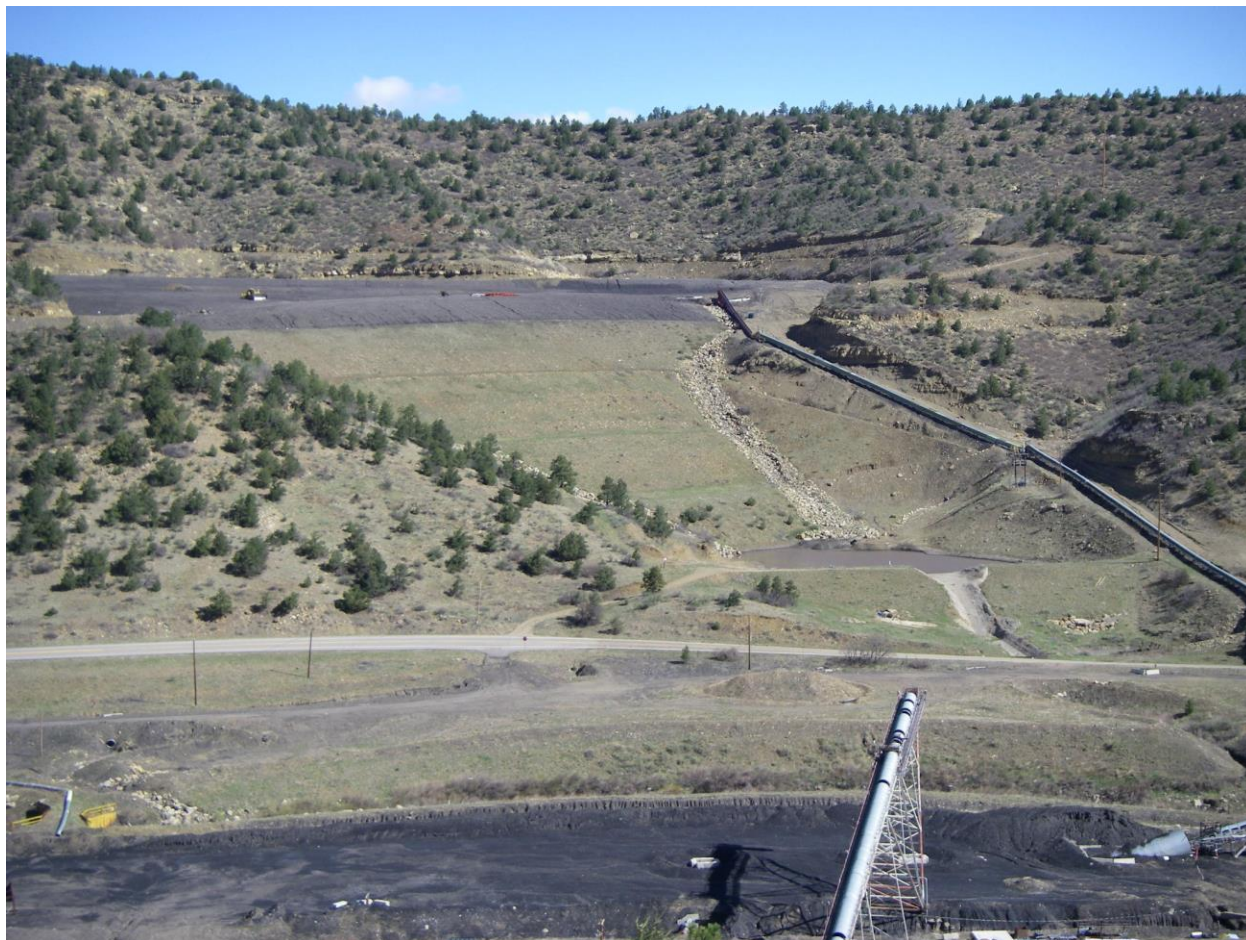
**RDA and Pond 08**

The RDA was observed from afar (from the water tanks). No problems were seen with the interface between the upper (un-reclaimed) portion of the RDA and the lower (reclaimed) portion. No erosion was seen on the face of the reclaimed portion of the RDA. The eastern ditch looked to be functioning well (the western ditch was not observed).

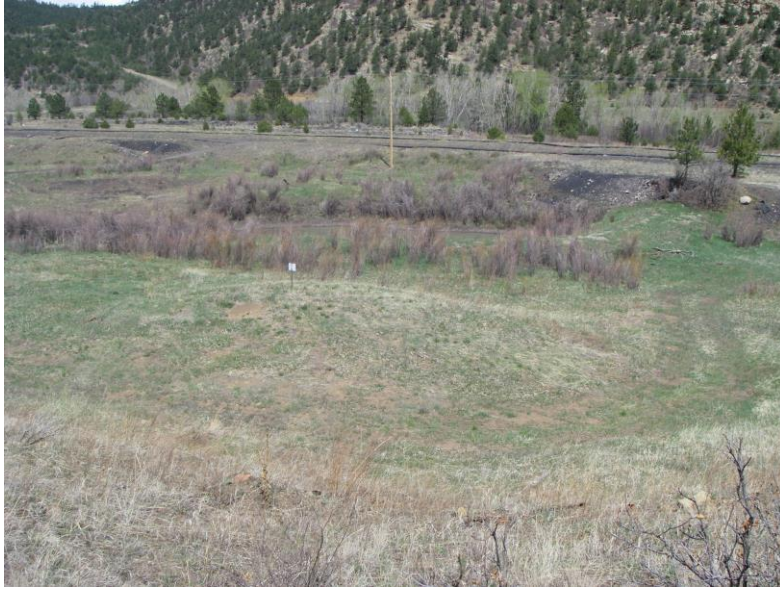
**Containment Area 1 and topsoil stockpile**

Containment Areas 2, 3, and 4 were holding no water. Water was in Containment Area 1. There were no signs of problems with these facilities.

Topsoil Stockpile #2 is mostly bare, with some vegetation emerging from 2016 seeding. The ring ditch and silt fence at this pile are in good shape. The vegetation is excellent on the topsoil stockpile next to Containment Area 1. Improvement of berms and ring ditches is needed at the soil storage area (west of Pond 001A).

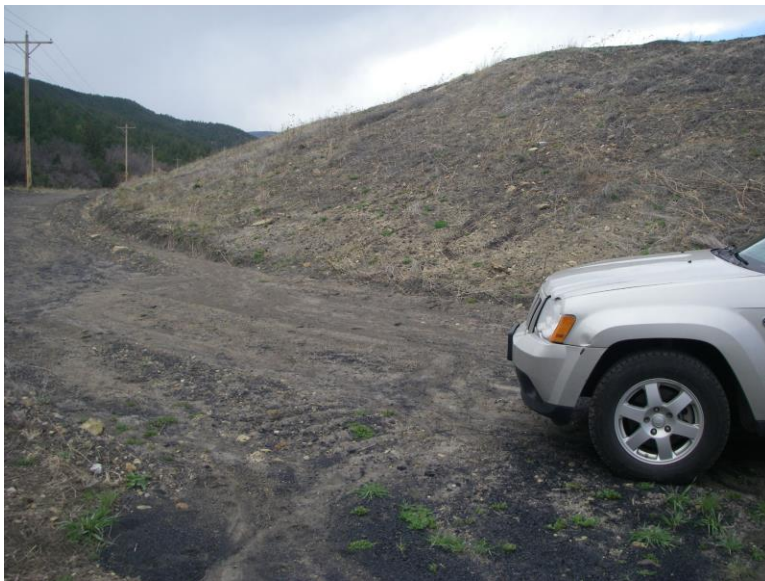
**Soil storage area in need of maintenance**
