COLORADO Division of Reclamation, Mining and Safety Department of Natural Resources

MINERALS PROGRAM INSPECTION REPORT PHONE: (303) 866-3567

| MINE NAME: | | MINE/PROSPECTING ID#: | MINERAL: | COUNTY: | | |
|---|---|---|---|---|--|--|
| NCCI Pit #1 | | M-2001-107 | Sand and gravel | Weld | | |
| Monitoring | | Peter S. Hays | March 22, 2017 | 11:00 | | |

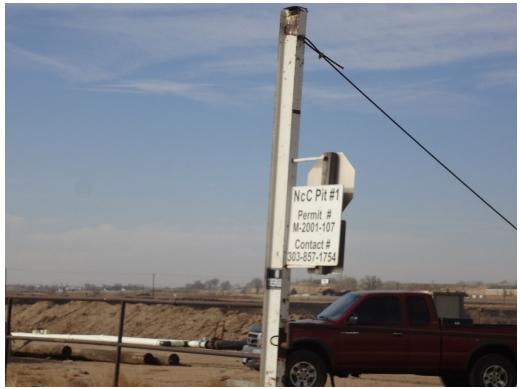
A mine sign and boundary markers were observed as required by Rule 3.1.12. The status of the site was well represented in the 2017 Annual Report. No problems were noted during the inspection. Photographs taken during the inspection are attached. A copy of the current Mine Plan Map is attached for reference.

NCCI Pit #1 mine sign

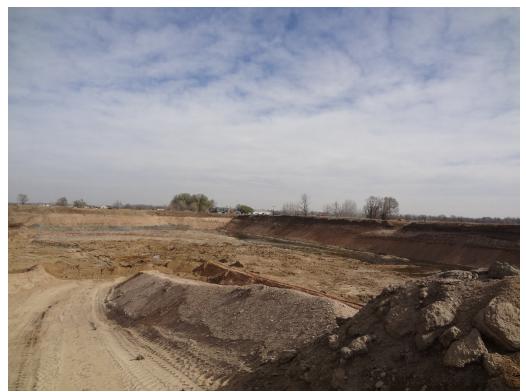
View of Phases 12 and 7 from processing plant area looking northeast

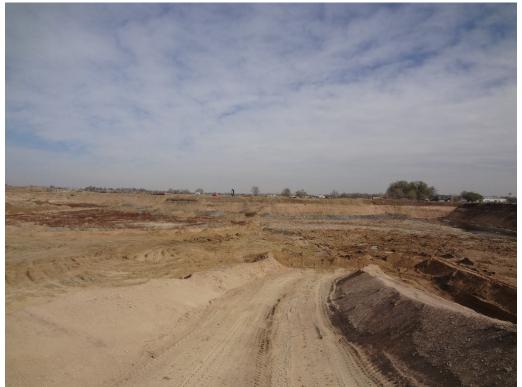
View of Phases 12, 7 and 6 from processing plant area looking north

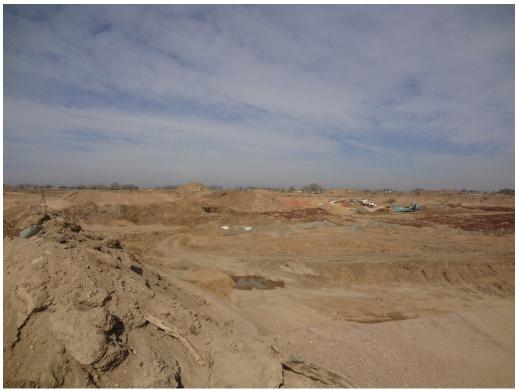
View of Phase 6 from processing plant area looking northwest

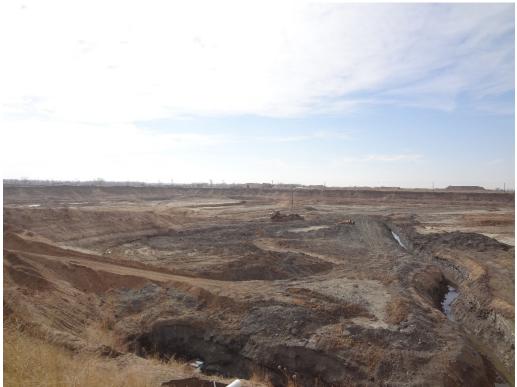
View of Phases 3, 4 and 5 from the NW corner of Phase 3 looking southeast

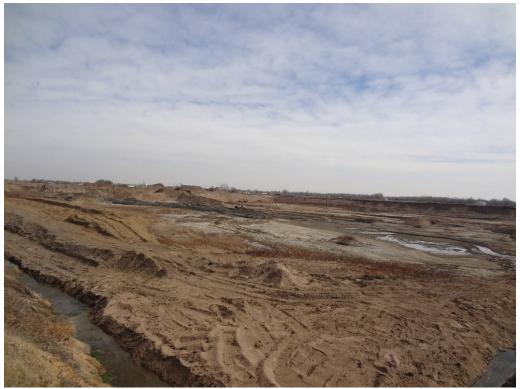
View of Phases 3, 4, 5 and 13 from the SW corner of Phase 3 looking northeast

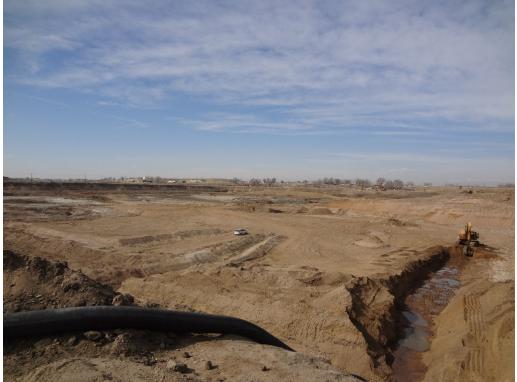
View of Phases 13, 11 and 5 from the NE corner of Phase 13 looking southwest

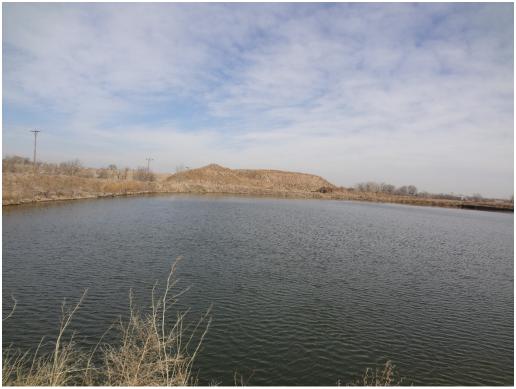
The amendment mining area was filled with groundwater. The northern portion of the area is mined out. The southern portion of the area is 90% mined with the southwest and eastern portions of the area remaining to be mined. The gas line separating the amendment mining areas has been removed and the gas line berm will be mined in the future. Overburden and topsoil stockpiles were observed in the northwest and southeast corners of the amendment area.

View of northern portion of amendment area looking north from gas line berm

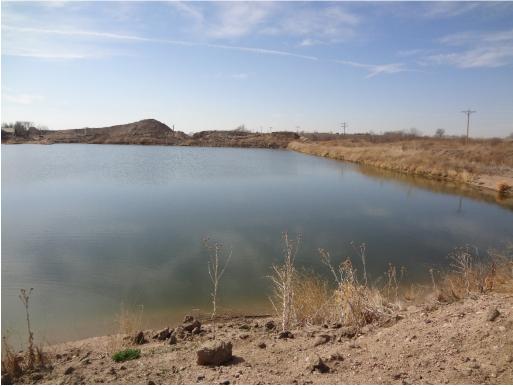
View of southern portion of amendment area looking south from gas line berm

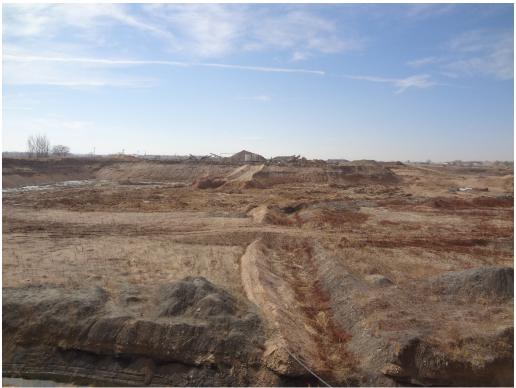
View of Phase 6, 1 and 12 from the northern KPK oil well pad looking south
