PERMIT INFORMATION

Permit Number: C-1981-035 Mine Name: King Coal Mine Operator: GCC Energy, LLC Operator Address: Mr. Tom Bird 6473 County Road 120 Hesperus, CO 81326	County: La Plata Operation Type: Underground Permit Status: Active Ownership: Federal
	Operator Representative Present: Tom Bird
Operator Representative Signature: (Field Issuance Only)

INSPECTION INFORMATION

Inspection Start Date: April 26, 2017 Inspection Start Time: 08:30 Inspection End Date: Inspection End Time:		Inspection Type: Coal Partial Inspection Inspection Reason: Normal I&E Program Weather: Clear	
Joint Inspection Agency: None		Joint Inspection Contacts:	
Post Inspection Agency: None		Post Inspection Contacts:	
Inspector(s): Robert D. Zuber, P.E.	Inspector's Signature: <i>Robert D. Zuber</i>		Signature Date: 5/2/2017

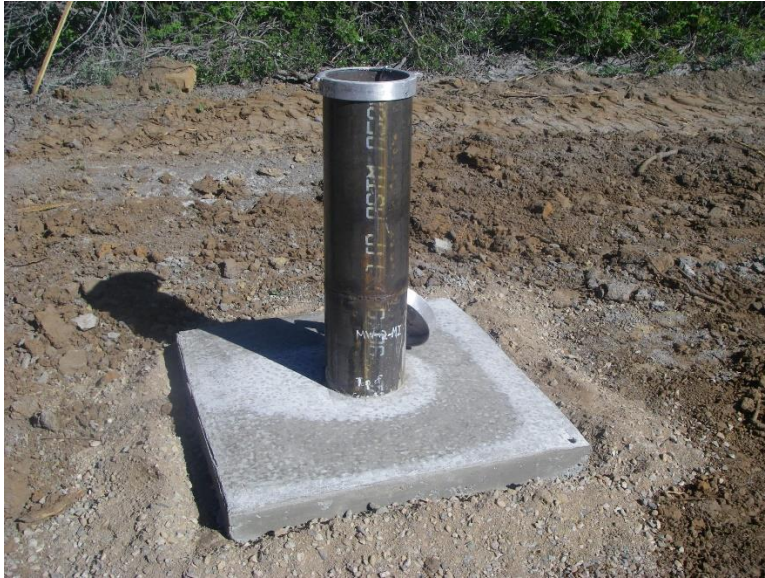
Well MW-2-MI

The surface conditions of the three recently completed well clusters (MW-2, MW-3, and MW-4) were inspected. All three sites included three wells (for the three formations) with steel casings, lids and locks on the casings, and 3' x 3' x 4" concrete pads that abut the casings. Well names were placed on the lids and the casings, in general, but the casings at MW-4 looked like they had been painted, and the paint obscured the well names. One of the pads at MW-4 had been damaged and should be repaired. The bore hole at MW-2-C (and possibly in the other Cliff House holes) was not completed, per the GCC plan if water was not encountered.

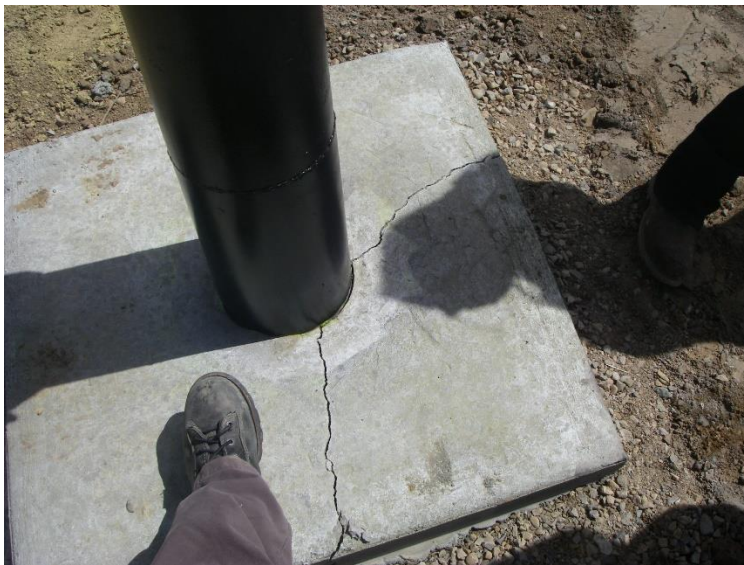
Cracked base at MW-4

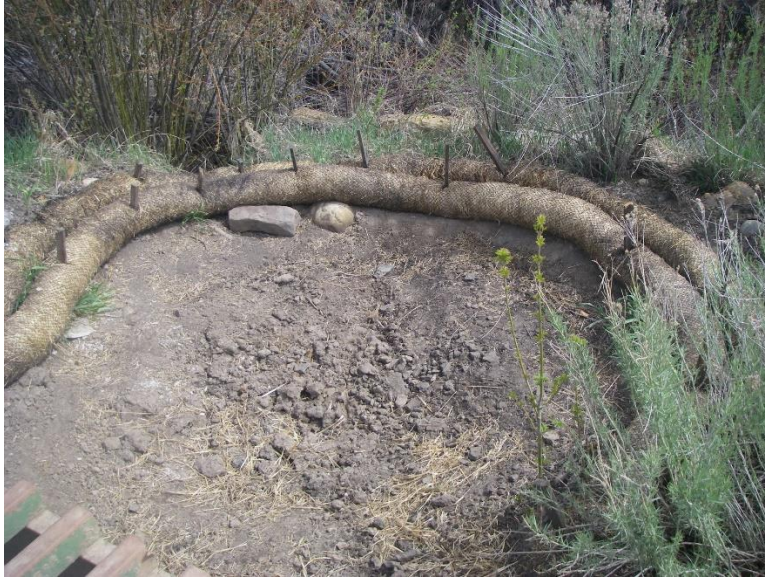
Near the entrance to King II, the surface water controls have been maintained. Sumps and the grated ditch across the road have been cleaned. The wattles look good.

Wattles near King II entrance

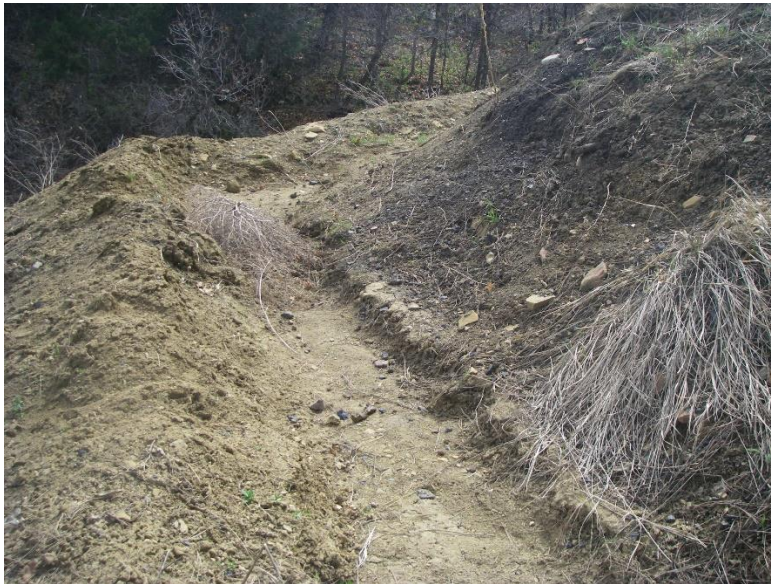
Ditch at plant growth medium storage area near Refuse Pile
Recently cleaned but needs more maintenance

At King I, Plant Growth Medium Storage Areas required additional work to protect the resource. At the storage area east of the Refuse Pile, the ditch should be extended around the southwest corner. At the storage area near the old tipple bench, a sump should be added at the low point at the southeast corner. During the inspection, Tom Bird ordered the work near the tipple bench to be done that day.

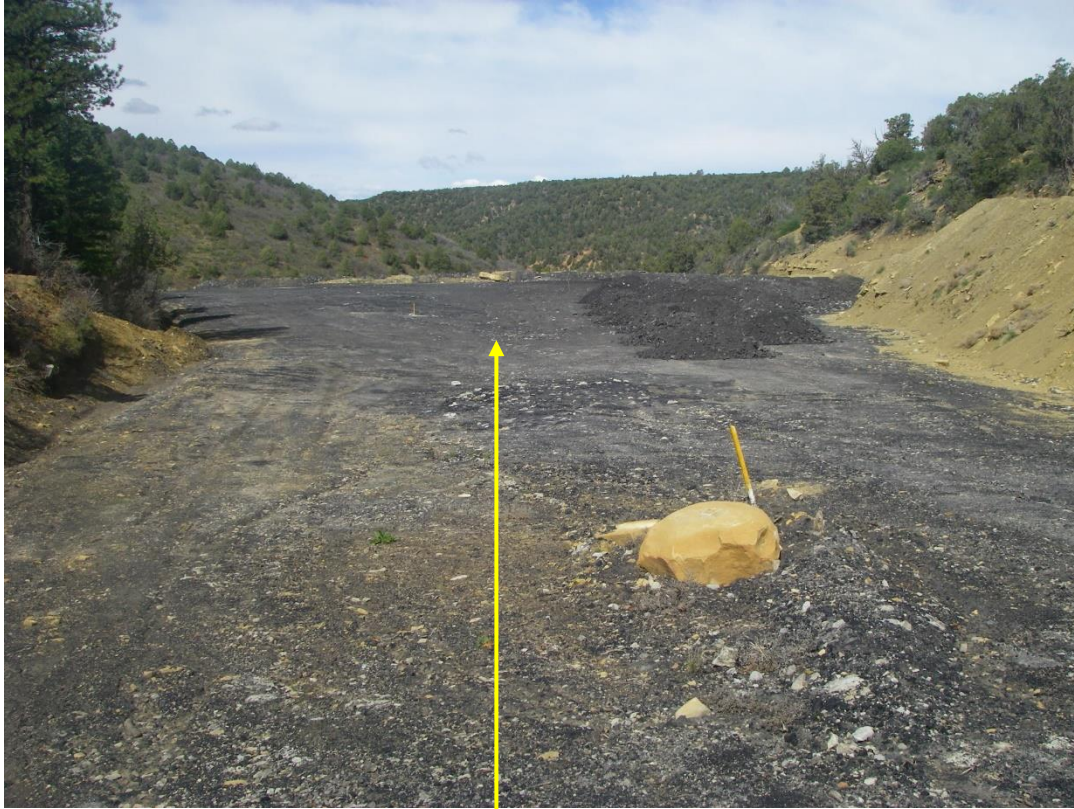
Refuse Pile – needs to be graded

Note low area in middle of pile surface

The un-reclaimed portion of the Refuse Pile (upper portion) requires grading to spread the piles of waste and insure a two percent slope from north to south across the pile. No flow was seen from the underdrain of the refuse pile, nor were there signs of recent flows.
