**U.S. DEPARTMENT OF INTERIOR
BUREAU OF LAND MANAGEMENT
ROYAL GORGE FIELD OFFICE
3600 INSPECTION REPORT**

MINE NAME:	Canyon Rim Sandstone
OPERATOR:	Everett and Florence Jackson
MAIN COMMODITY:	Specialty Stone (Sandstone)
TYPE OF OPERATION:	110c
COUNTY:	Las Animas
LOCATION:	Northwest of Kim, CO
INSPECTOR(S)/ OP. REP PRESENT:	Kelsey Zabrusky & William Jenkins, BLM
INSPECTION DATE:	01/11/2017
DATE OF COMPLAINT, if applicable:	N/A

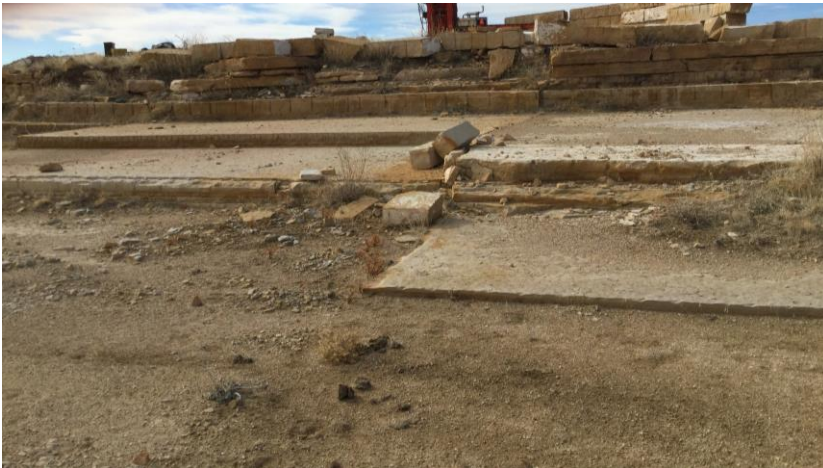
Bench the new material was cut from

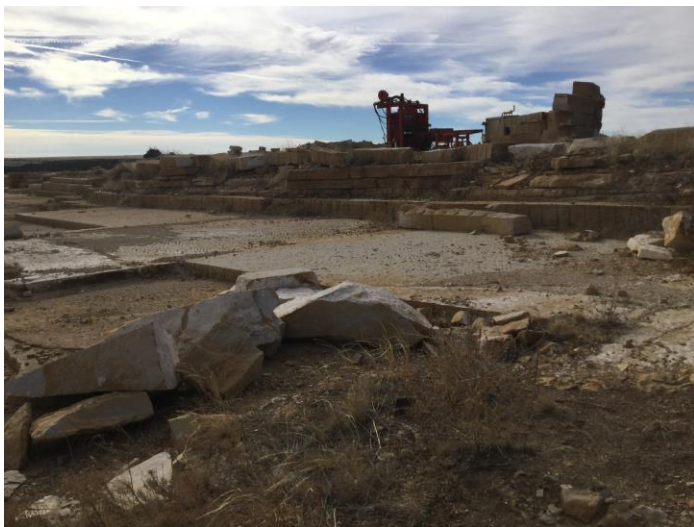
Working floor with splitter in background

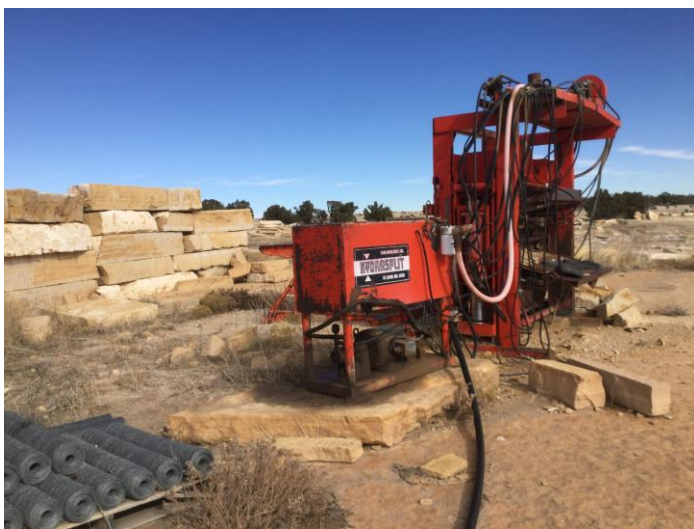
was tidy

The splitter seemed to be in good order and the work area

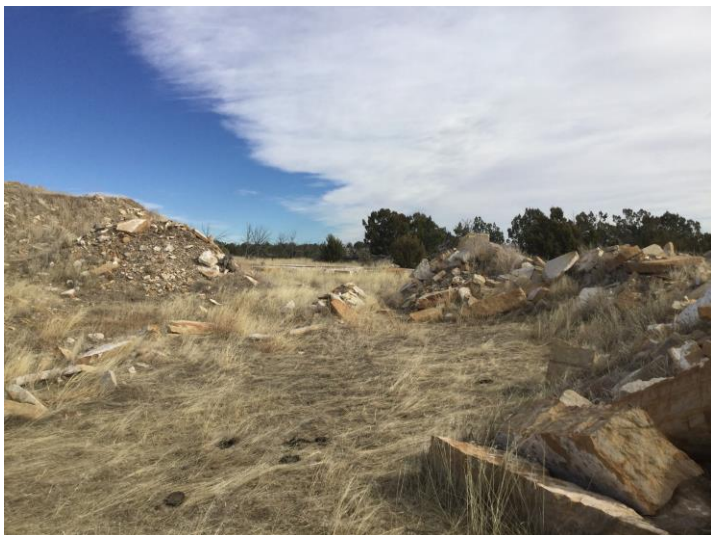
Vegetated and armored topsoil stockpiles

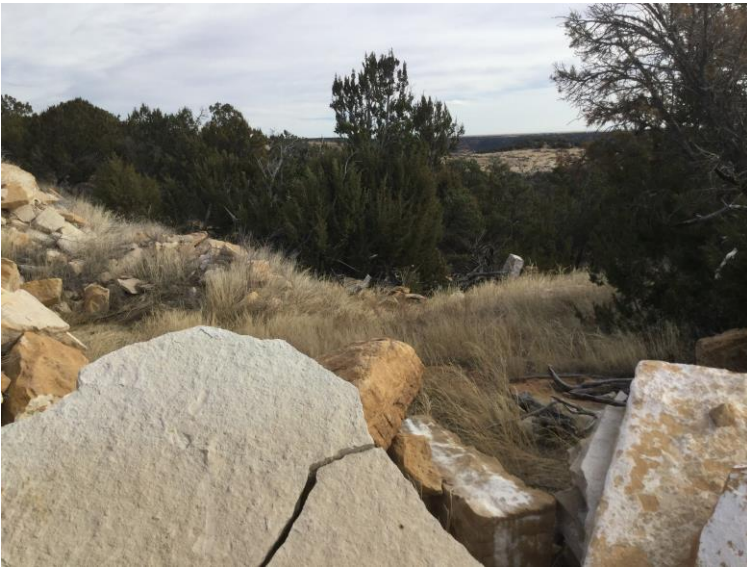
be any drainage leaving the site.

The lowest point of the site. There does not appear to

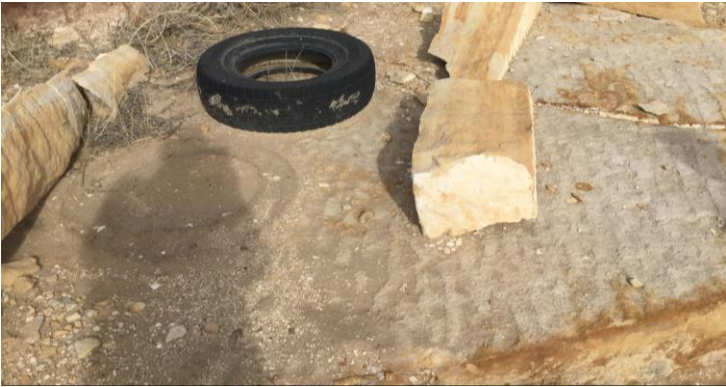
prevent the material from breaking during transport.

Recycled tires are used instead of wooden pallets to

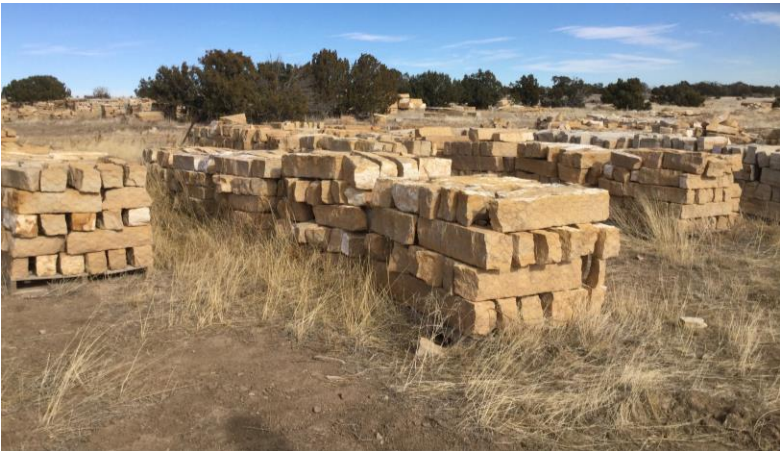
Material stockpiled on pallets

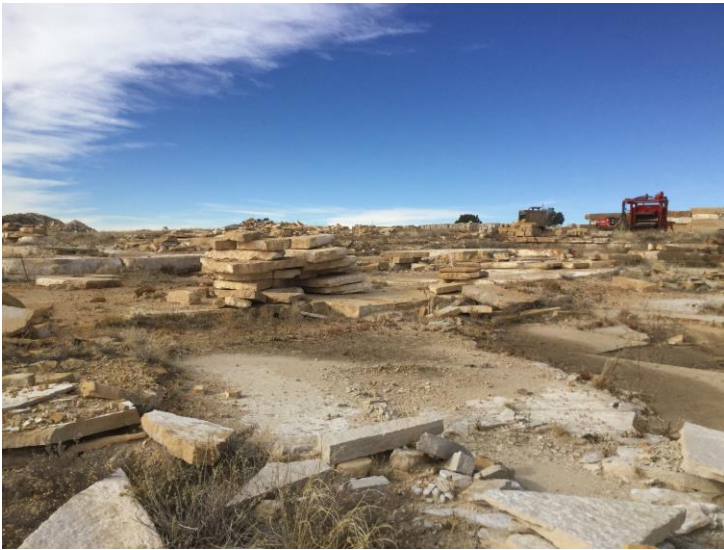
Example of the slabs quarried at the site
