MINERALS PROGRAM INSPECTION REPORT
PHONE: (303) 866-3567

MINE NAME: Perdue	MINE/PROSPECTING ID#: M-2000-089	MINERAL: Sandstone (silica, stone, quartzite)	COUNTY: Boulder
INSPECTION TYPE: Monitoring	INSPECTOR(S): Amy Eschberger	INSP. DATE: April 6, 2017	INSP. TIME: 09:50
OPERATOR: Mary Vasquez	OPERATOR REPRESENTATIVE: Armando Vasquez	TYPE OF OPERATION: 110c - Construction Limited Impact

M-2000-089 and M-2012-046 / Perdue / Mary Vasquez

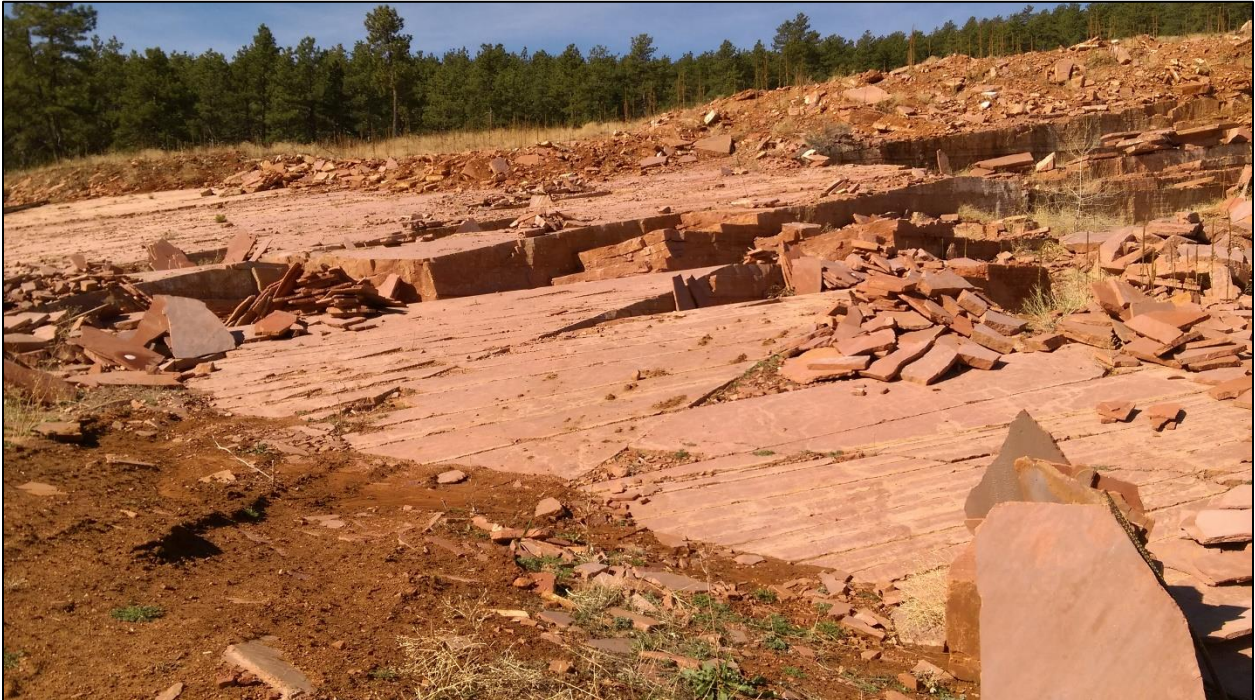
The Division observed that the majority of the site has been disturbed by mining activities. Disturbance includes a few sandstone working faces near ground level in the southern portion of the site (**Photos 1-3**), a haul road that loops through the site, several stacks of mined stone stored along the haul road (**Photos 4 and 5**), a somewhat flat storage area in the eastern portion of the site (**Photo 6**), and a few areas that are in reclamation. The large overburden stockpile that had been stored in the northwestern portion of the site was used for backfilling disturbed areas in 2015. The stockpile area was then graded to 3H:1V and retopsoiled, and now has native grasses growing across the area (**Photo 7**). Disturbed land near the center of the site was backfilled, graded to 3H:1V, and retopsoiled. This area has some rock outcropping across the surface, but blends in well with surrounding topography (**Photo 8**). Native grasses, shrubs, and pine trees are volunteering across the entire permit area. The Division did observe some common mullein growing in the permit area, which is a state-listed noxious weed species. The operator will need to implement the approved weed control plan as soon as possible to eliminate this species from the affected land.

Photo 1. View of sandstone working face located in southeastern portion of permit area.

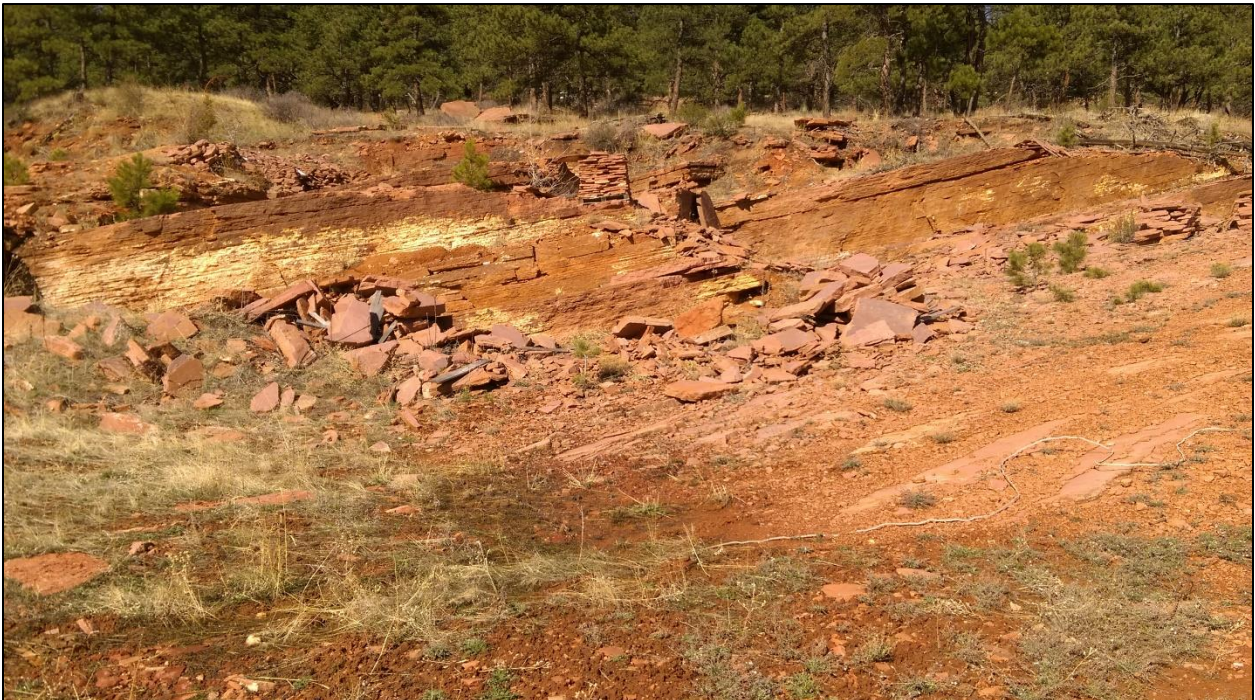
Photo 2. View of sandstone working face located in southwestern portion of permit area.

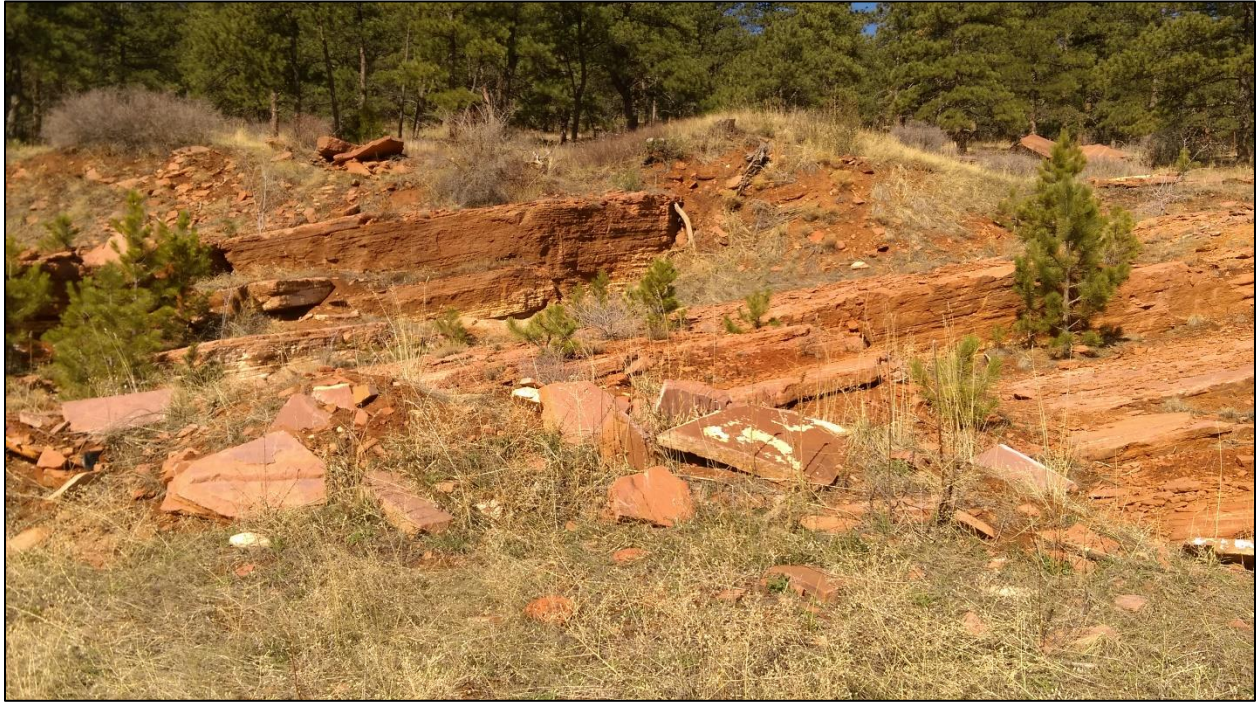
Photo 3. View of sandstone working face located in southwestern portion of permit area.

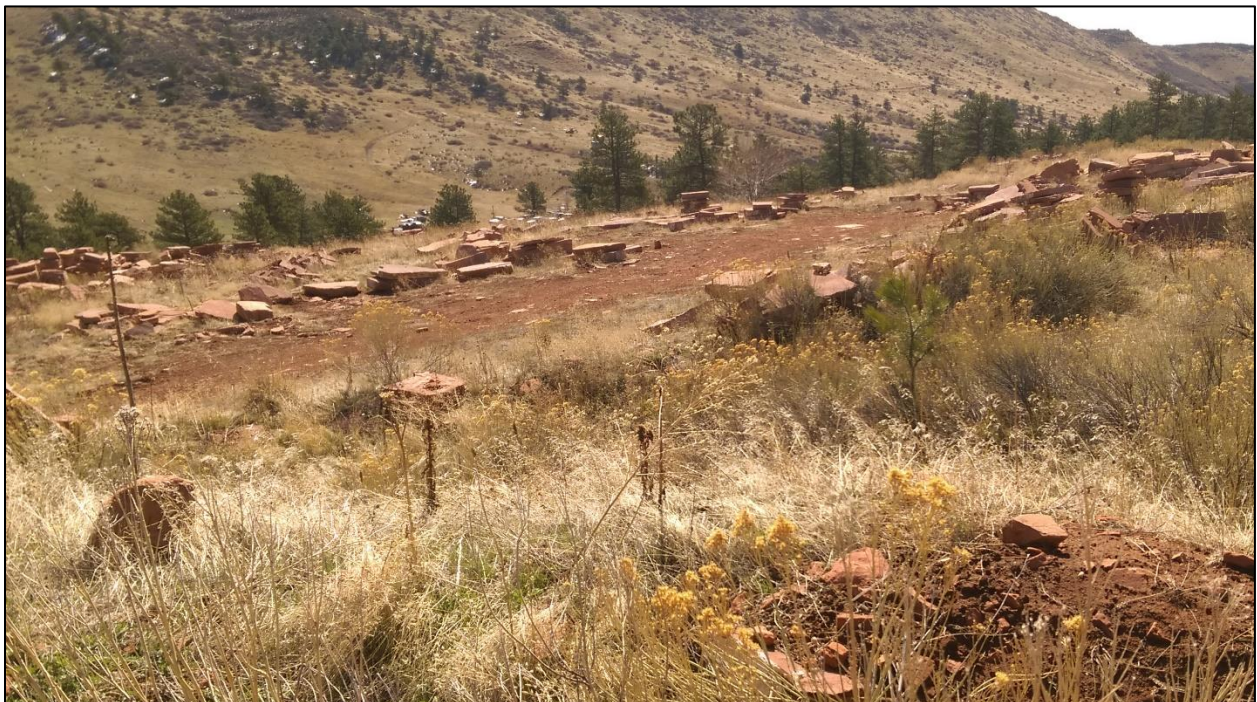
Photo 4. View looking east from northern portion of site, showing stacks of stone stored along internal haul road.

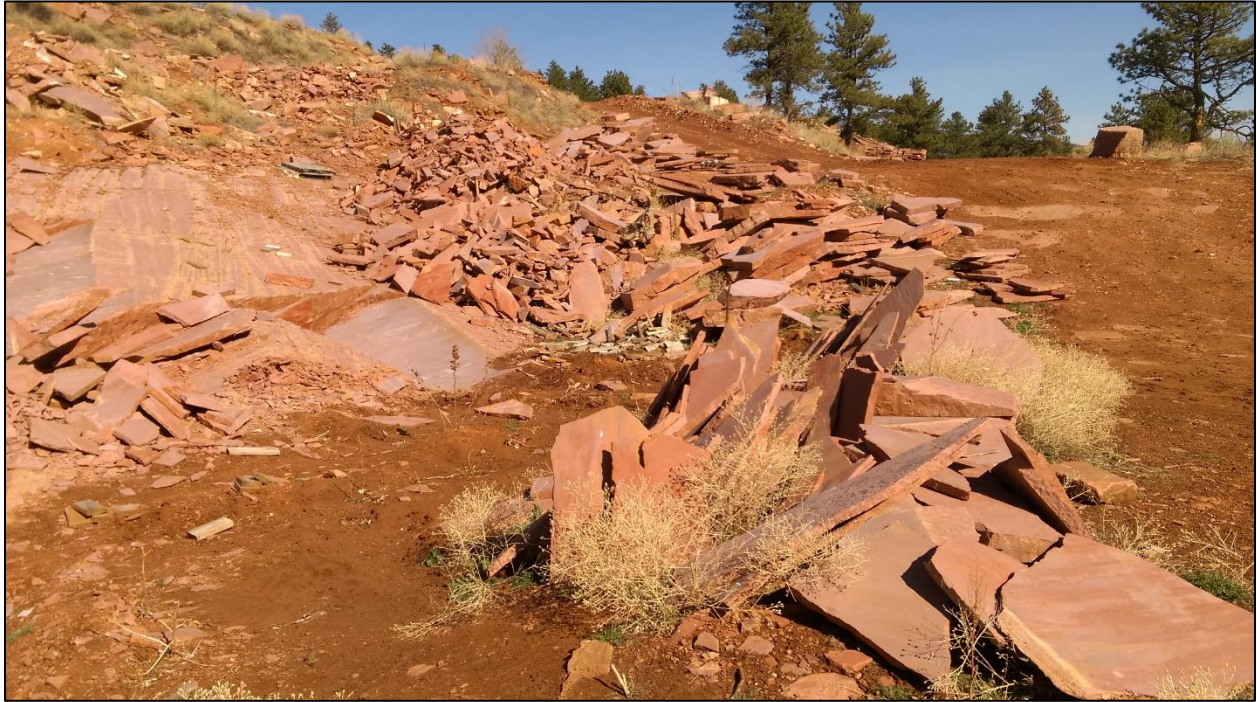
Photo 5. View of excavated stone stacked along haul road in northeastern portion of site.

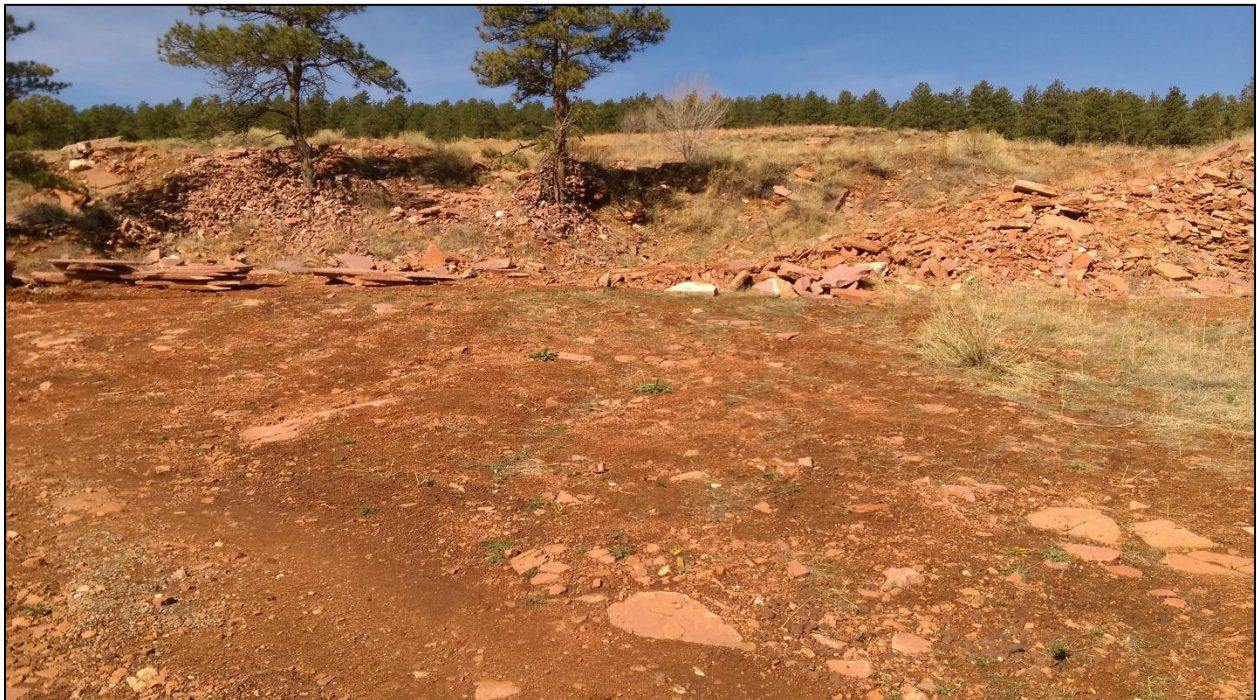
Photo 6. View looking west across relatively flat storage area located in eastern portion of site.

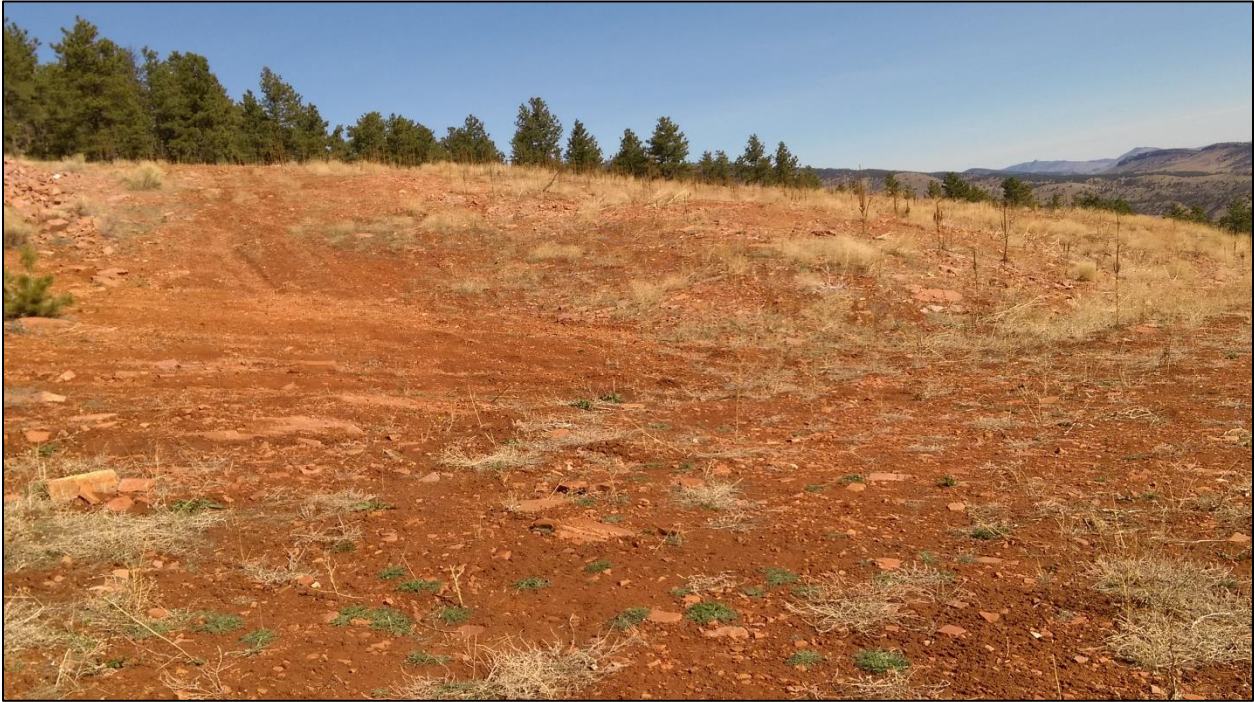
Photo 7. View looking northwest at area where large overburden stockpile was used for reclamation, and the area graded to slopes of 3H:1V or flatter.

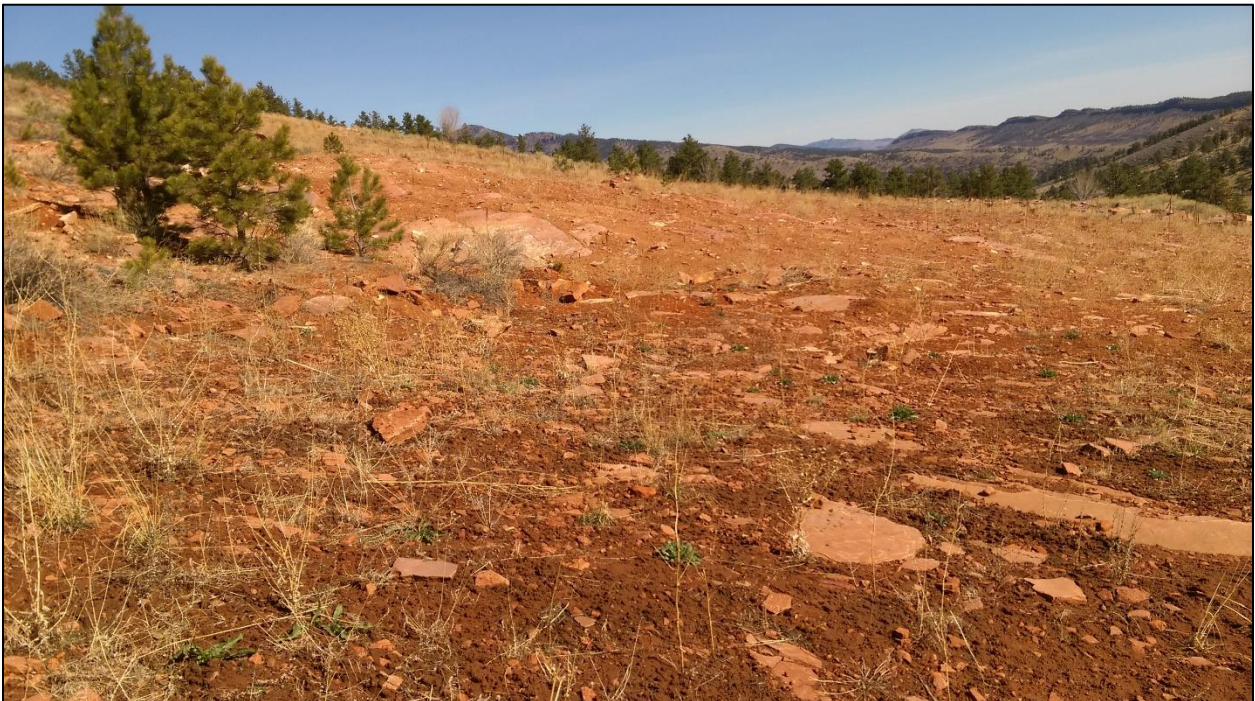
Photo 8. View looking north across central portion of site that was backfilled and graded to slopes of 3H:1V or flatter.
