**COLORADO**Division of Reclamation,
Mining and Safety

MINERALS PROGRAM INSPECTION REPORT**PHONE: (303) 866-3567**

MINE NAME: Duckworth Pit	MINE/PROSPECTING ID#: M-2003-091	MINERAL: Sand and gravel	COUNTY: Weld
INSPECTION TYPE: Preoperation Inspection	INSPECTOR(S): Peter S. Hays	INSP. DATE: April 13, 2017	INSP. TIME: 13:30
OPERATOR: Martin Marietta Materials, Inc.	OPERATOR REPRESENTATIVE: Julie Mikulas	TYPE OF OPERATION: 112c - Construction Regular Operation

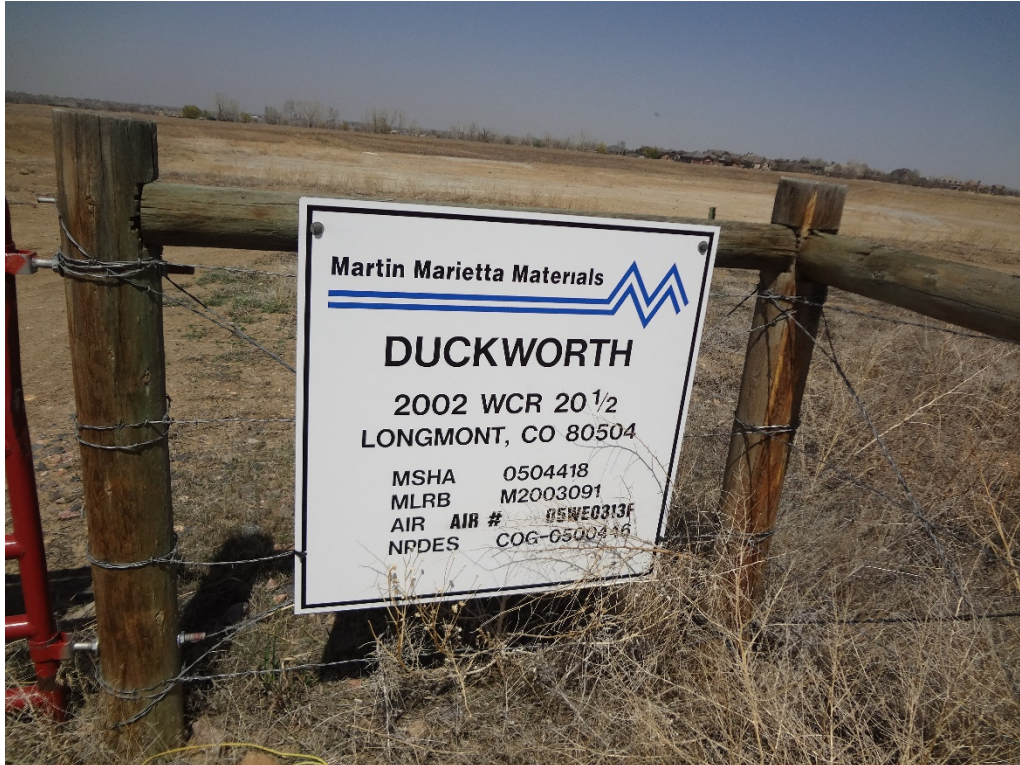
Duckworth Pit sign

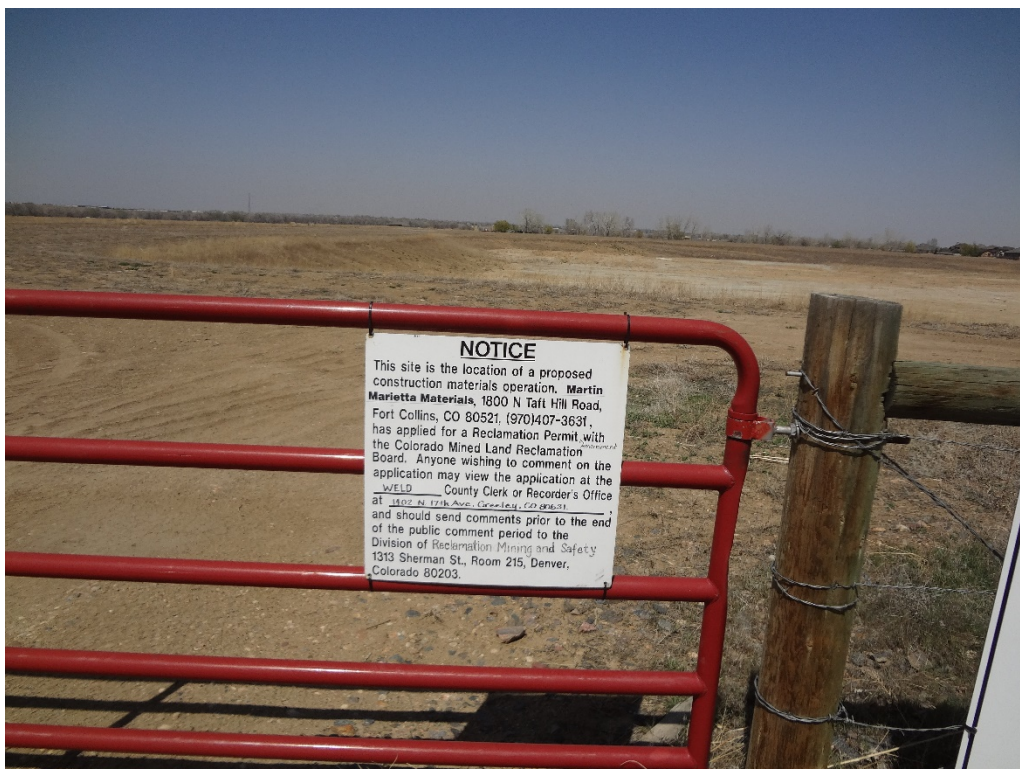
Duckworth Pit amendment notice sign

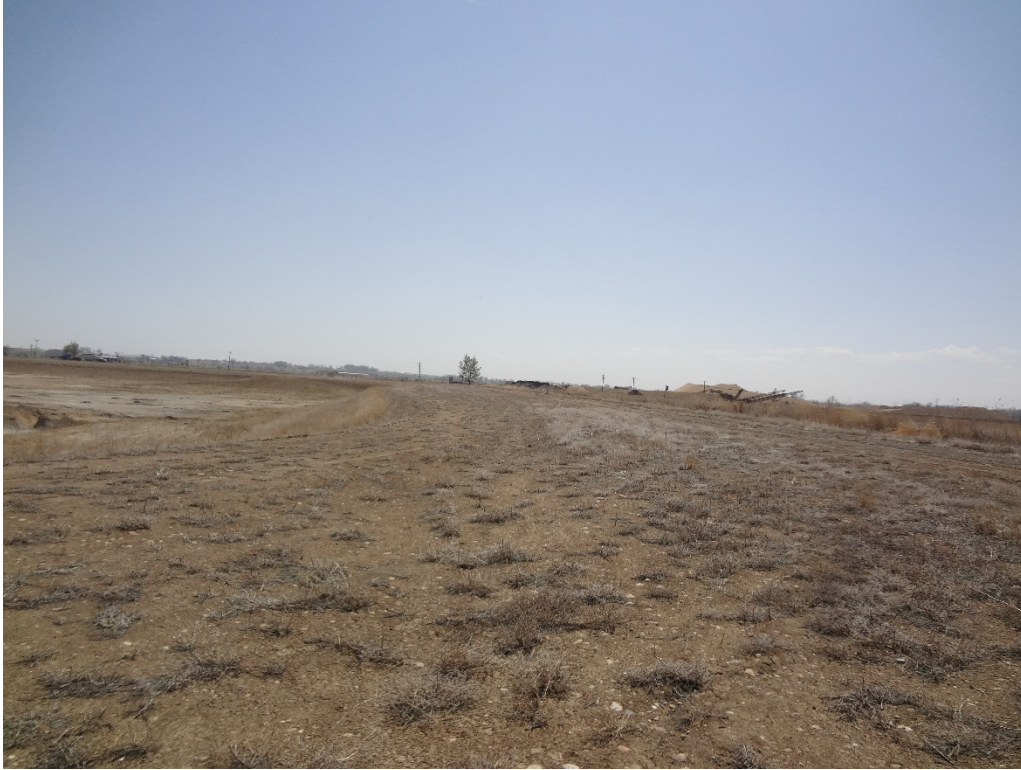
View of vegetation from NW corner of west pit looking south

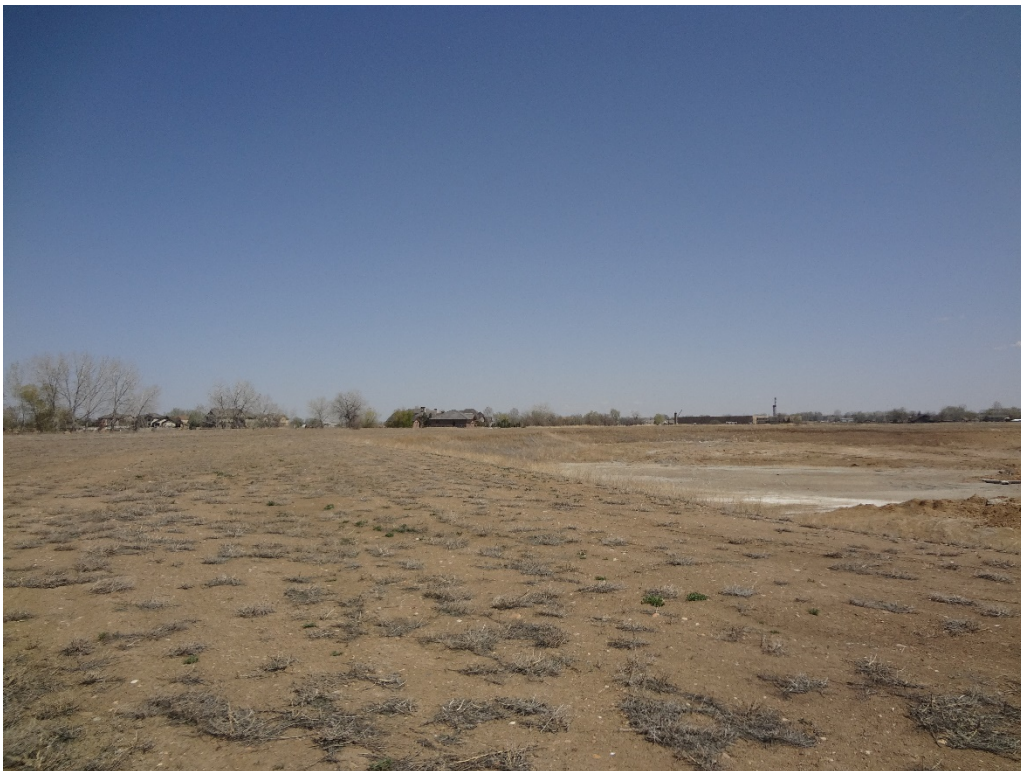
View of vegetation from NW corner of west pit looking east

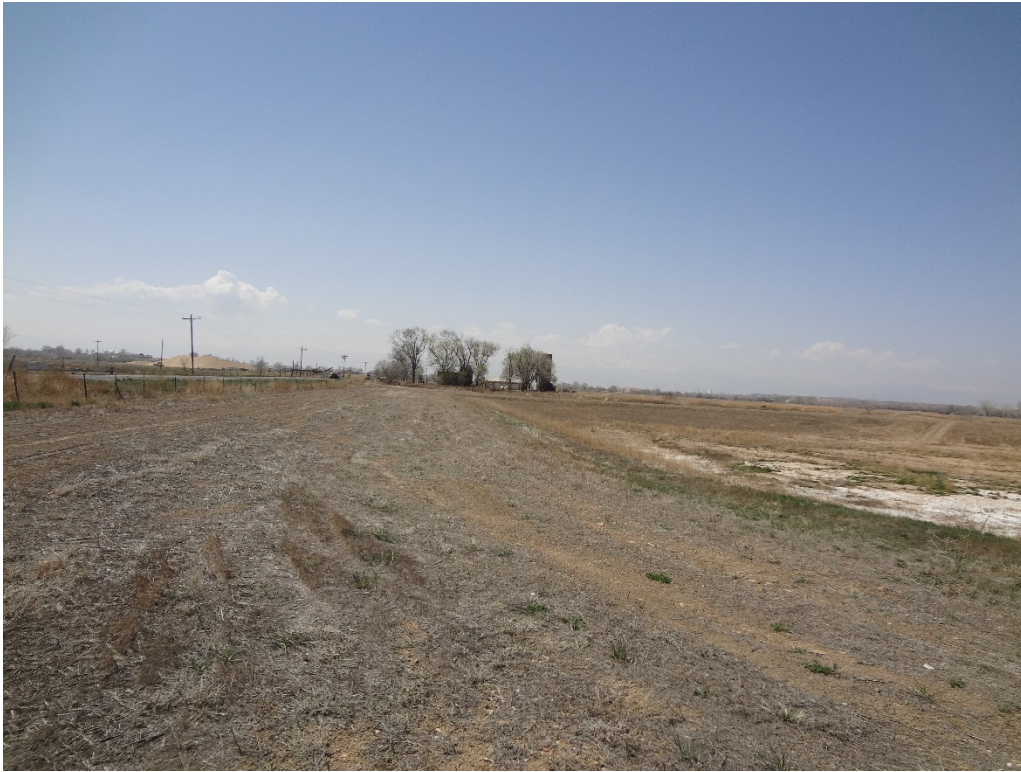
View of vegetation from SE corner of east pit looking west

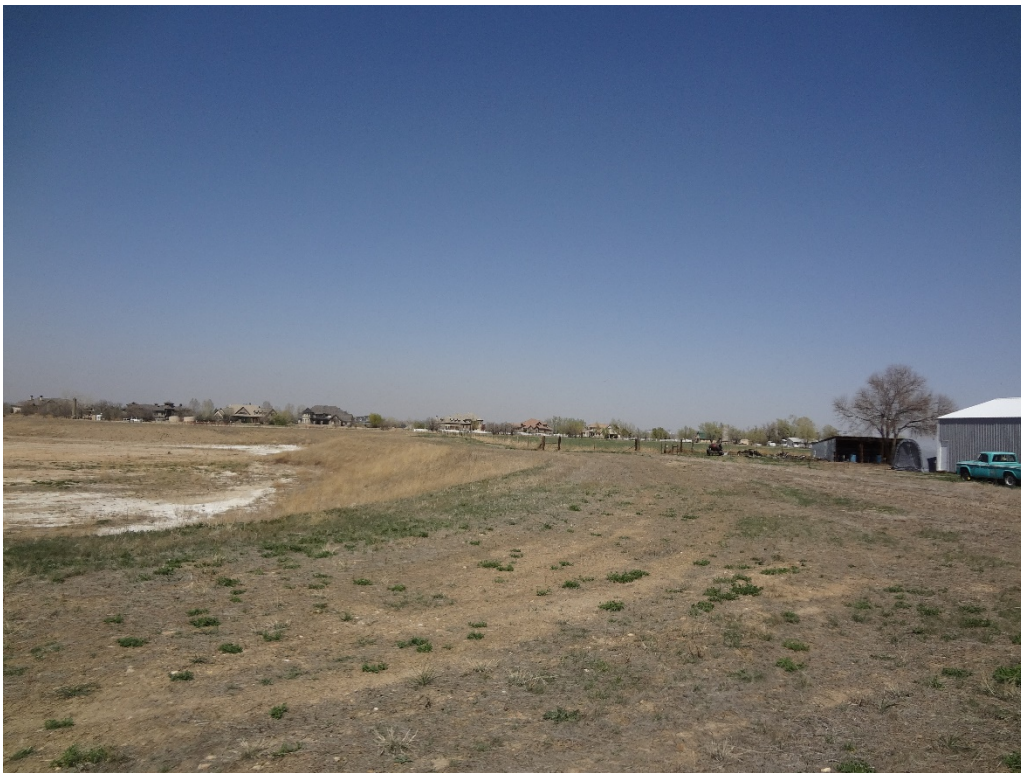
View of vegetation from SE corner of east pit looking north

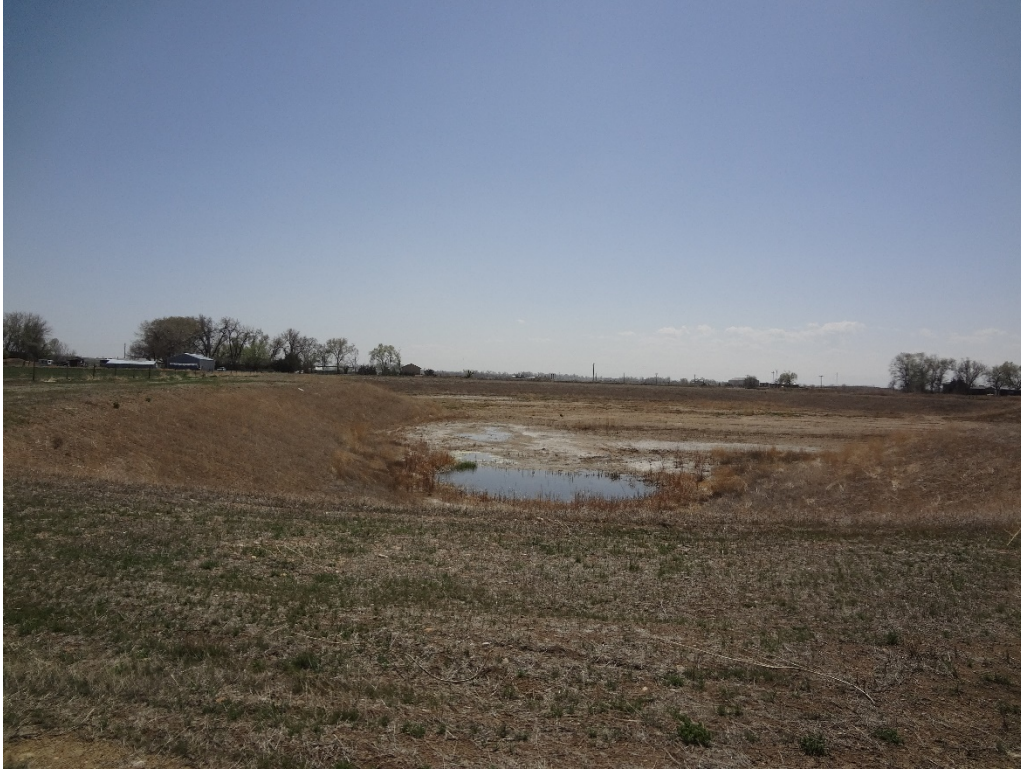
View of vegetation from NE corner of east pit looking south

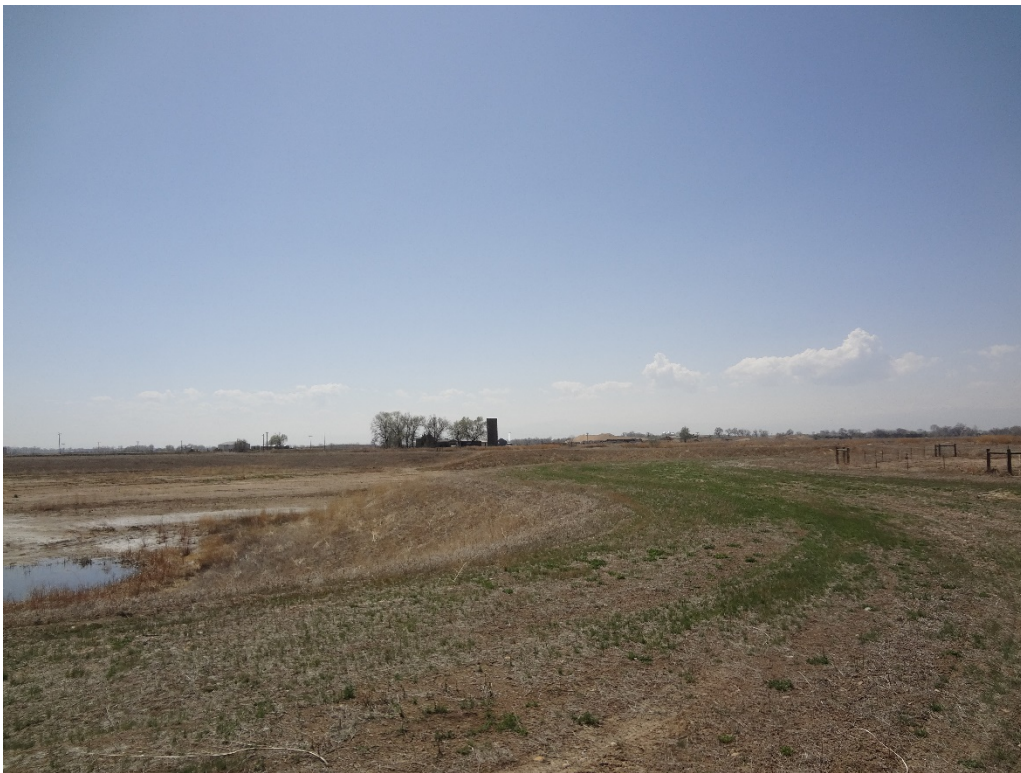
View of vegetation from NE corner of east pit looking west

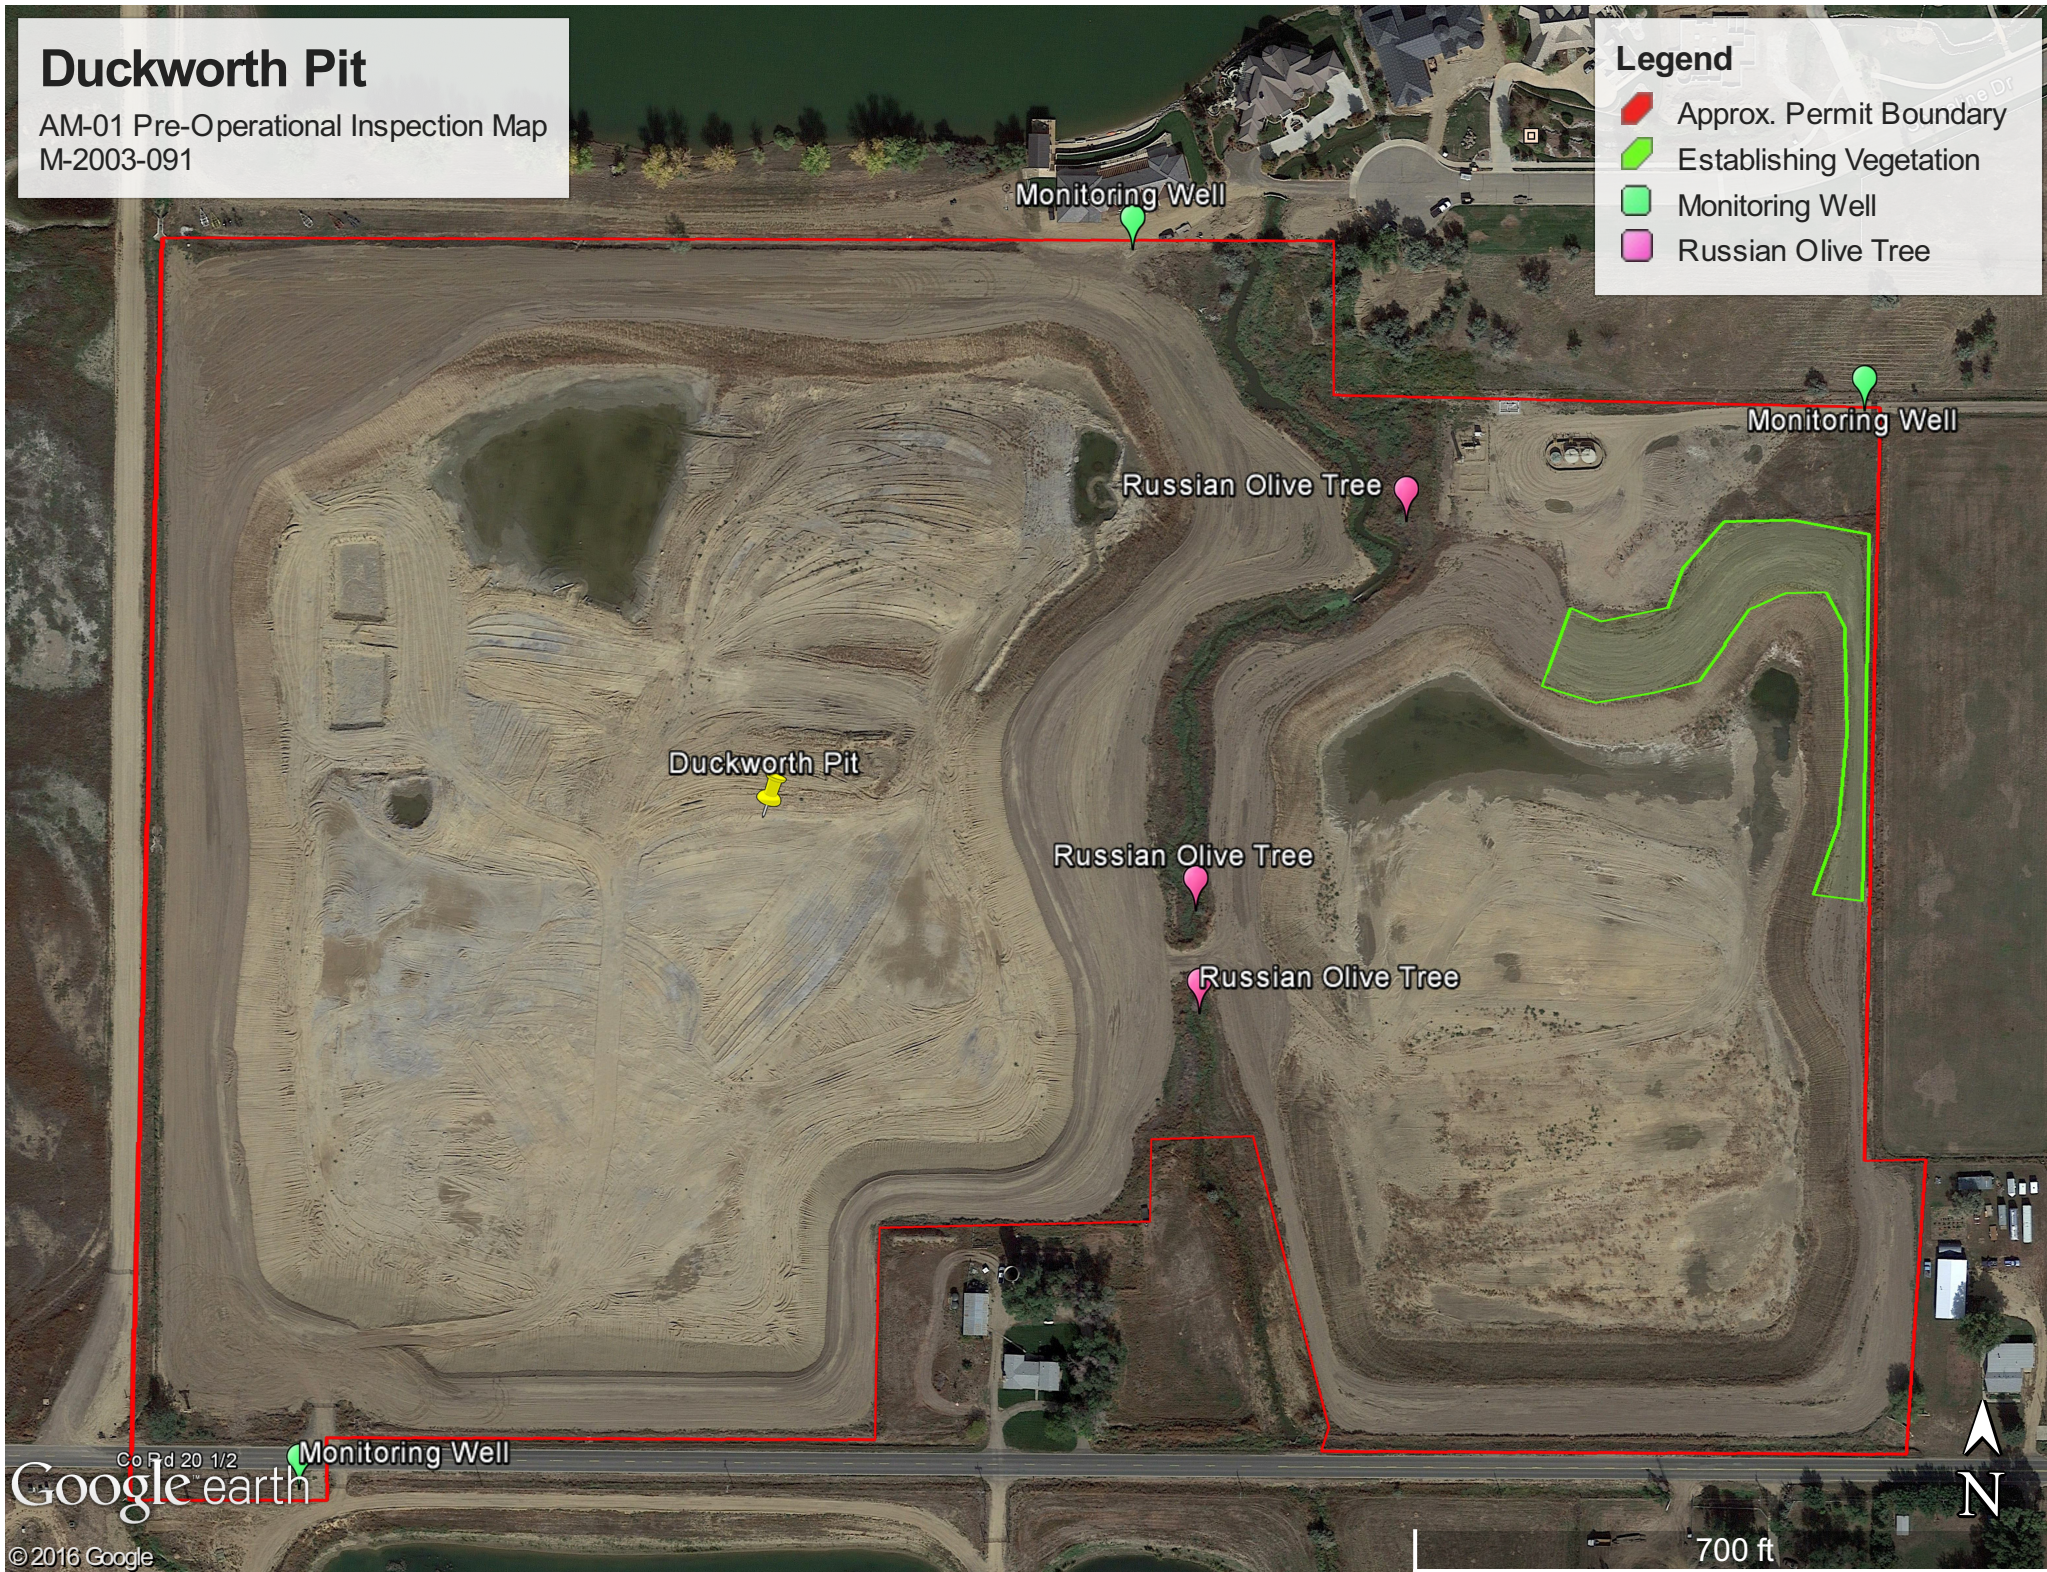
AM-01 Pre-Operational Inspection Map
M-2003-091

As cited as a problem on Page 1 of this report, Russian olive trees, a Class B noxious weed listed on Colorado's Noxious Weed List were observed adjacent to Idaho Creek. The Operator must develop or implement a weed control plan to control the Russian olive trees at the site and provide evidence of the Russian olive tree removal by the corrective action due date.

CORRECTIVE ACTIONS: The Operator shall either implement the existing weed control plan, or develop a weed control and management plan in accordance with Section 3.1.10(6) of the Rule. This plan should be developed in consultation with the county extension agency, or weed control district office and should include specific control measures to be applied, a schedule for when control measures will be applied and a post-treatment monitoring plan. This weed control plan may be submitted to the Division as a Technical Revision to the approved plan with the appropriate Technical Revision fee of \$216.00 or in response to the Division's adequacy letter for the amendment application. Please submit photographic evidence of the removal of the Russian olive trees by the corrective action due date.
