## MINERALS PROGRAM INSPECTION REPORT

<b>MINE NAME:</b> Quagmire Creek	<b>MINE/PROSPECTING ID#:</b> M-1990-047	<b>MINERAL:</b> Gravel	<b>COUNTY:</b> Fremont
<b>INSPECTION TYPE:</b> Monitoring	<b>INSPECTOR(S):</b> Timothy A. Cazier	<b>INSP. DATE:</b> April 27, 2017	<b>INSP. TIME:</b> 11:40
<b>OPERATOR:</b> Fremont County	<b>OPERATOR REPRESENTATIVE:</b> Sterling Rife	<b>TYPE OF OPERATION:</b> 110c - Construction Limited Impact	
<b>REASON FOR INSPECTION:</b> Normal I&E Program	<b>BOND CALCULATION TYPE:</b> None	<b>BOND AMOUNT:</b> \$0.00	
<b>DATE OF COMPLAINT:</b> NA	<b>POST INSP. CONTACTS:</b> U.S.BLM	<b>JOINT INSP. AGENCY:</b> U.S.BLM	
<b>WEATHER:</b> Cloudy	<b>INSPECTOR'S SIGNATURE:</b>

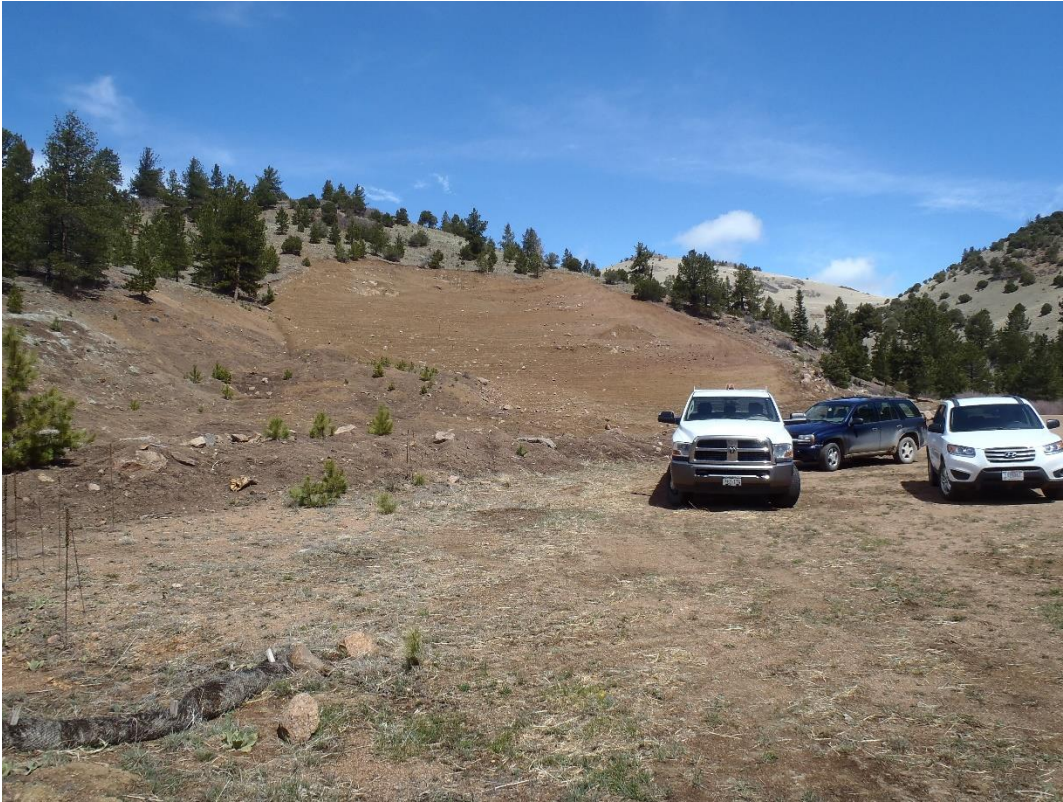
Backfilling and Grading: Backfilling and grading has been completed (see **Photo 1**) with the exception of the area around the small material stockpile remaining on the pit floor (see **Photo 2**).

Photo 1. Nearly completed backfilling and grading (looking north).

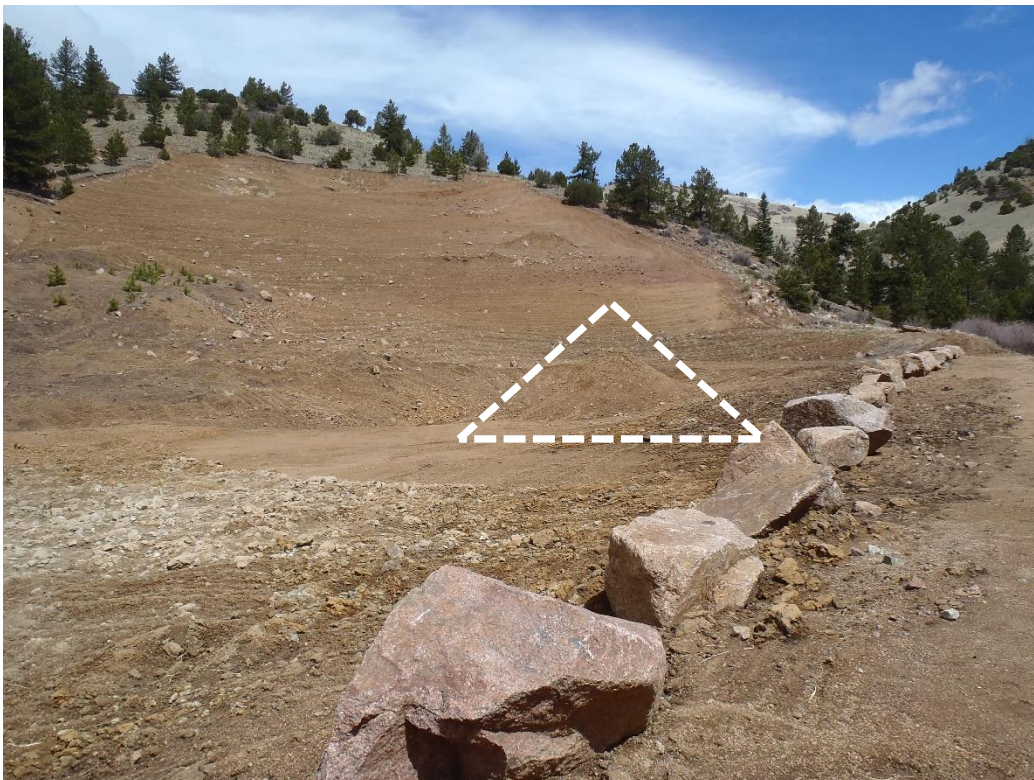
Photo 2. Small material stockpile remaining on the pit floor.

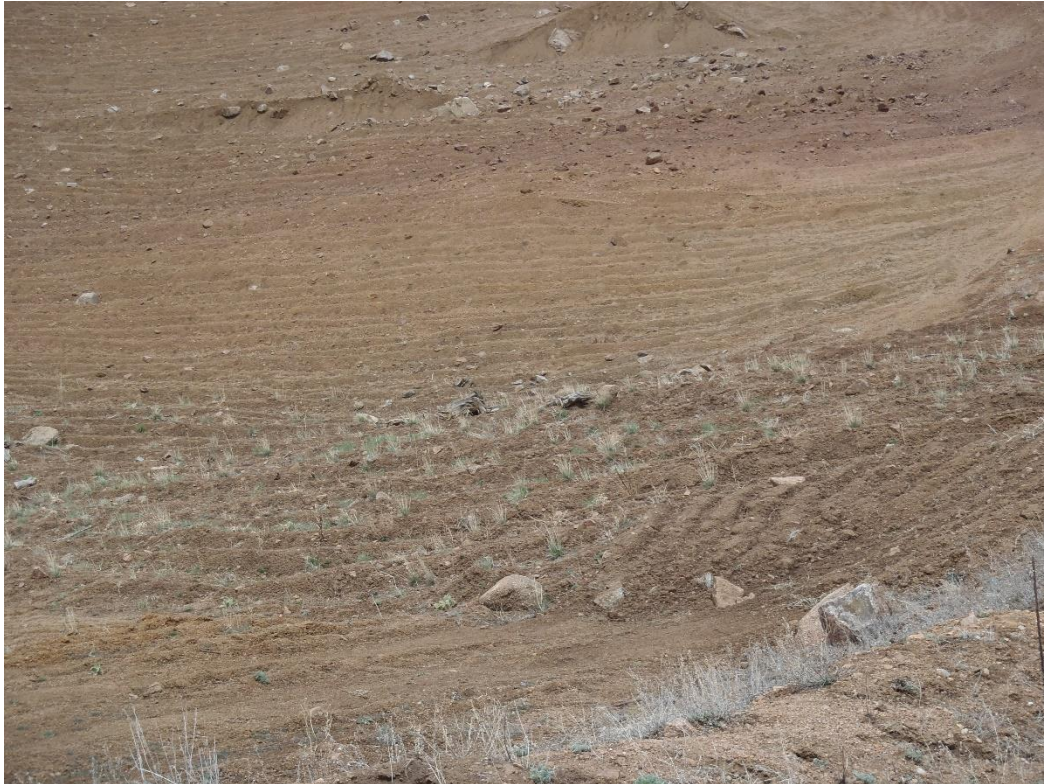
Reclamation Success: With the exception of the remaining material stockpile, the site had been graded to approximately 3H:1V or flatter, topsoil placed, steeper slopes contoured (see **Photo 3**), and seeded (according to Mr. Rife).

Revegetation: No noxious weeds were observed. Some volunteer grasses were observed (see **Photo 3**).

Photo 3. Typical contoured steeper slopes and volunteer grasses (north end).

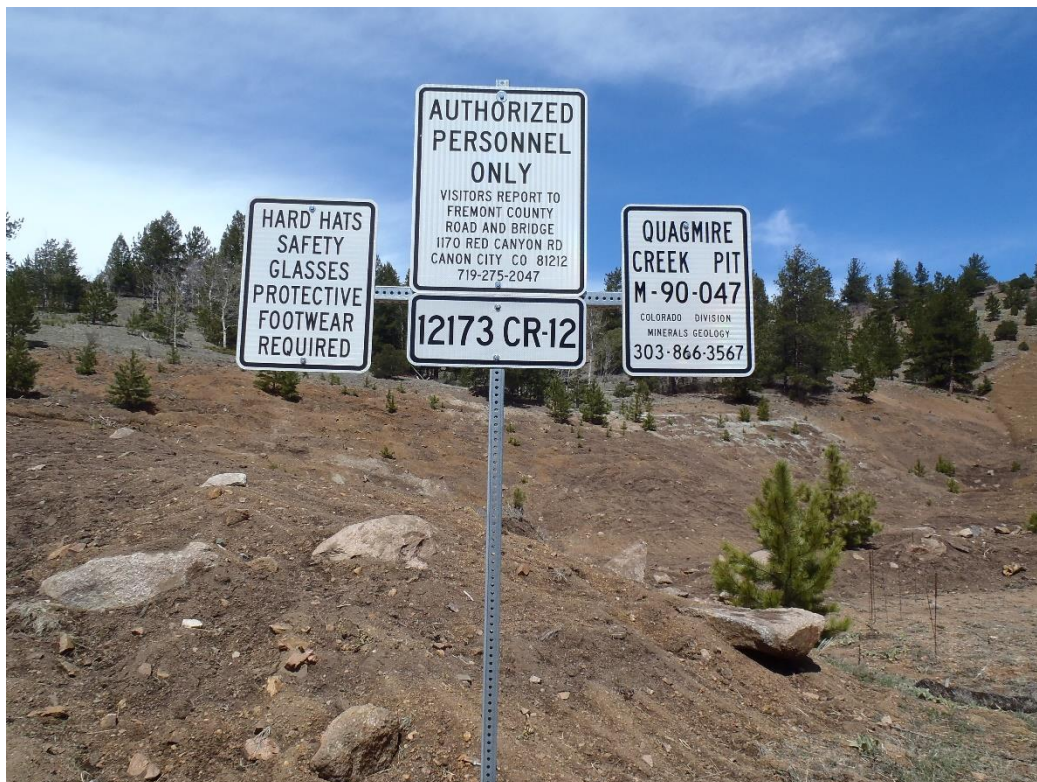
Signs and Markers: The permit sign was properly posted (see **Photo 4**).

Photo 4. Permit sign.
