MINERALS PROGRAM INSPECTION REPORT
PHONE: (303) 866-3567

MINE NAME: Ranch Land Rock Pit #1	MINE/PROSPECTING ID#: M-2002-096	MINERAL: Sandstone (silica, stone limestone (general) and gravel	COUNTY: Fremont
INSPECTION TYPE: Monitoring	INSPECTOR(S): Timothy A. Cazier	INSP. DATE: April 26, 2017	INSP. TIME: 14:45
OPERATOR: Holcim (US) Inc.	OPERATOR REPRESENTATIVE: Nick Bellino	TYPE OF OPERATION: 112c - Construction Regular Operation	
REASON FOR INSPECTION: Normal I&E Program	BOND CALCULATION TYPE: Partial Bond	BOND AMOUNT: \$43,500.00	
DATE OF COMPLAINT: NA	POST INSP. CONTACTS: None	JOINT INSP. AGENCY: None	
WEATHER: Cloudy	INSPECTOR'S SIGNATURE:

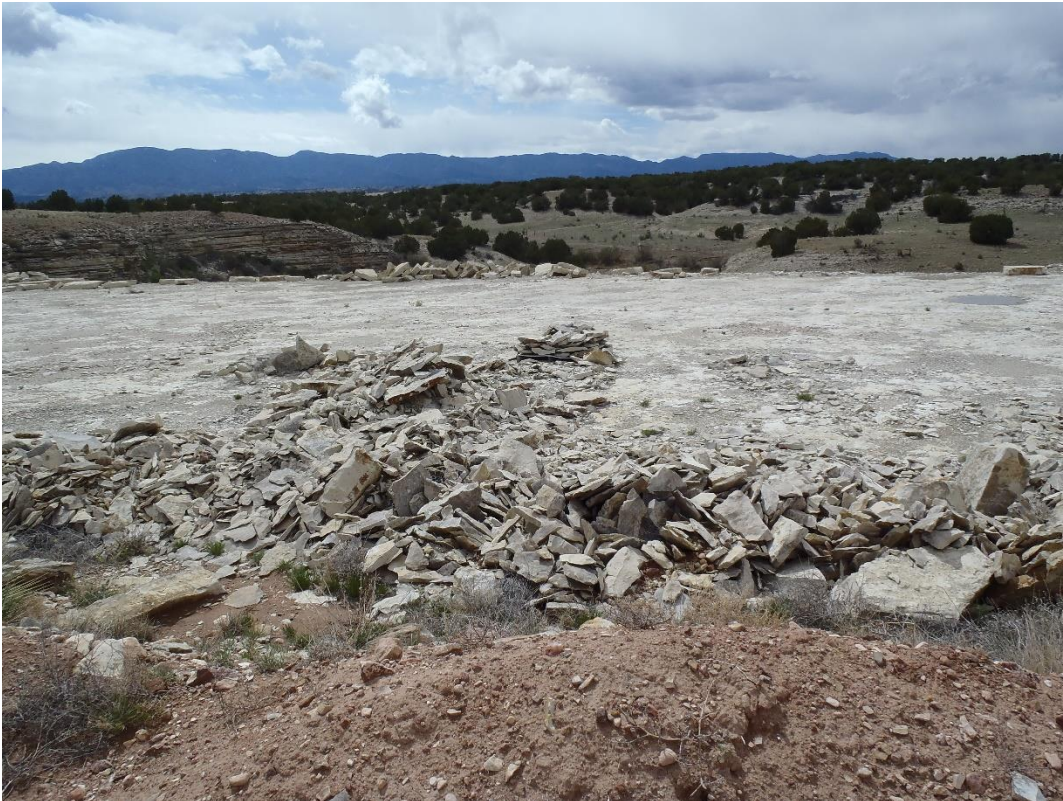
Processing Waste: Stockpiles of previously extracted rock were observed in the pit area (see **Photo 2**).

Photo 1. Stockpiles of previously extracted rock (looking west).

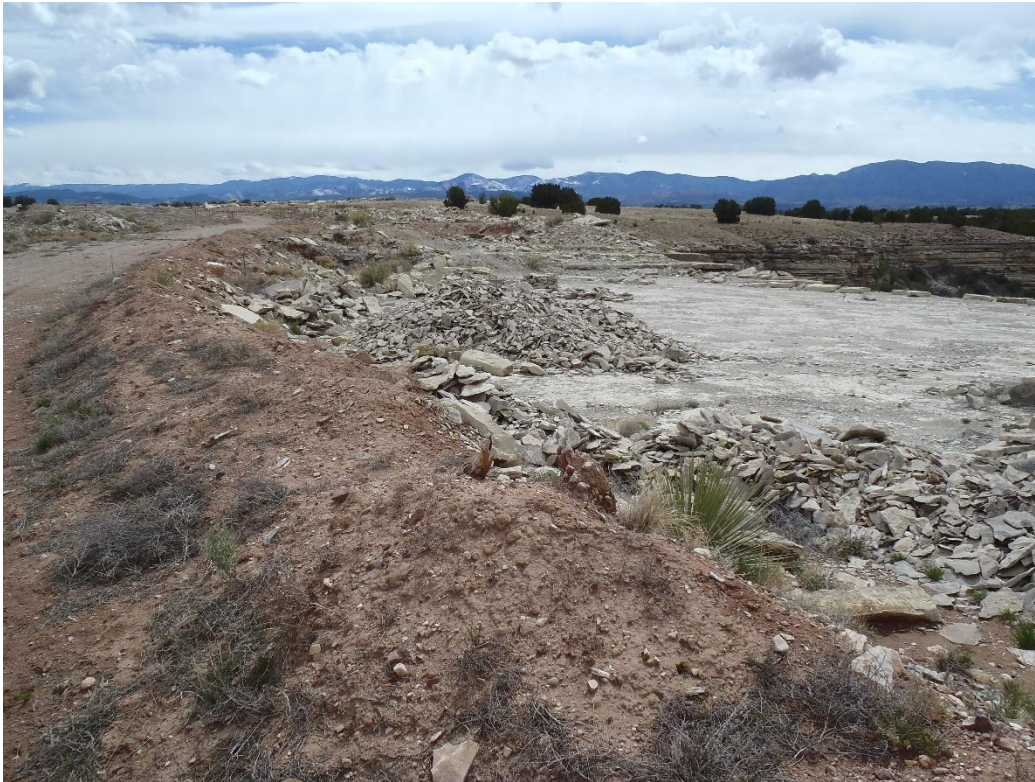
Gen. Compliance with Mine Plan: The operation appeared to be in compliance with the approved mine plan. Google Earth was used to measure the disturbed area, which was estimated to be approximately 6.4 acres (based on 2013 satellite imagery). High walls were estimated to vary between 4 and 6 feet in high and appeared stable (see **Photo 1**).

Photo 2. Typical 4 – 6 foot highwalls (looking SW).

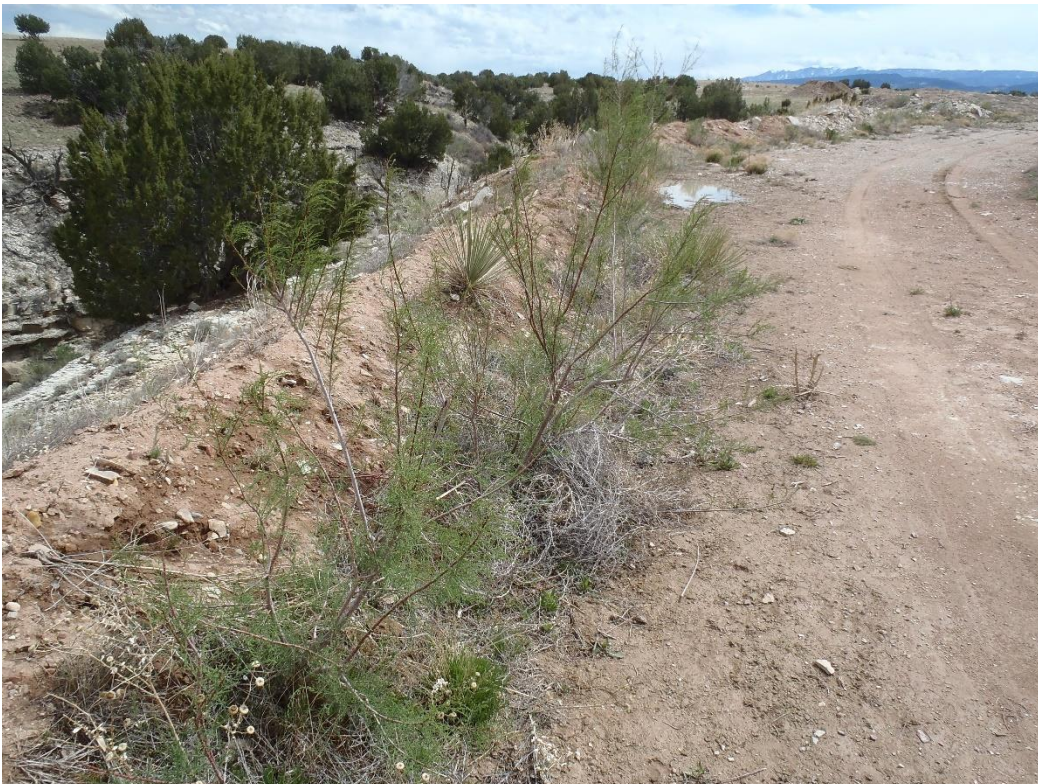
Revegetation: A few tamarisk plants were observed on the haul road near the pit area (see **Photo 3**). These were of insufficient quantity to be cited as a problem, but should be removed as soon as possible to prevent tamarisk from becoming a problem on site.

Photo 3. Tamarisk plants observed on east side of haul road near pit area (looking south).

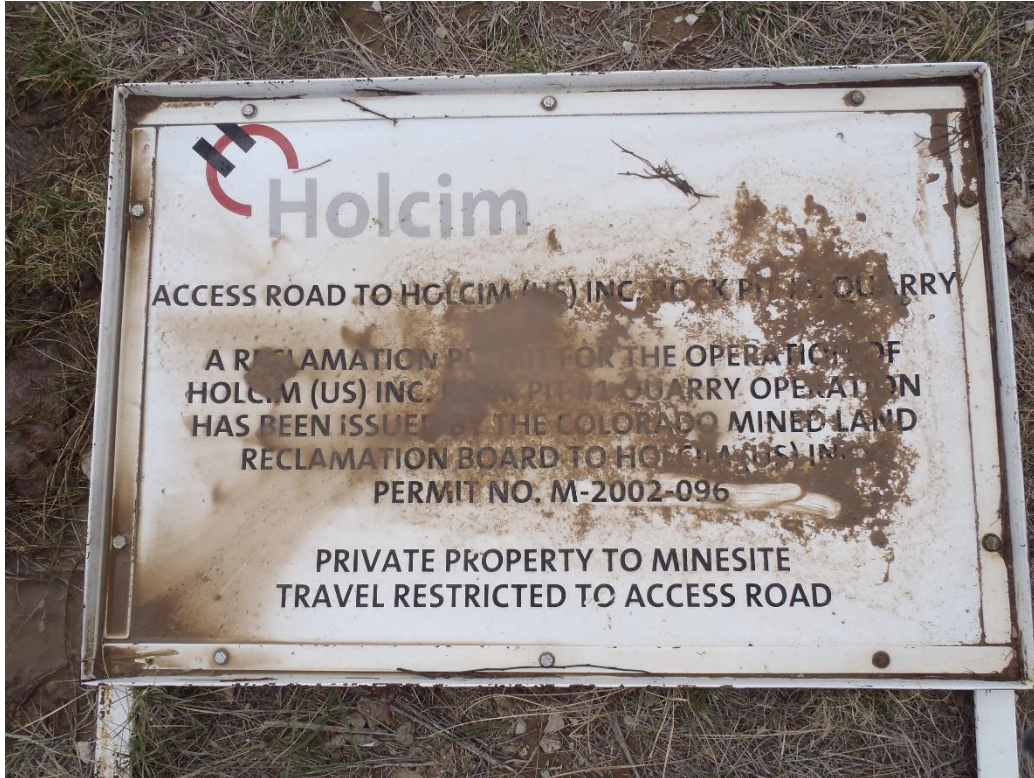
Signs and Markers: The permit sign was observed at the site entrance (see **Photo 4**), but had been knocked down. Mr. Bellino said he would get it put back up and stabilized. The current mine area is constrained by topography ensuring mine activities are confined within the permit boundary.

Photo 4. Permit sign.
