MINERALS PROGRAM INSPECTION REPORT
PHONE: (303) 866-3567

MINE NAME: Miller Gravel Pit	MINE/PROSPECTING ID#: M-1982-112	MINERAL: Sand and gravel	COUNTY: Elbert
INSPECTION TYPE: Monitoring	INSPECTOR(S): Peter S. Hays	INSP. DATE: April 28, 2017	INSP. TIME: 10:00
OPERATOR: Estate of Rick L Hunt	OPERATOR REPRESENTATIVE: Mark Heifner, O.J. Pratt	TYPE OF OPERATION: 112c - Construction Regular Operation	
REASON FOR INSPECTION: Normal I&E Program	BOND CALCULATION TYPE: Partial Bond	BOND AMOUNT: \$44,146.00	
DATE OF COMPLAINT: NA	POST INSP. CONTACTS: None	JOINT INSP. AGENCY: None	
WEATHER: Clear	INSPECTOR'S SIGNATURE:

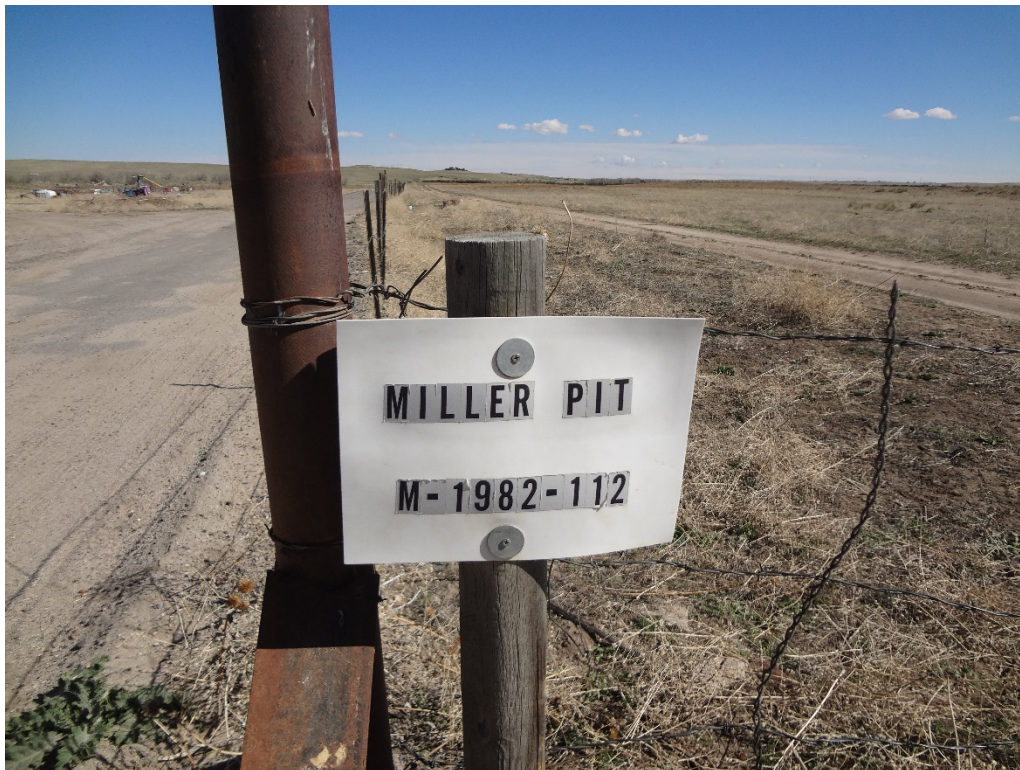
The required mine sign was observed on the entrance gate and the site boundaries were delineated as required by Rule 3.1.12. Photographs taken during the inspection are attached.

Miller Gravel Pit mine sign

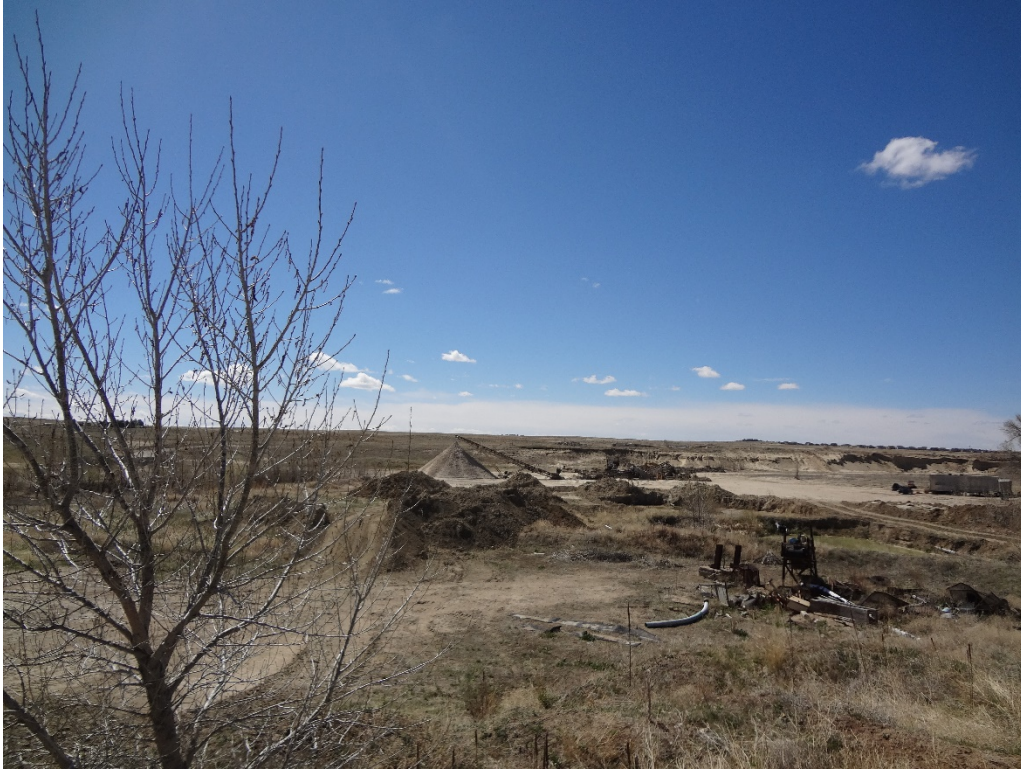
View of site from north topsoil stockpile looking south

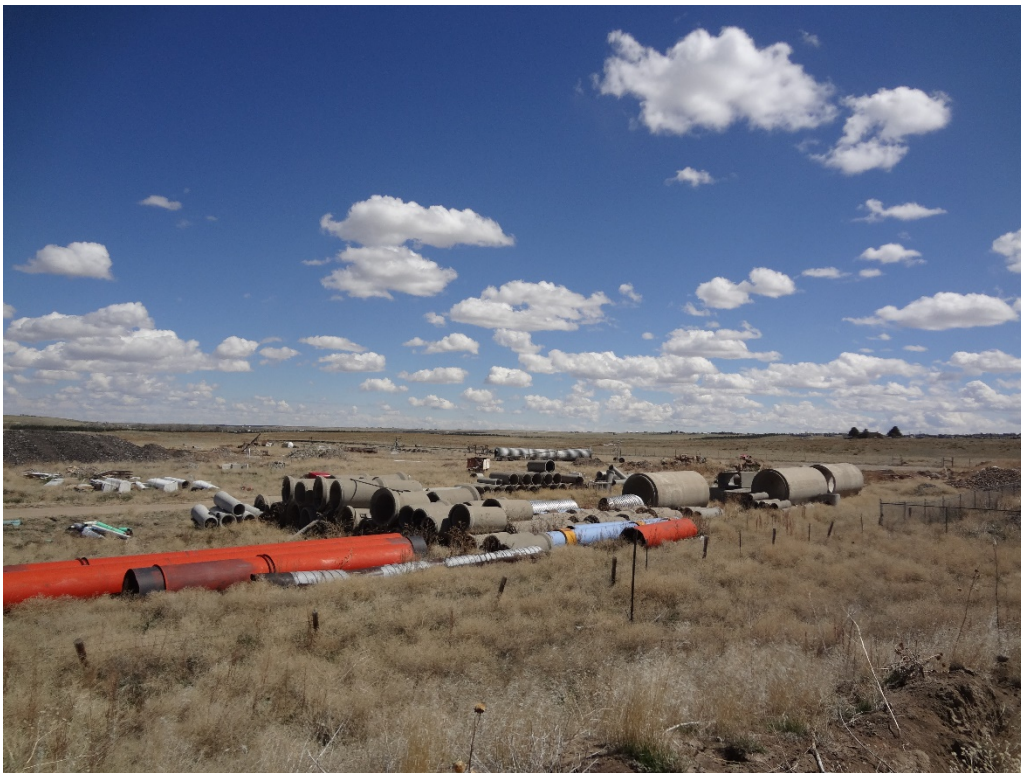
View of construction storage yard from the south boundary looking NE

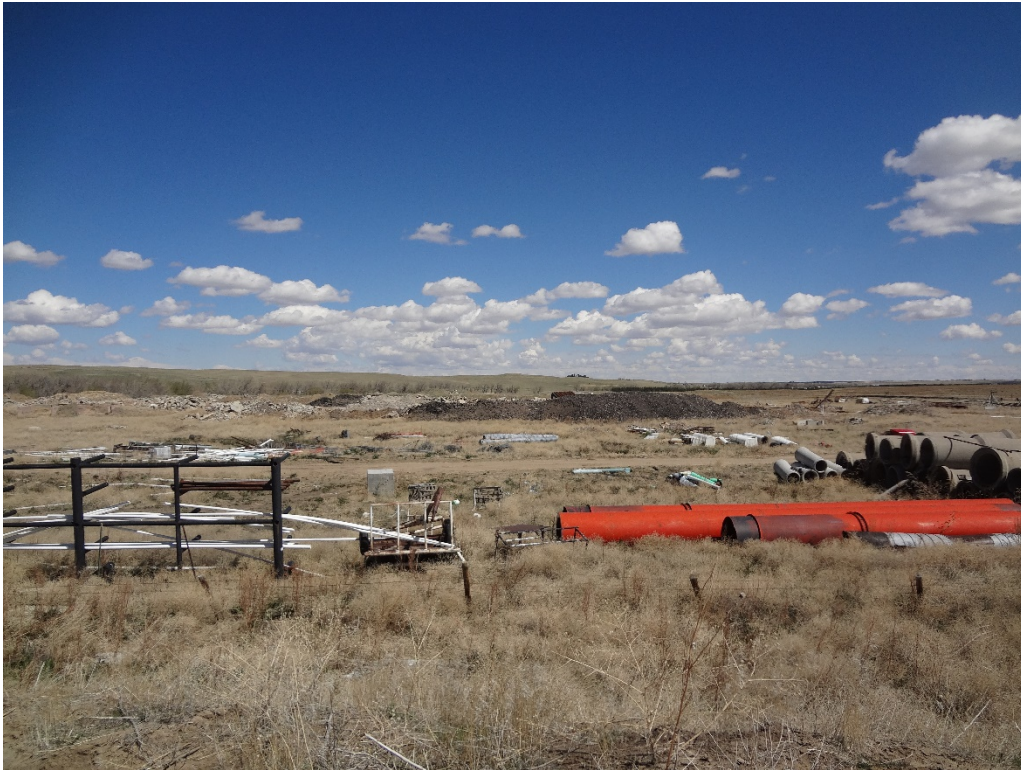
View of construction storage yard from the south boundary looking north

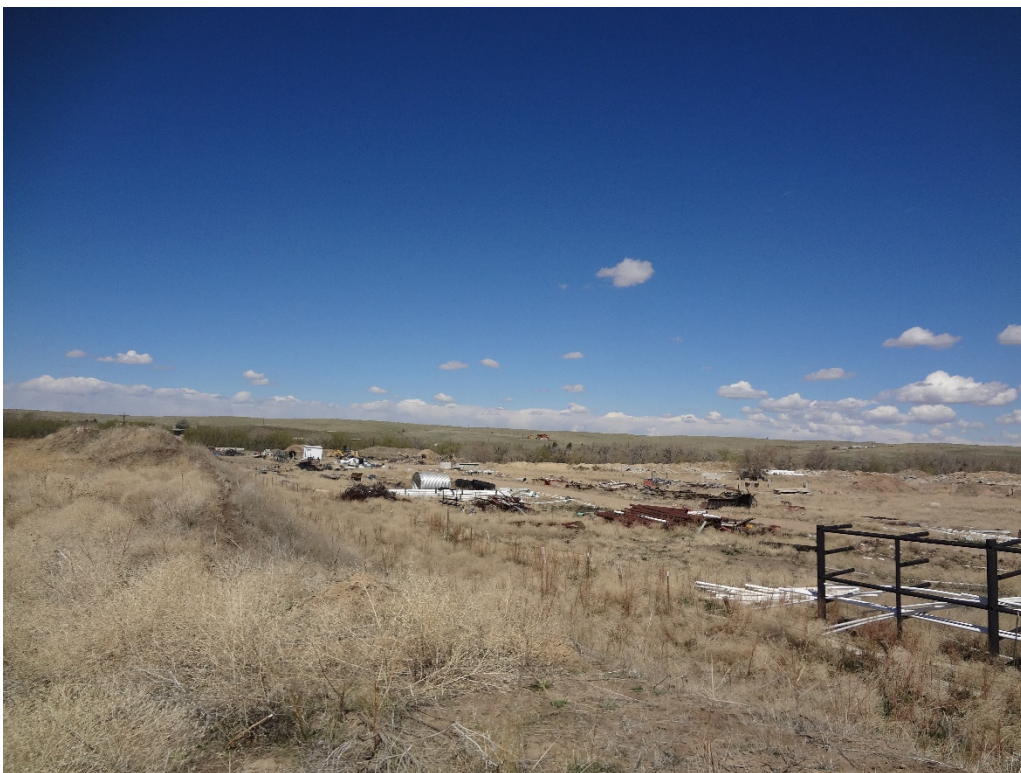
View of construction storage yard from the south boundary looking NW

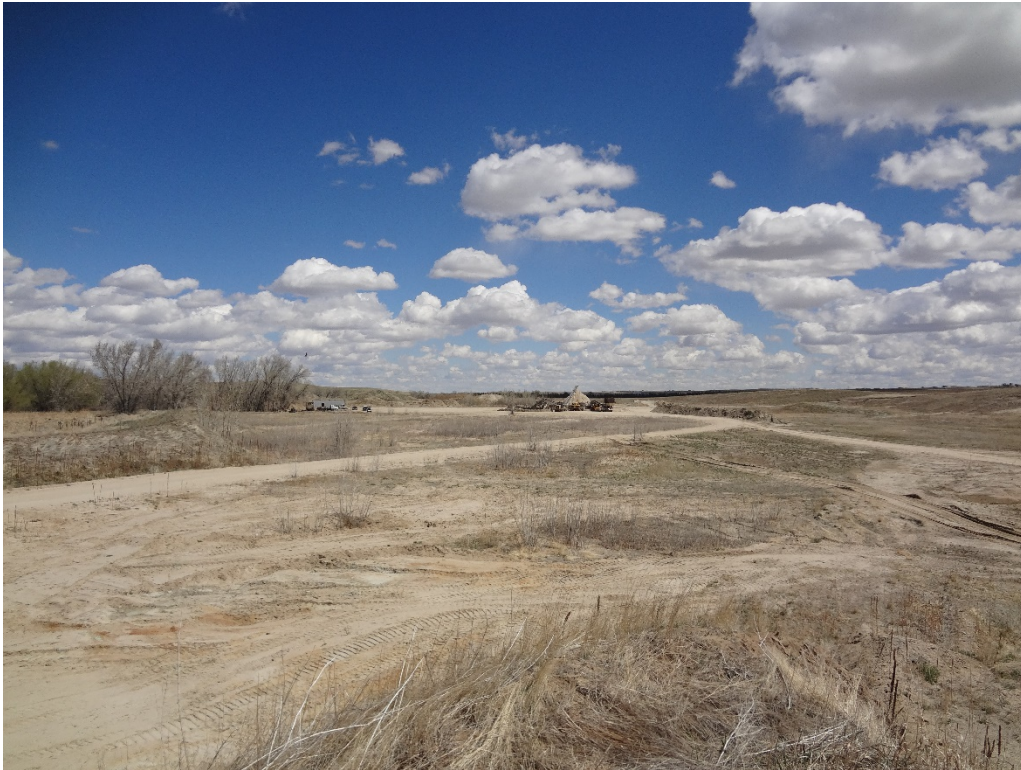
View of site from middle of pit floor looking north

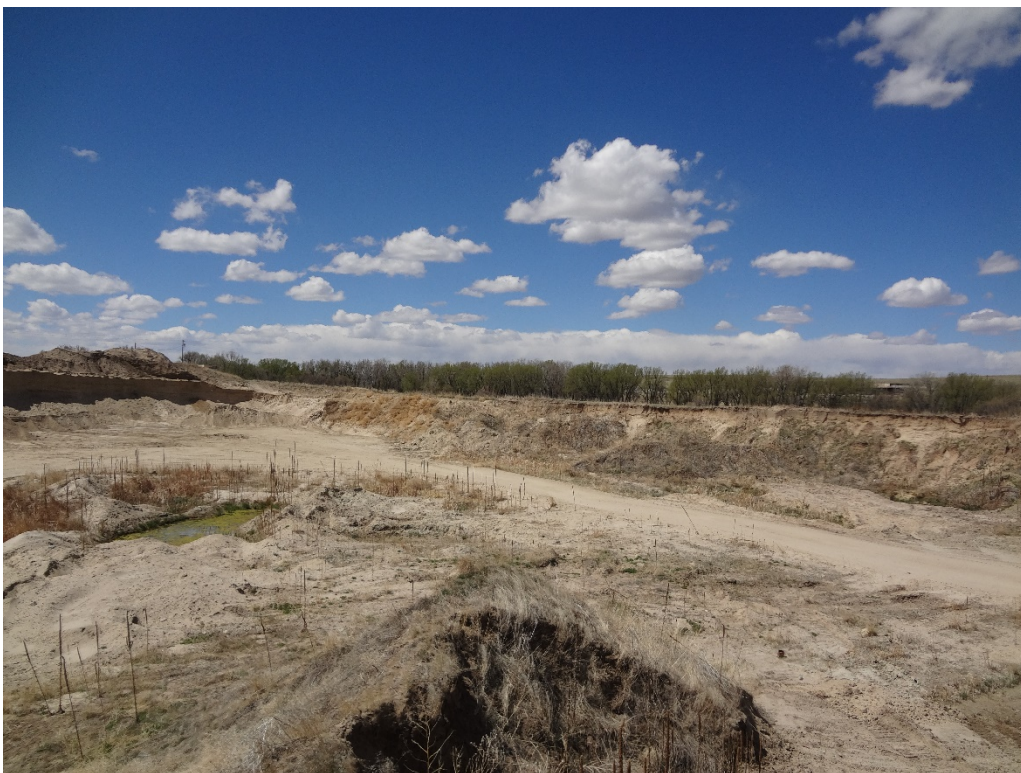
View of site from middle of pit floor looking southwest

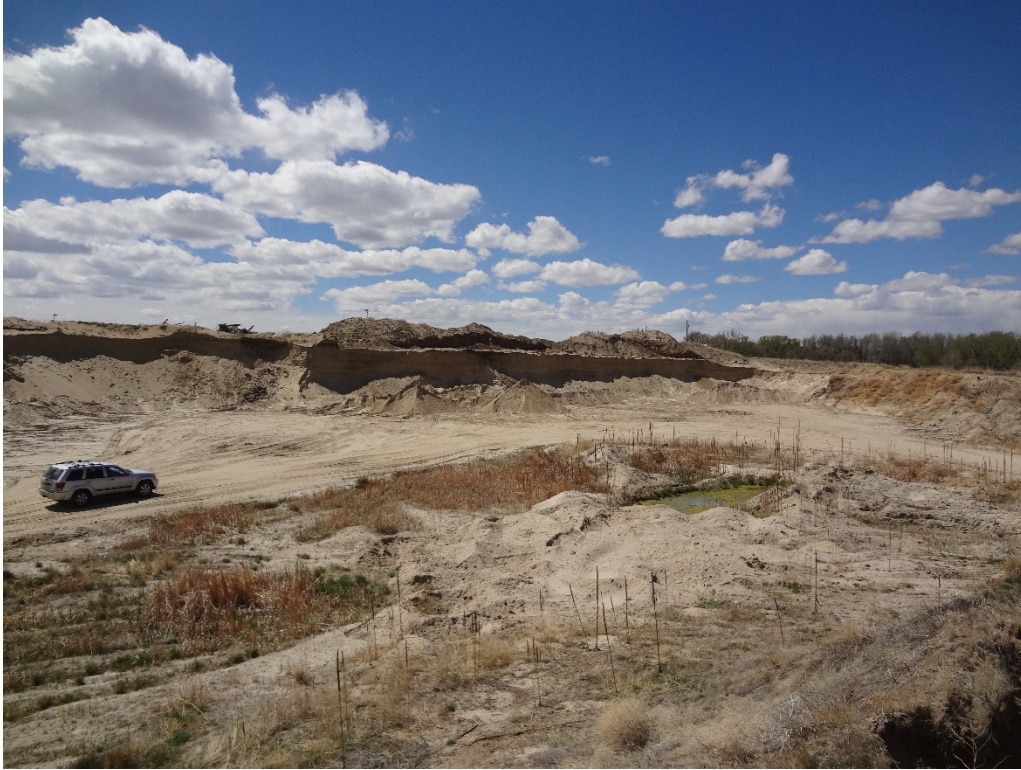
View of site from middle of pit floor looking south

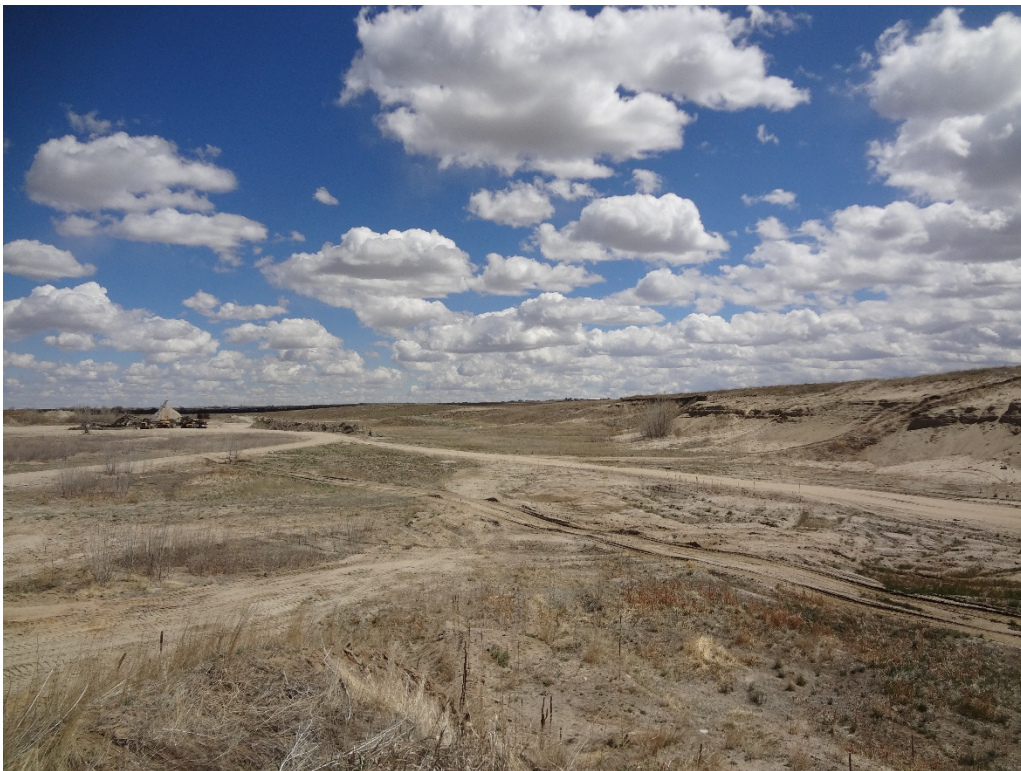
View of site from middle of pit floor looking northeast
