MINERALS PROGRAM INSPECTION REPORT PHONE: (303) 866-3567

MINE NAME:		MINE/PROSPECTING ID#:	MINERAL:	COUNTY:
Big R Pit		M-1988-052	Sand and gravel	Elbert
INSPECTION TYPE:		INSPECTOR(S):	INSP. DATE:	INSP. TIME:
Monitoring		Peter S. Hays	April 28, 2017	11:00
OPERATOR:		OPERATOR REPRESENTATIVE:	TYPE OF OPERATION:	
Estate of Rick L Hunt		O.J. Pratt	110c - Construction Limited Impact	
REASON FOR INSPECTION:		BOND CALCULATION TYPE:	BOND AMOUNT:	
Normal I&E Program		Partial Bond	\$18,642.19	
DATE OF COMPLAINT:		POST INSP. CONTACTS:	JOINT INSP. AGENCY:	
NA		None	None	
WEATHER:	INSPECTOR'S SIGNATURE:		SIGNATURE DATE:	
Clear	Athe		May 5, 2017

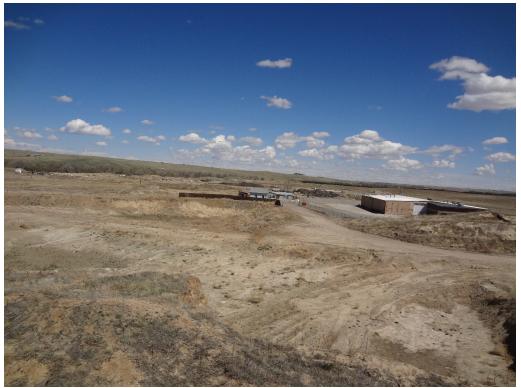
View of site from the SE corner looking north

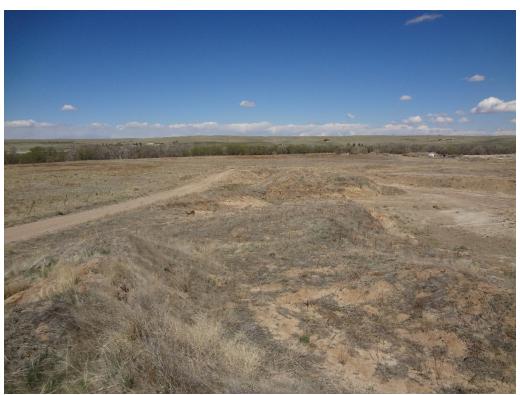
The site is divided by an interior road into two pit areas, north and south. The north pit contains a large topsoil stockpile along the north boundary and a shallow, regraded excavation area in the remaining area. The south pit contains a mining area with 1H:1V highwall slopes of up to 15 feet in height. Two erosion features in the southwest highwall are approaching the permit boundary. Attention should be paid to these areas during reclamation regrading to prevent off-site disturbance, which could result in a possible violation from the Division.

View of the western portion of the south pit highwall looking west

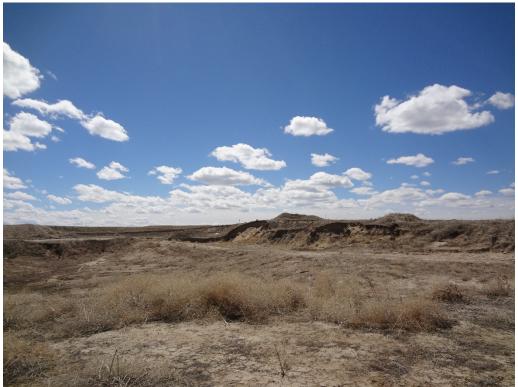
View of the south pit highwall from the pit floor looking southeast

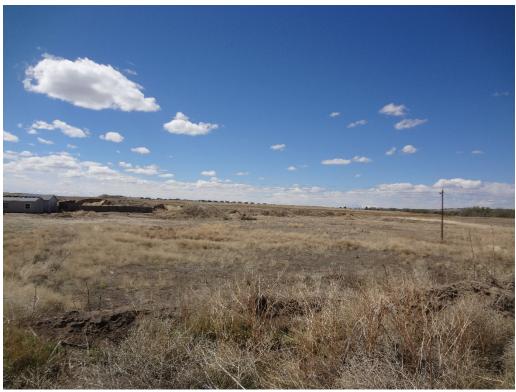
Diffuse Knapweed, a List B noxious weed listed on Colorado's Noxious Weed List, was observed throughout the site with a large patch located in the northeast corner of the site and extending off site. The diffuse knapweed must be controlled and monitored prior to the start and during the reclamation process. The presence of the knapweed could prevent the establishment of reclamation grasses and delay the release of the permit by the Division.

View of the site from the northeast corner looking south

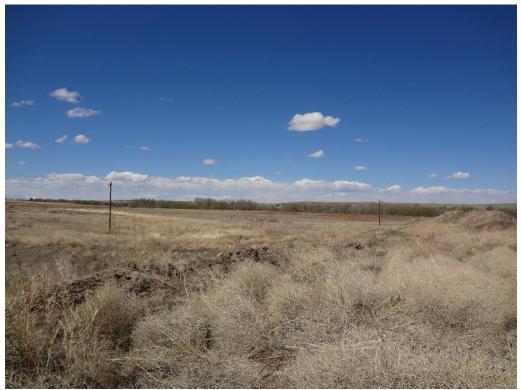
View of the site from the northeast corner looking southwest
