**MINERALS PROGRAM INSPECTION REPORT**  
**PHONE: (303) 866-3567**

<b>MINE NAME:</b> Deakins Pit	<b>MINE/PROSPECTING ID#:</b> M-2001-060	<b>MINERAL:</b> Sand and gravel	<b>COUNTY:</b> Moffat
<b>INSPECTION TYPE:</b> Monitoring	<b>INSPECTOR(S):</b> Amy C. Yeldell	<b>INSP. DATE:</b> April 26, 2017	<b>INSP. TIME:</b> 14:35
<b>OPERATOR:</b> 3B Enterprises, LLC	<b>OPERATOR REPRESENTATIVE:</b> Steve Baker	<b>TYPE OF OPERATION:</b> 112c - Construction Regular Operation	
<b>REASON FOR INSPECTION:</b> Normal I&E Program	<b>BOND CALCULATION TYPE:</b> Complete Bond	<b>BOND AMOUNT:</b> \$66,800.00	
<b>DATE OF COMPLAINT:</b> NA	<b>POST INSP. CONTACTS:</b> None	<b>JOINT INSP. AGENCY:</b> None	
<b>WEATHER:</b> Cloudy	<b>INSPECTOR'S SIGNATURE:</b>

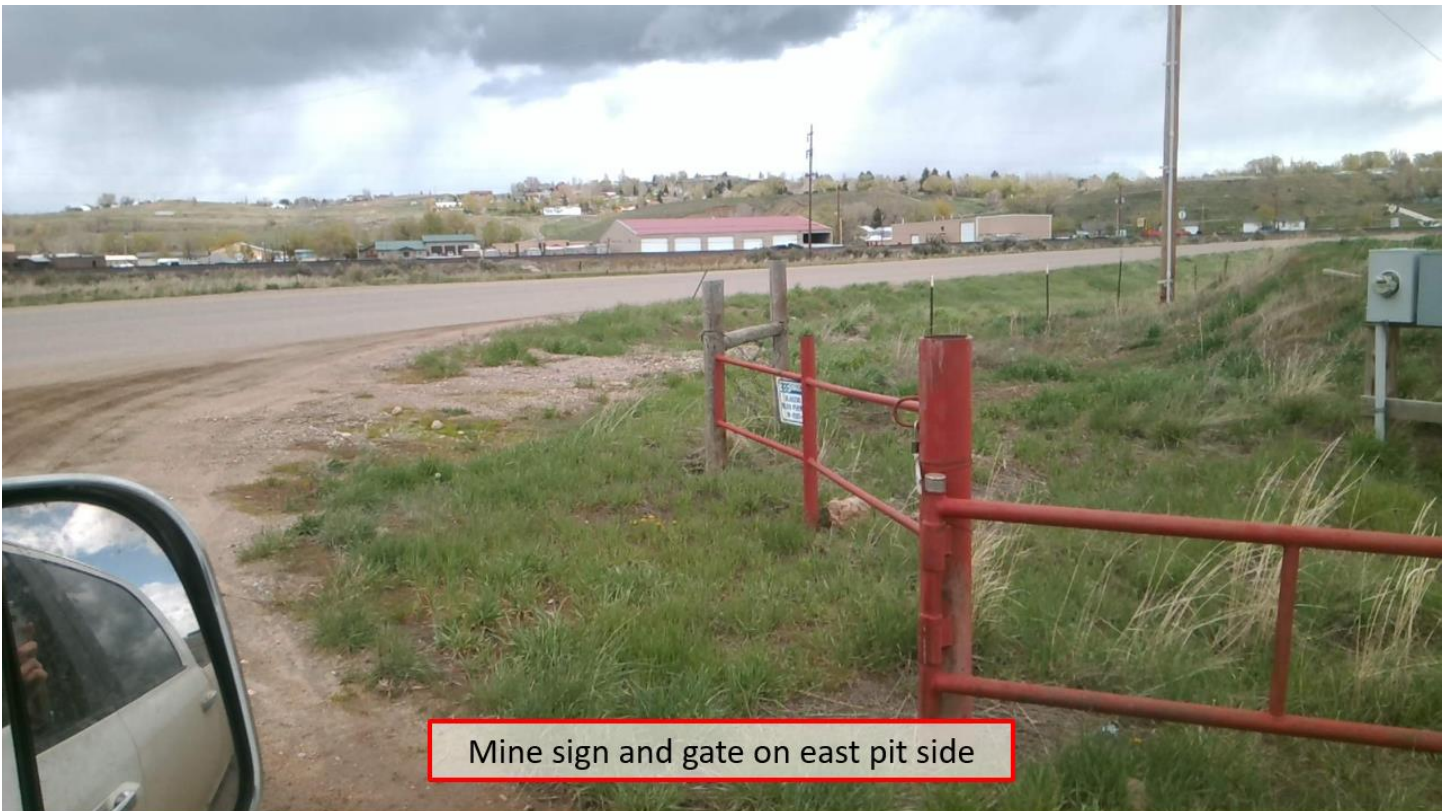
The mine identification sign and affected area boundary markers are in place and in compliance with Rule 3.1.12. The sign is located at the entrance of the permit boundary fastened to the gate that secures the pit. The entire permit boundary is fenced in. It is noted that East 1st street divides the pit in two (East and West).

Mine sign and gate on east pit side
