MINERALS PROGRAM INSPECTION REPORT
PHONE: (303) 866-3567

MINE NAME: Bunn Ranch Pit	MINE/PROSPECTING ID#: M-1980-131	MINERAL: Sand and gravel	COUNTY: Moffat
INSPECTION TYPE: Monitoring	INSPECTOR(S): Amy C. Yeldell	INSP. DATE: April 27, 2017	INSP. TIME: 11:45
OPERATOR: Elam Construction, Inc.	OPERATOR REPRESENTATIVE: None	TYPE OF OPERATION: 112c - Construction Regular Operation	
REASON FOR INSPECTION: Normal I&E Program	BOND CALCULATION TYPE: Complete Bond	BOND AMOUNT: \$178,600.00	
DATE OF COMPLAINT: NA	POST INSP. CONTACTS: None	JOINT INSP. AGENCY: None	
WEATHER: Cloudy	INSPECTOR'S SIGNATURE:

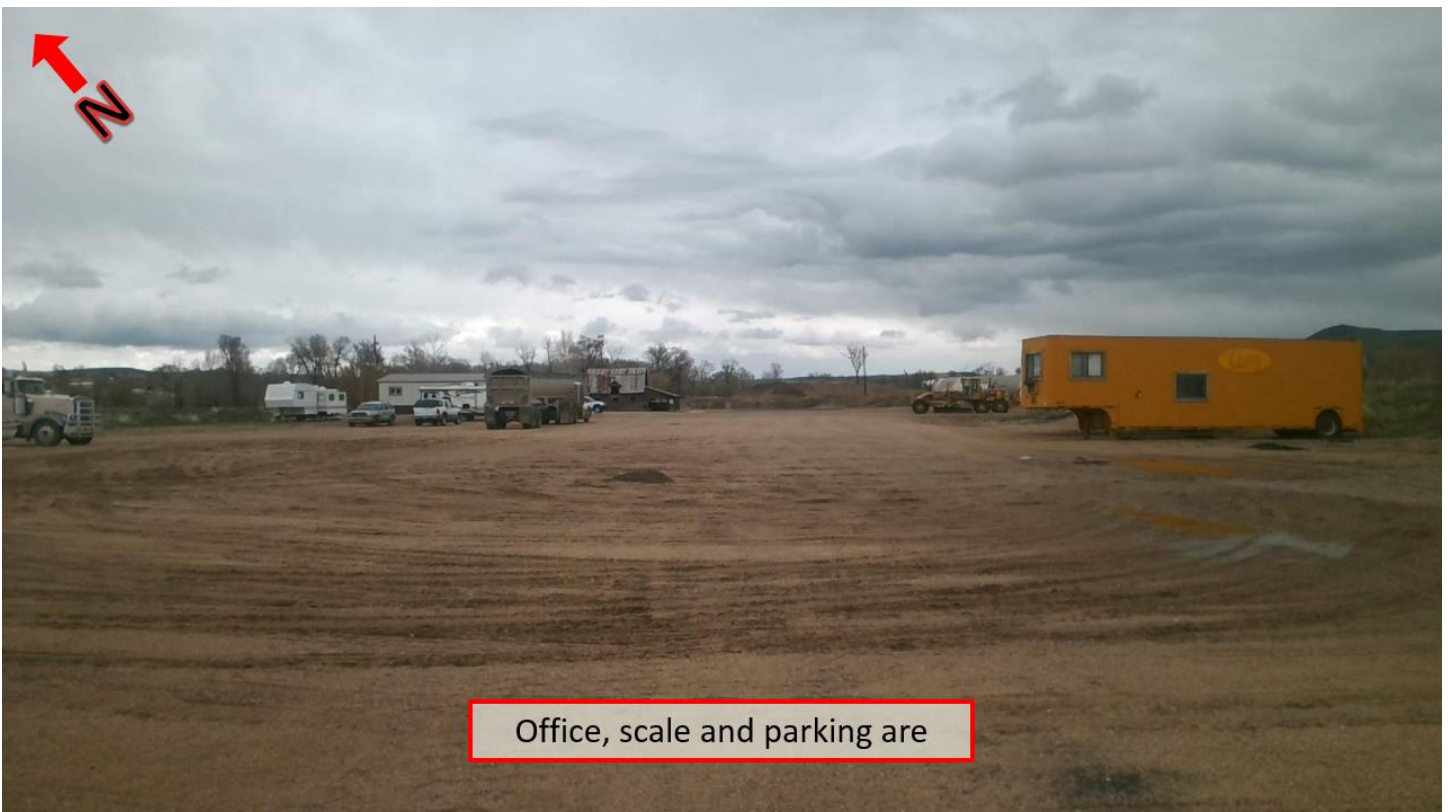
A permanent scale, scale house and office are located towards the entrance of the pit.

Office, scale and parking are

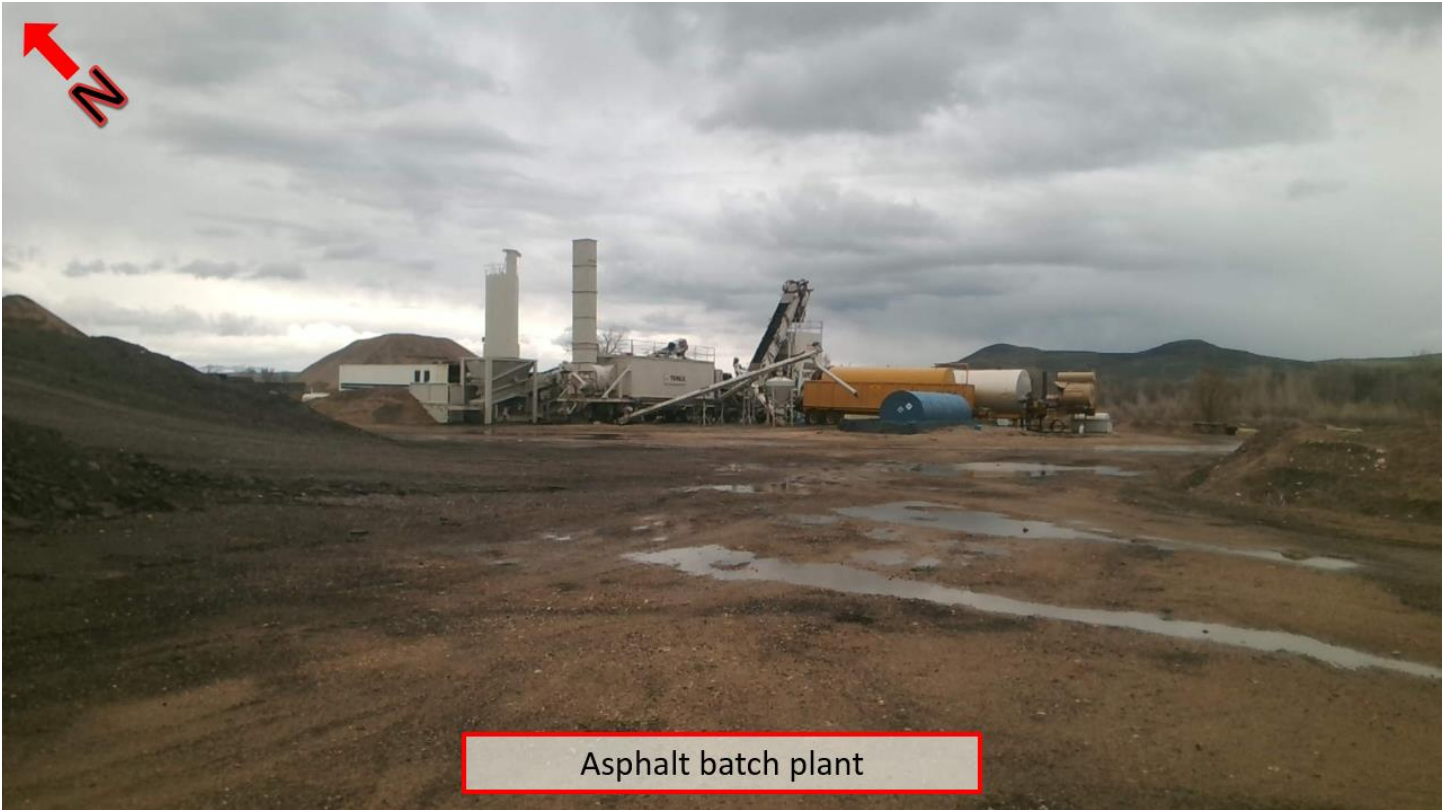
Asphalt batch plant

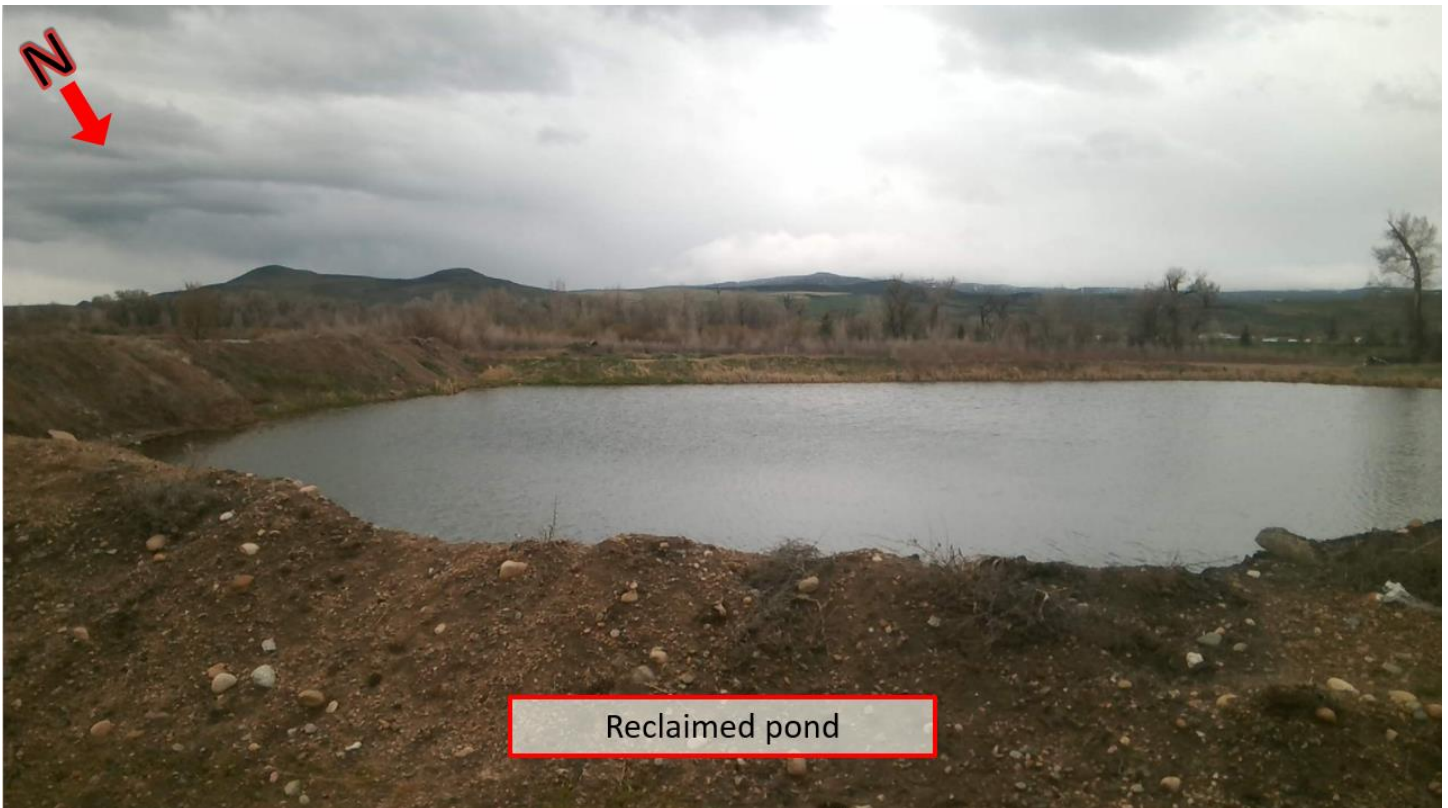
The site consists of several large reclaimed ponds. The majority of them have proper sloping and are stabilized well with native vegetation. Several of the ponds are releasable if the operator no longer needs access to those areas. It's noted that one drives through several of these corridors to access other areas of the Bunn Ranch Pit as well as other pits permitted by the operator.

Reclaimed pond
