**COLORADO**Division of Reclamation,
Mining and Safety

MINERALS PROGRAM INSPECTION REPORT**PHONE: (303) 866-3567**

MINE NAME: Golden Wonder Mine	MINE/PROSPECTING ID#: M-1978-091-UG	MINERAL: Gold	COUNTY: Hinsdale
INSPECTION TYPE: Monitoring	INSPECTOR(S): Travis H. Marshall	INSP. DATE: October 12, 2016	INSP. TIME: 11:00
OPERATOR: LKA International Inc.	OPERATOR REPRESENTATIVE: Kye Abraham	TYPE OF OPERATION: 110d - Designated Limited Impact

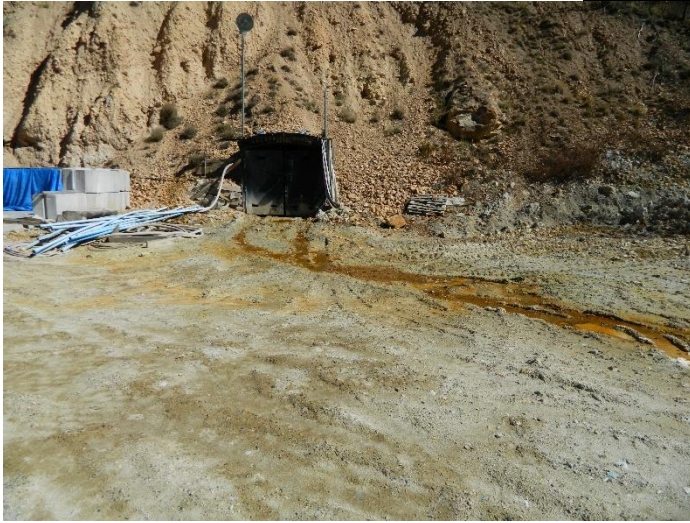
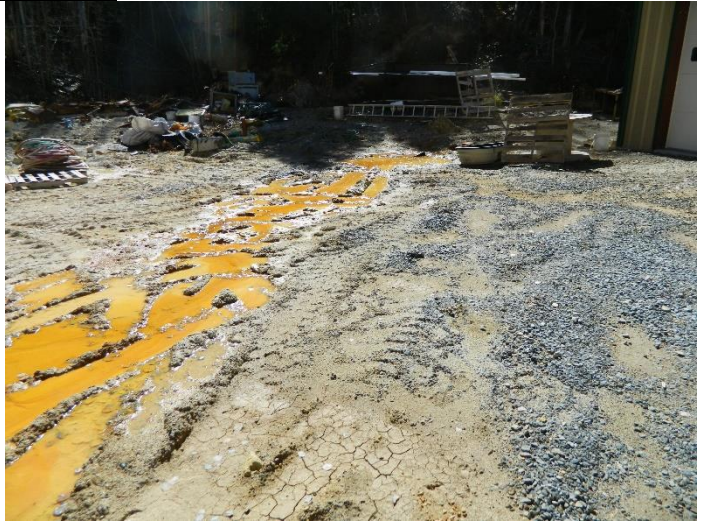
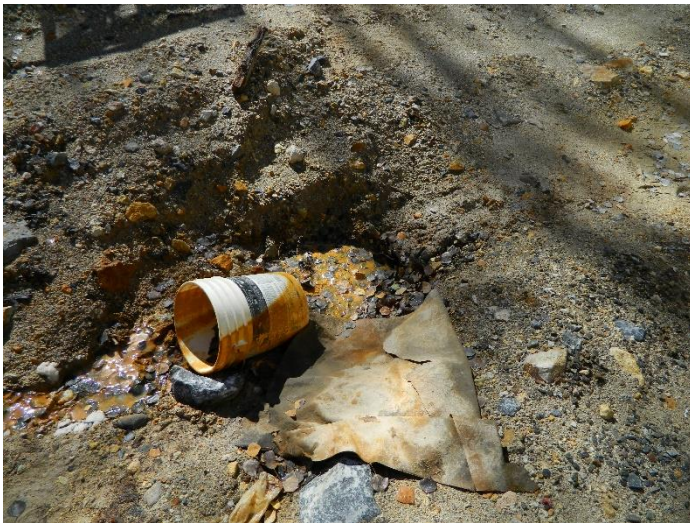
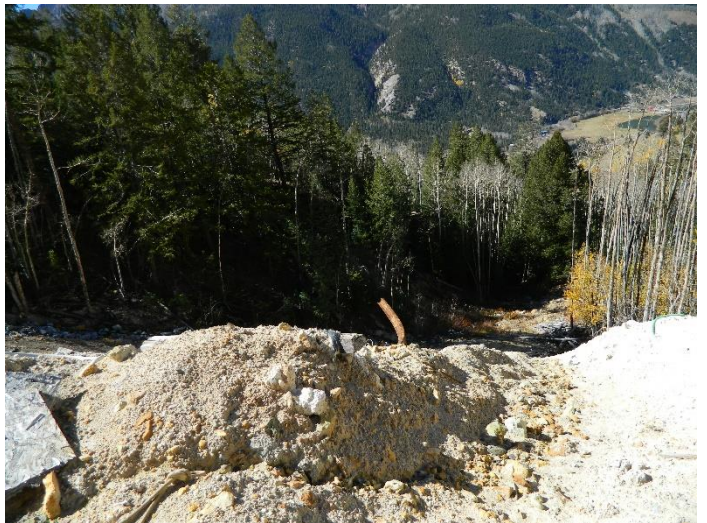
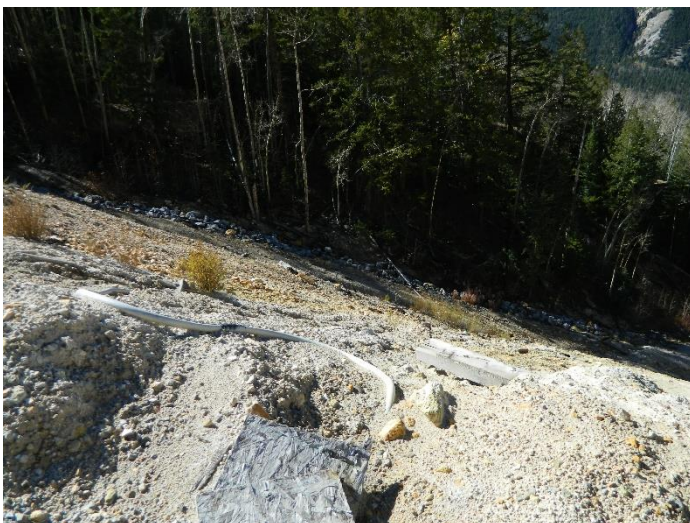
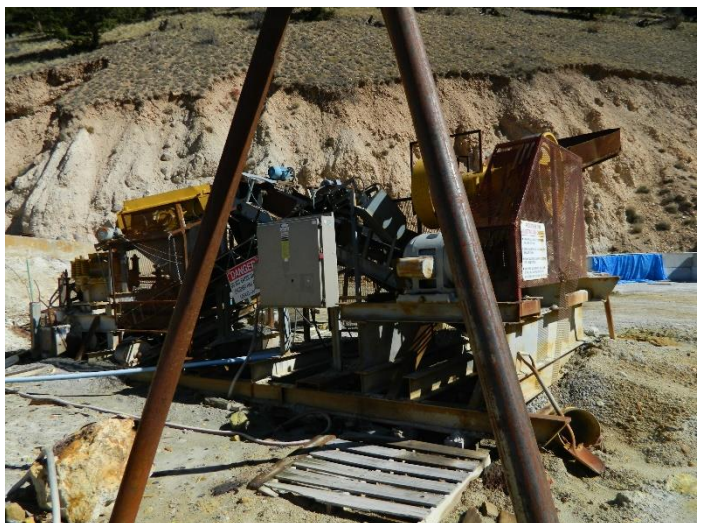
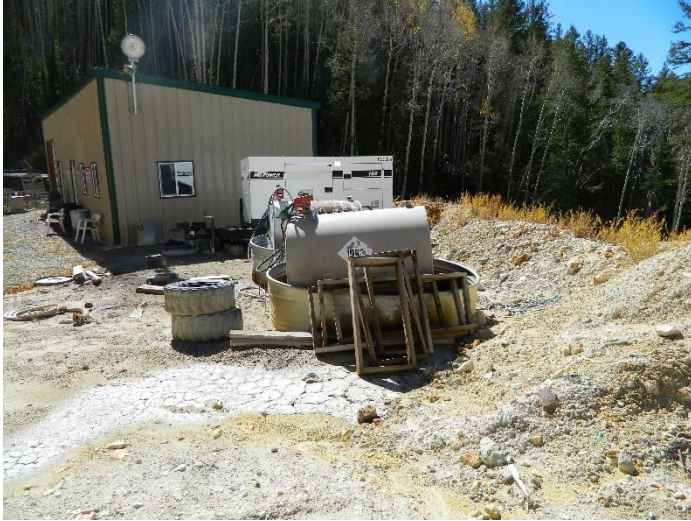
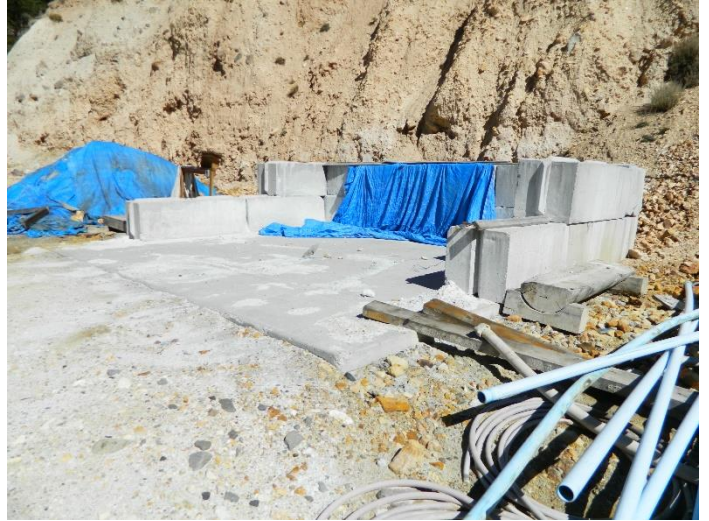
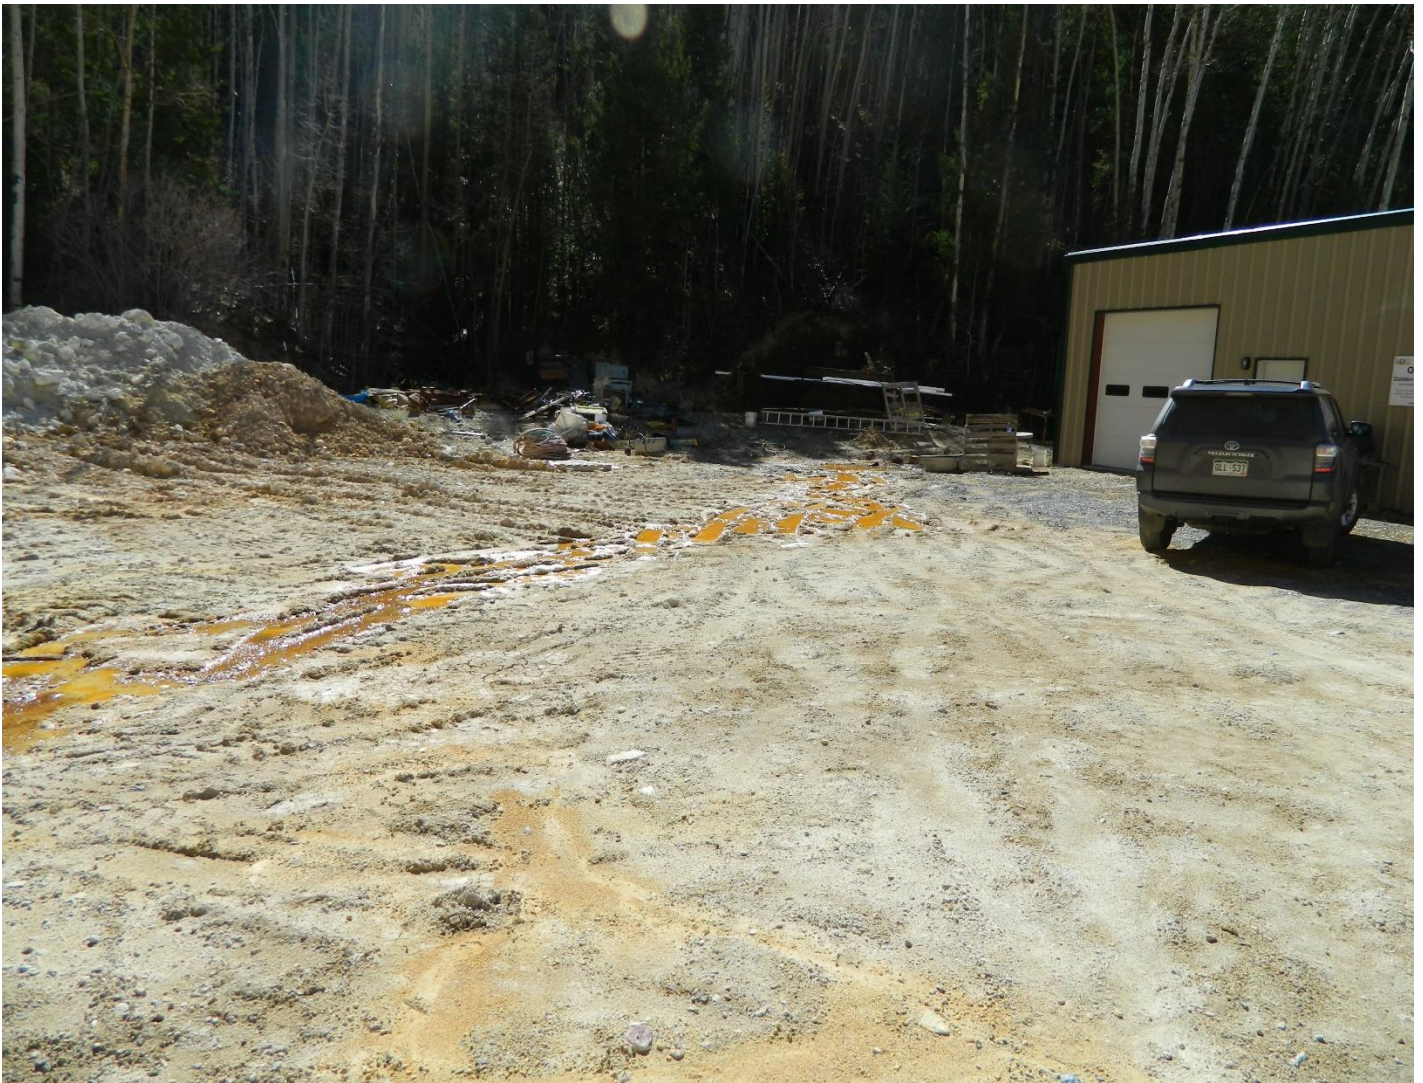
No mining activity was observed. An orange colored mine water discharge was observed exiting the portal. The flow is estimated to be 0.1 gpm. Mr. Abraham stated that when the mine is active the discharge is handled internally but due to no mining activity occurring at the site the discharge now exists. Mr. Abraham stated that he plans to build an additional treatment sump on the mine bench to address the mine water discharge. This is seen as a problem and the corrective action requirements are described above.

Secondary containment for the fuel tanks located on the 6 Level were partially filled with a water and diesel mixture. This is seen as a problem and the corrective action requirements are described in detail above.

INSPECTION TOPIC: Acid And Toxic Materials**PROBLEM/POSSIBLE VIOLATION:** Problem: Improper storage and containment of fuels and/or other hazardous materials was present on site. The fuel storage secondary containment was partially filled with water and diesel.**CORRECTIVE ACTIONS:** All storage tanks, petroleum and any hazardous materials on site for any period of time shall have appropriate secondary containment. The site will also have to comply with all applicable SPCC requirements. Please supply photo documentation that any fuel or hazardous materials containers are stored properly - including applicable secondary containment structures by the corrective action date. Note that secondary containment structures shall consist of an impermeable containment which could contain all contents of the tanks and various containers (when full) plus 10% of the total capacity. The operator may also provide photo documentation that all containers have been removed from the site on or before the corrective action date.**CORRECTIVE ACTION DUE DATE:** 11/30/16**INSPECTION TOPIC:** Hydrologic Balance**PROBLEM/POSSIBLE VIOLATION:** The operator failed to prevent disturbances to the hydrologic balance through inadequate containment or treatment of mine discharge water, specifically; the mine is discharging water at the 6 Level portal. Furthermore, ponds that have been installed are malfunctioning by allowing leakage and loss of containment of the process water. C.R.S. 34-32.5-116(4)(h) and Rule 6.4.7(2)(c)

CORRECTIVE ACTIONS: The operator shall install an additional process water control/treatment system that employs an engineered design and is incorporated into the permit with the submittal and approval of a technical revision.
