COLORADO
Division of Reclamation,
Mining and Safety
Department of Natural Resources

PERMIT INFORMATION

Permit Number: C-1981-008 Mine Name: New Horizon Mine Operator: Elk Ridge Mining and Reclamation, LLC Operator Address: Mr. Tony Tennyson 5731 State Highway 13 Meeker, CO 81641	County: Montrose Operation Type: Surface Permit Status: Active Ownership: Private
	Operator Representative Present: Cliff Chiles
Operator Representative Signature: (Field Issuance Only)

Inspection Start Date: May 1, 2017 Inspection Start Time: 14:00 Inspection End Date: May 2, 2017 Inspection End Time: 12:00		Inspection Type: Coal Partial Inspection Inspection Reason: Normal I&E Program Weather: Clear	
Joint Inspection Agency: None		Joint Inspection Contacts: 	
Post Inspection Agency: None		Post Inspection Contacts: 	
Inspector(s): Brock F. Bowles	Inspector's Signature:

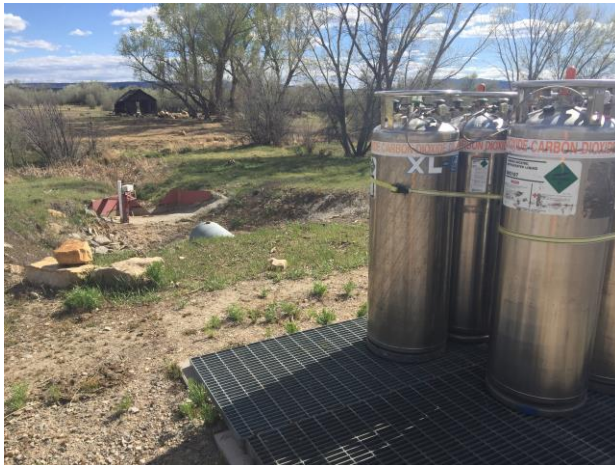
Photo 1 – Pond 7 Discharge Structure

Pond 7 contained water but was not discharging. The surrounding fields that drain to pond 7 were being irrigated. The CCC Ditch started providing water for the irrigation season. CO2 tanks were in place to treat the Pond 7 discharge when the water reaches the level of discharge (photo 1).

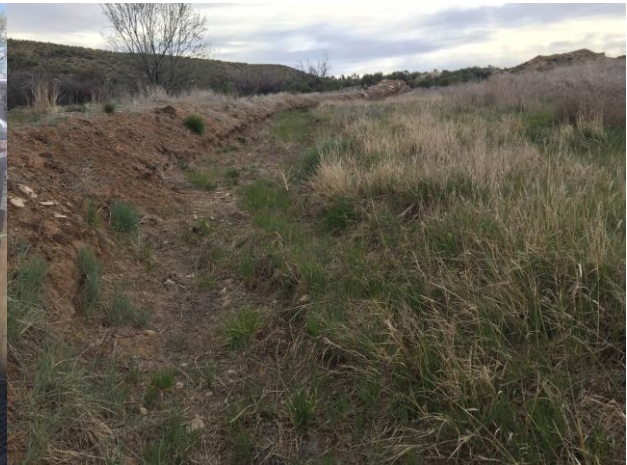
Photo 2 – Ditch C7

Pond 12 contained water but was not discharging. Ditch C7 that flows to Pond 12 has been cleared of debris (photo 2). The pond discharge structure was free and clear of obstructions. The inlet structure from Ditch C8 was in good condition.

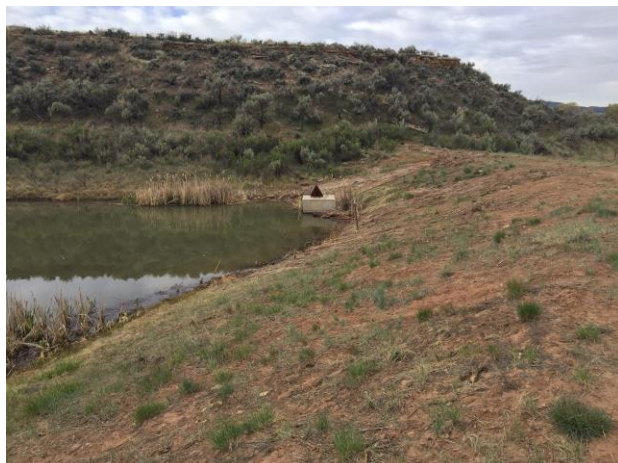
Photo 3 – Pond 13 Discharge Structure

Pond 13 contained water and was discharging. The trench drain was also discharging. The cattails that surrounded the Pond 13 primary discharge structure have been removed (photo 3). Ditch C9 that flows to Pond 13 has been cleared of debris.

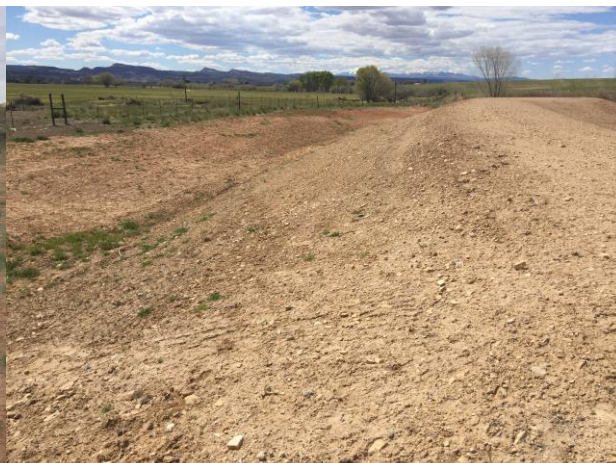
Photo 4 – Pond 18 Embankment

Pond 18 did not contain water. The embankment appeared to be stable (photo 4). Grasses were starting to sprout on the embankment.

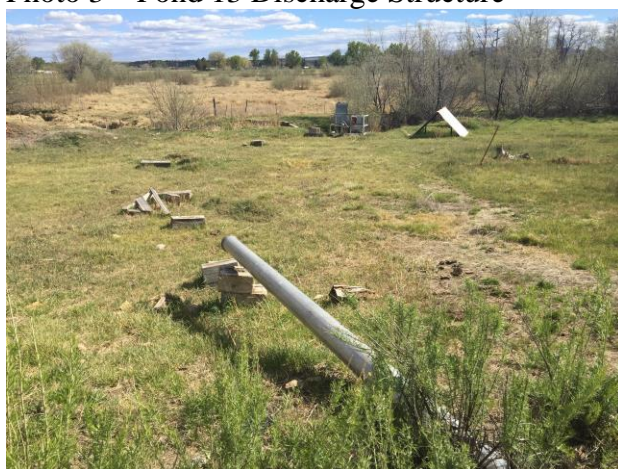
Photo 5 – Pump Station on Calamity Draw

Water was not being pumped from Calamity Draw to irrigate the fields on the south side of 5th Street as has been done in the past. The pump from Calamity Draw was not assembled (photo 5). Irrigation water was being directed from the CCC Ditch on the north side of 5th Street through an irrigation pipe under 5th Street. A wheel

line irrigation system was being utilized on both sides of 5th Street.

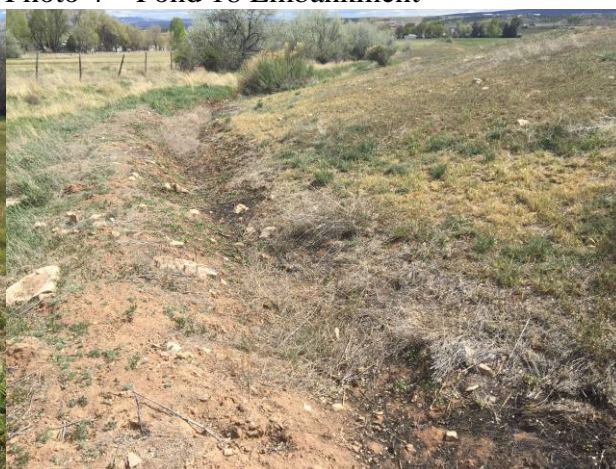
Photo 6 – Topsoil Ring Ditches by Facilities

The ring ditches around the topsoil piles by the facilities area have been maintained. The weeds have been removed/burned (photo 6) and the sediment wattles were in place. A few thistle rosettes on the southeast corner were noted in the ring ditch and need to be treated.
