MINERALS PROGRAM INSPECTION REPORT
PHONE: (303) 866-3567

MINE NAME: Pioneer Mine	MINE/PROSPECTING ID#: M-1977-252	MINERAL: Clay (general)	COUNTY: Douglas
INSPECTION TYPE: Monitoring	INSPECTOR(S): Peter S. Hays	INSP. DATE: May 10, 2017	INSP. TIME: 10:30
OPERATOR: General Shale Brick, Inc.	OPERATOR REPRESENTATIVE: Jason McGraw	TYPE OF OPERATION: 112c - Construction Regular Operation	
REASON FOR INSPECTION: Priority	BOND CALCULATION TYPE: Partial Bond	BOND AMOUNT: \$91,243.00	
DATE OF COMPLAINT: NA	POST INSP. CONTACTS: None	JOINT INSP. AGENCY: None	
WEATHER: Raining	INSPECTOR'S SIGNATURE:

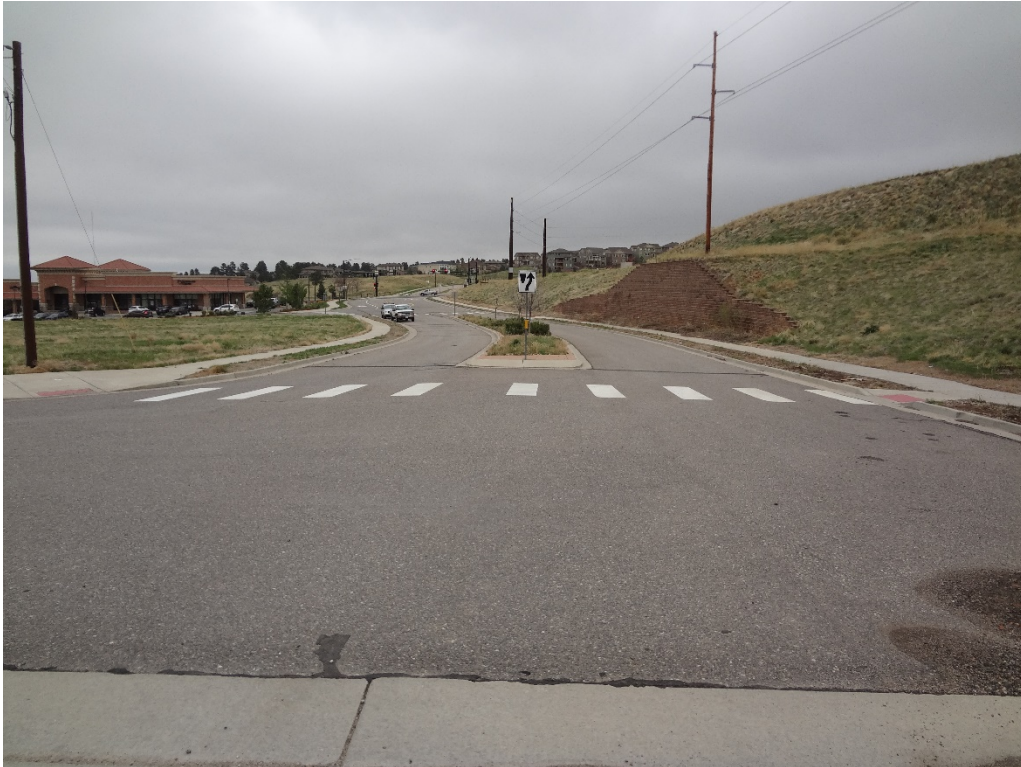
Pine Bluffs Way looking north from south end of road

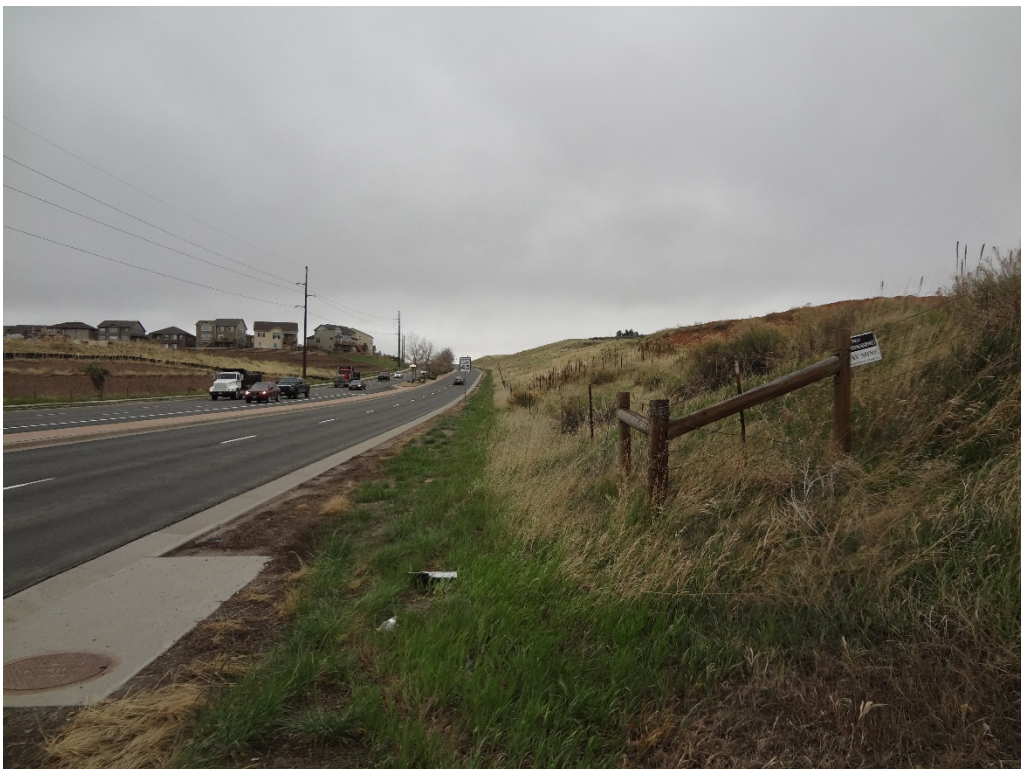
Hess Road looking east from the northwest corner of the permit boundary
