PERMIT INFORMATION

Permit Number: C-1996-084 Mine Name: Lorencito Canyon Mine Operator: New Elk Coal Company, LLC Operator Address: Mr. Louis Head 12250 Highway 12 Weston, CO 81091	County: Las Animas Operation Type: Surface Permit Status: Permanent Cessation Ownership: Private
	Operator Representative Present: Vince Massarotti
Operator Representative Signature: (Field Issuance Only)

Inspection Start Date: April 27, 2017 Inspection Start Time: 13:40 Inspection End Date: Inspection End Time:	Inspection Type: Coal Partial Inspection Inspection Reason: Normal I&E Program Weather: Clear
Joint Inspection Agency: None	Joint Inspection Contacts:
Post Inspection Agency: None	Post Inspection Contacts:
Inspector(s): Robert D. Zuber, P.E.	Inspector's Signature: <i>Robert D. Zuber</i> Signature Date: 5/1/2017

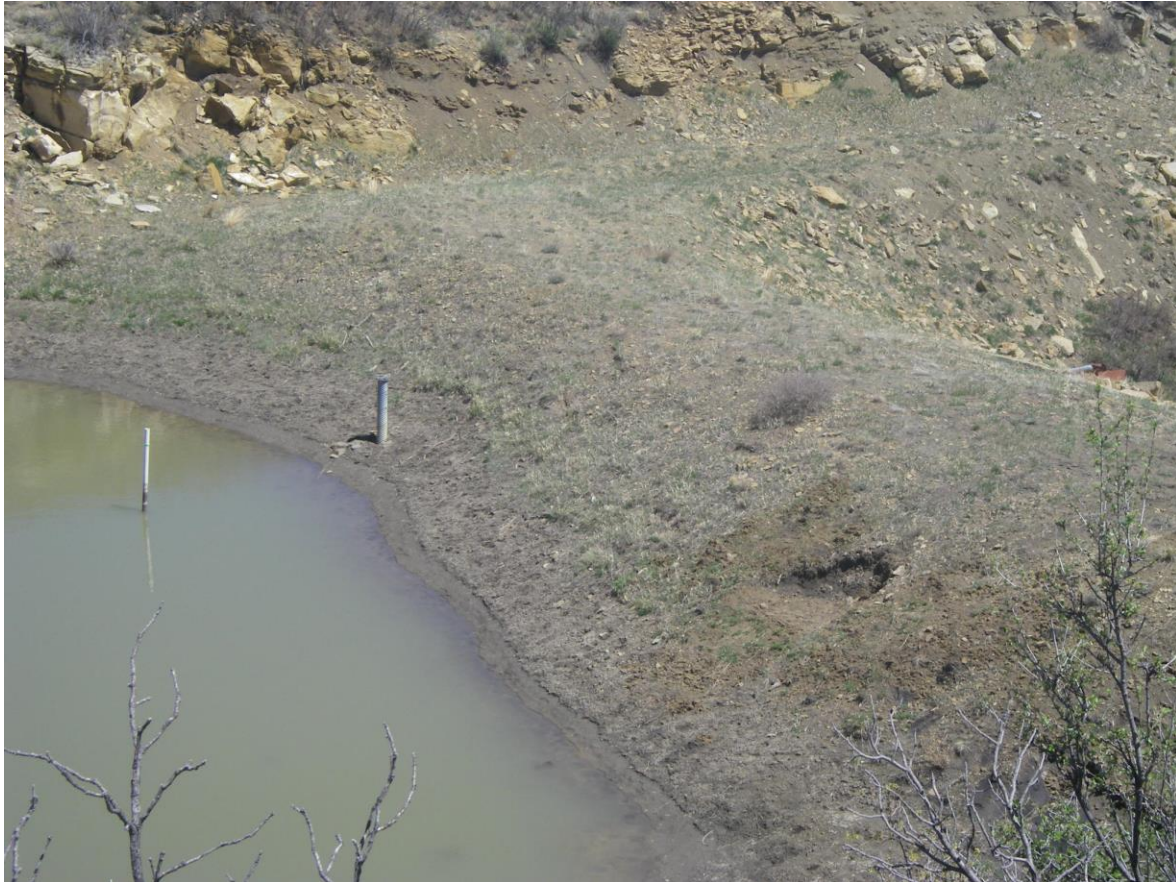
Pond 9A embankment with damage

The damage on the Pond 9A embankment requires repair. If the third party does not perform the work by the time NECC takes equipment to the Lorencito Canyon site for spring maintenance, NECC should perform the work.

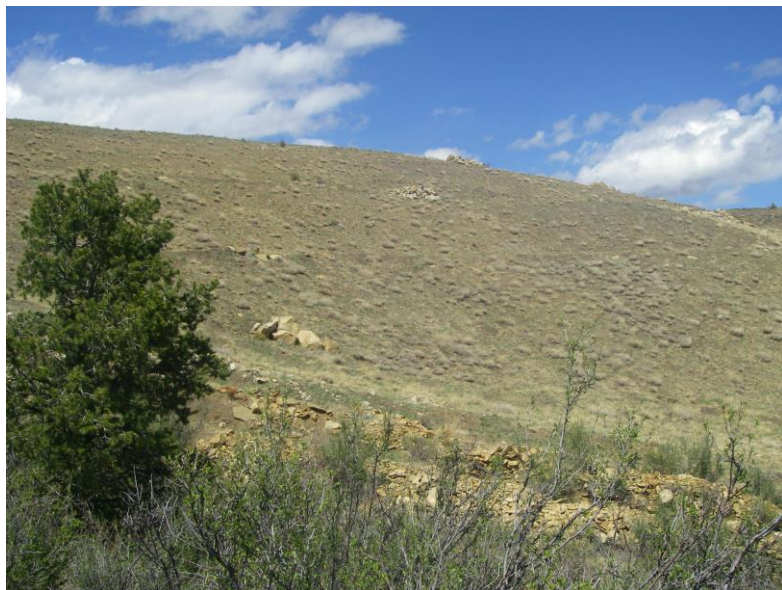
Fills 7, 8, and 9 were inspected, and all were generally in good condition. No large bare areas or weed patches were seen, and some new vegetation is present on the south-facing fills (7 and 9). There were no signs of instability or erosion on the faces, except for rills on Fill 7. These may not require repair (despite notes in past inspections) due to the appearance of self-healing, but close monitoring is highly recommended. The east channel at Fill 9 has some erosion at the bottom; the benefits of adding riprap should be weighed against the damage of driving on the fill with heavy equipment.

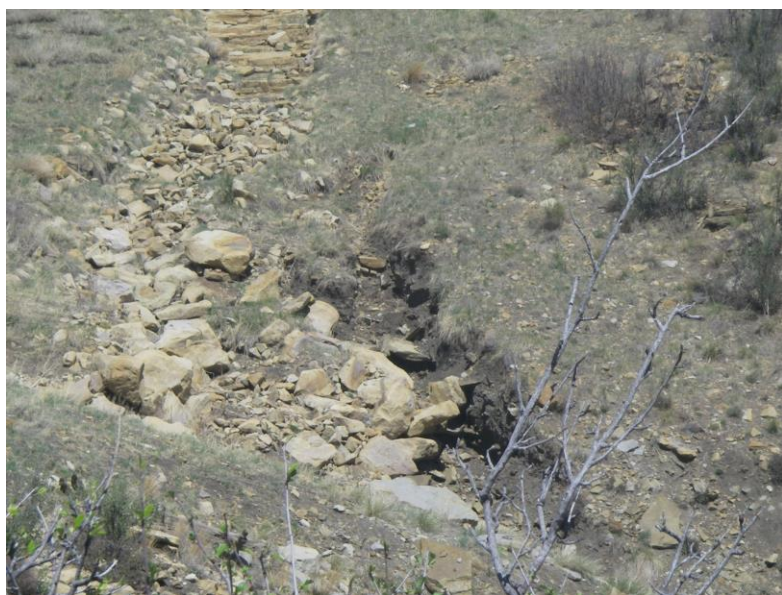
East channel of Fill 9 – possible need for more riprap

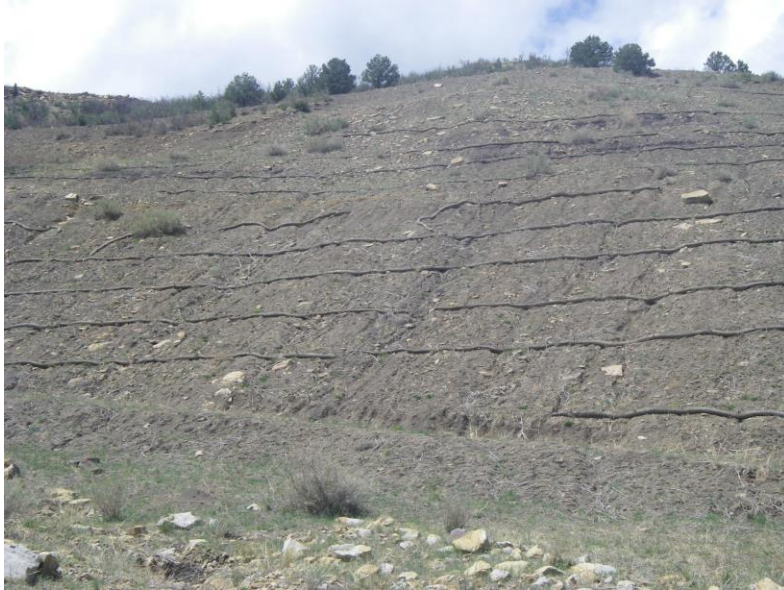
On the hillside above Pond 6 (where Fill 6 was planned), erosion is not currently a large problem, but rills may soon undercut the wattles, and maintenance of the wattles is needed.

Damaged wattles on hill above Pond 6

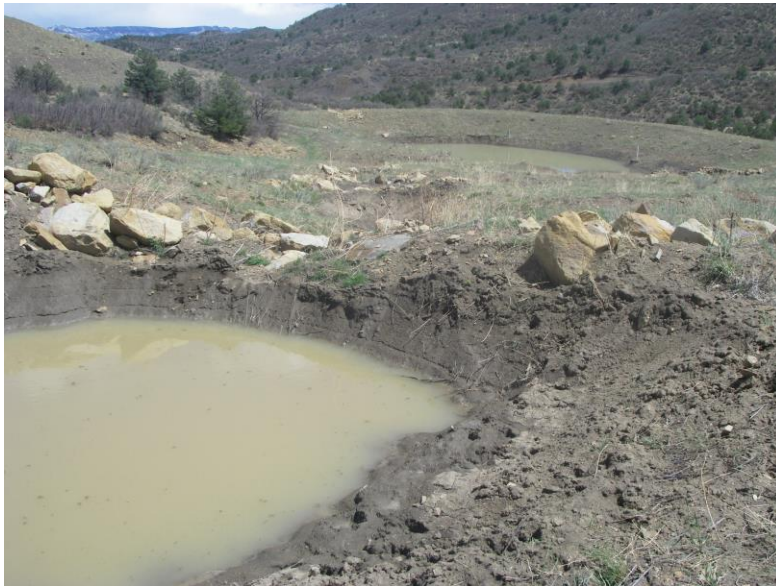
Ditches and check dams above Pond 6 appear to be functioning well.

Check dams above Pond 6

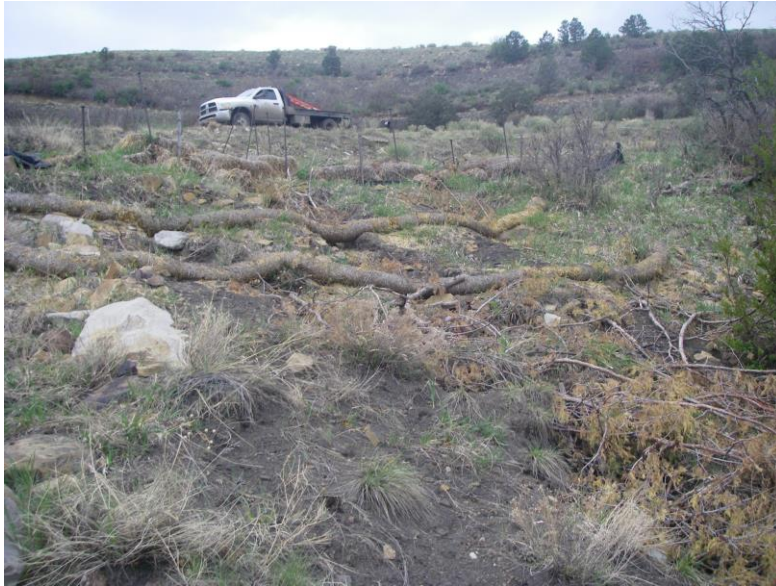
The following ponds were inspected: 6, 7, 8, 9, and 9A. None of them were discharging, although none of them were dry. Embankments and spillways were generally in good condition (exception: see Slides and Other Damage section of this report). The rills on the downstream side of the Pond 9 embankment have been addressed by NECC with branches and other erosion control practices. These appear to be functioning well.

Sediment and erosion controls below Pond 9
